Overtopping Tests on Lime Treated Clay in the Hedwigepolder

Overall report

Client	Waterschap Limburg
Contact	A. Gerrits
Reference	Order HWBP, POV DGG
Keywords	Lime treated clay, overtopping, erosion inner slope, dikes

Version	1.0
Date	20-12-2022
Project nr.	11206930-004
Document ID	11206930-004-GEO-0001
Pages	78
Classification	
Status	final

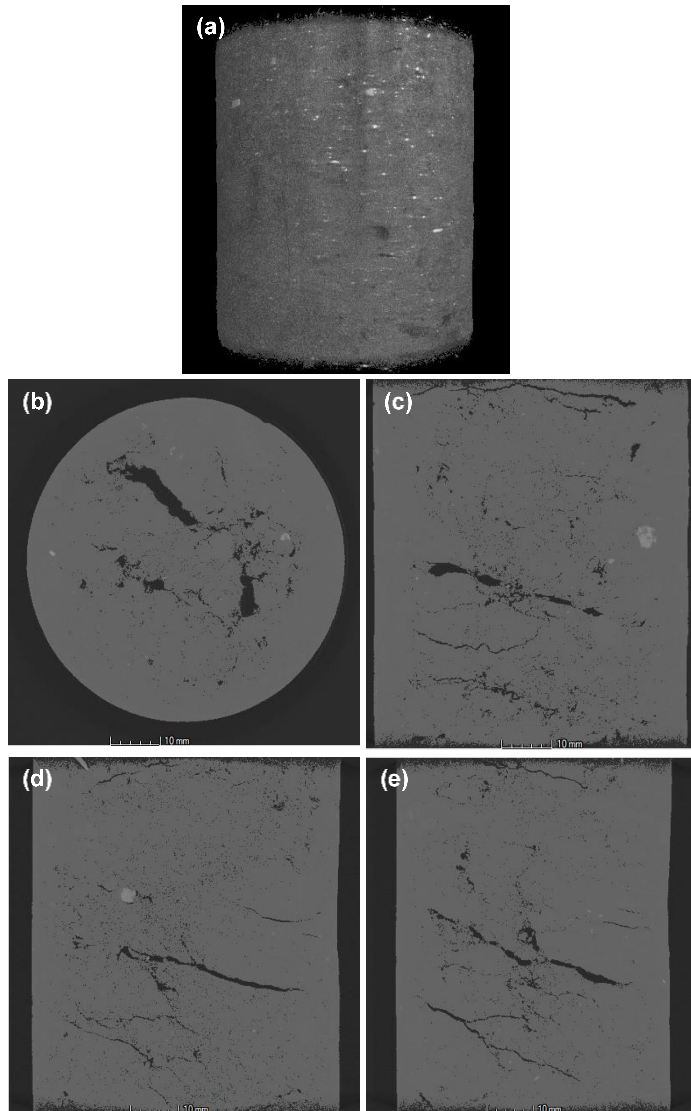
Figure 4-4 X-Ray μ CT scans on samples TXL_S1_1C: (a) 3D reconstruction image of the surface of the clay sample, (b) horizontal and (c), (d), (e) vertical sections of the sample.

The samples showed many defects. Apparently the method of taking samples does not provide trustworthy results. The alternative explanation, that the deficiencies are already present in the material in the slope prior to sampling, is considered less probable. By communication of Lhoist past experiences in France also lead to serious doubts about the integrity of the specimens microstructure after the coring operations.

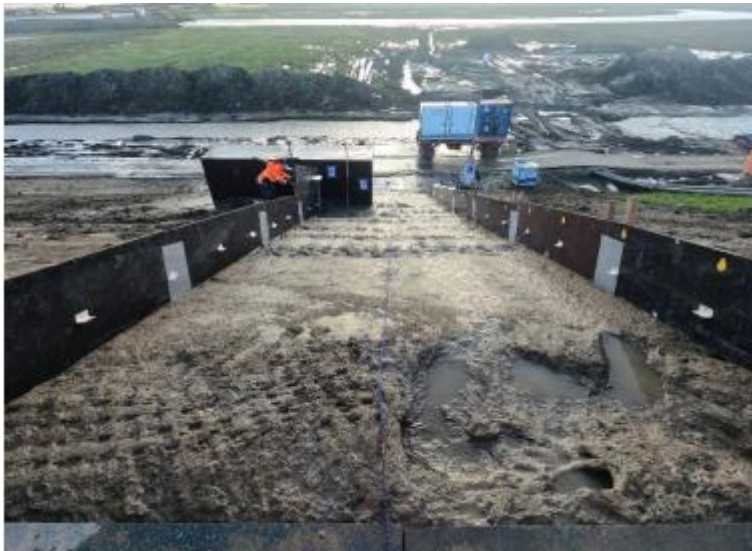
Figure 6-2 Erosion near the crest after 50 l/s/m'.

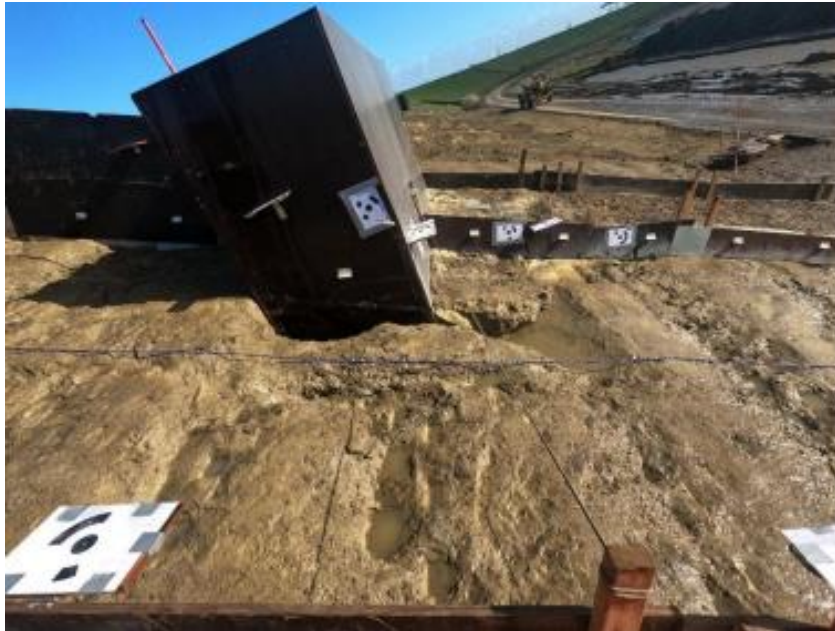
Figure 6-3 Erosion also below the obstacle.

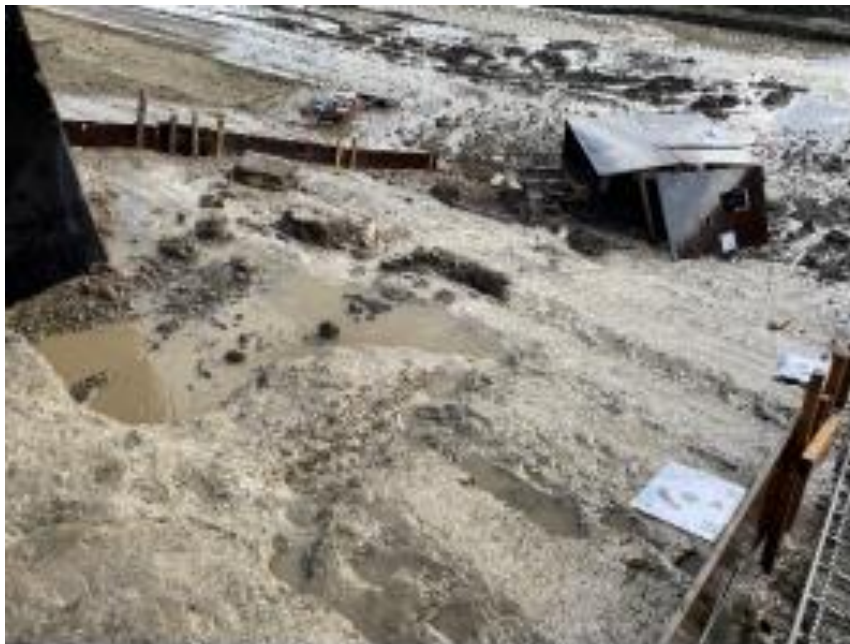
Figure 6-4 The failed obstacle.

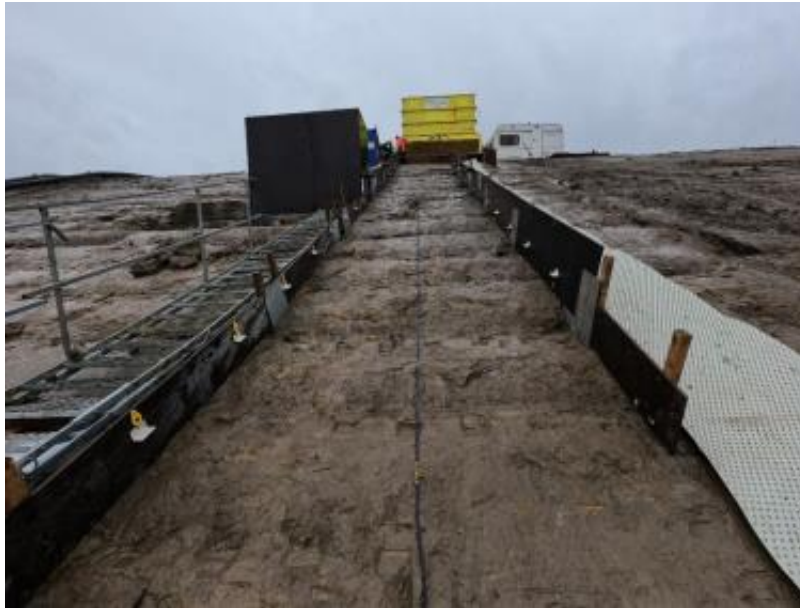
Figure 6-5 Test section 1B and erosion trench next to the obstacle after the test with 10 l/s/m'.

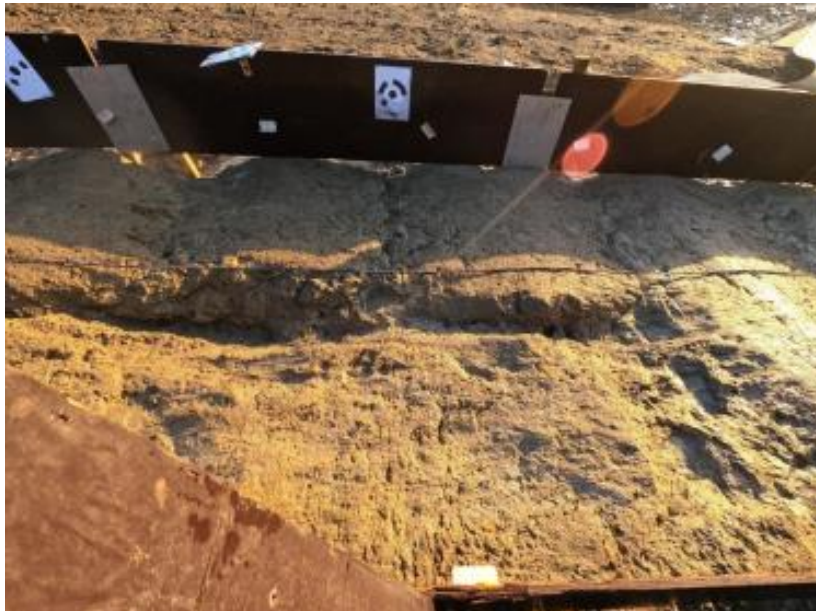
Figure 6-6 The erosion trench after the last test (2m 50 lsm).

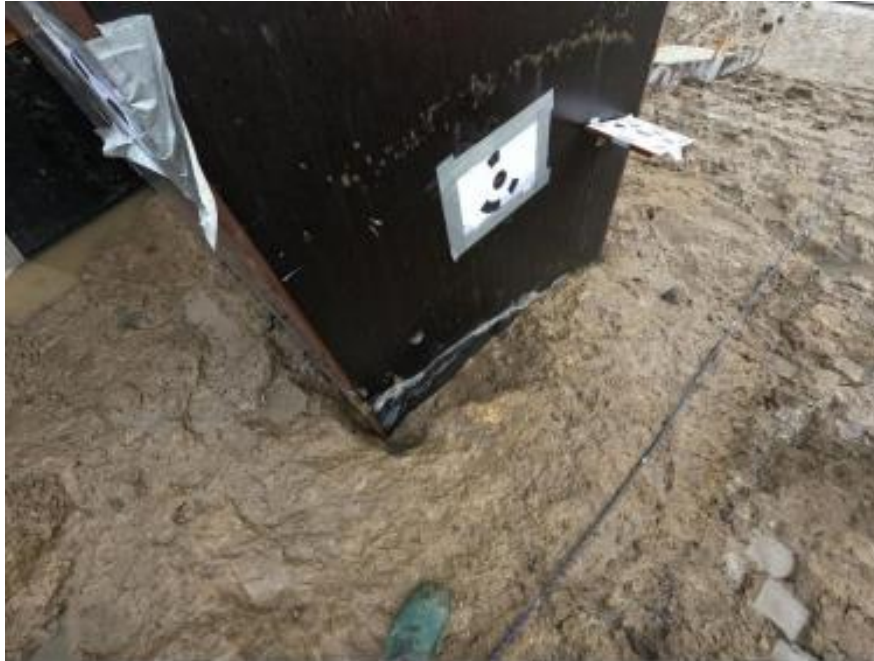
Figure 6-7 Erosion around the object after the final test (2m 50 lsm).

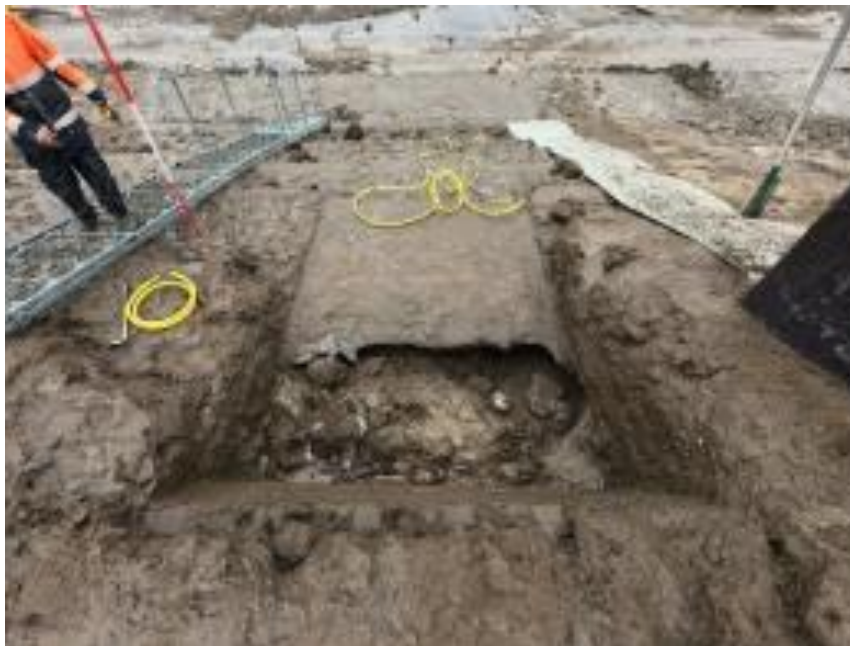
Figure 6-10 One step has been eroded and the next step is seriously undermined (picture courtesy of Infram).

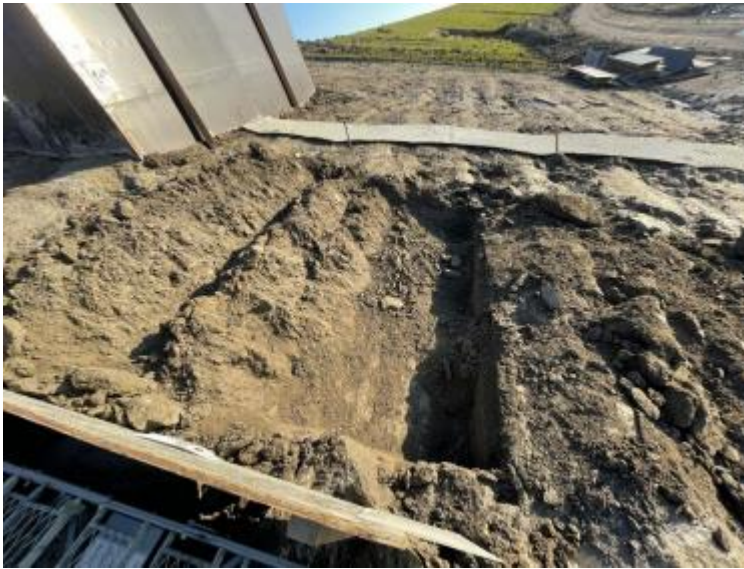
Figure 6-11 A Vertical cliff was dug into the slope (picture courtesy of Infram).

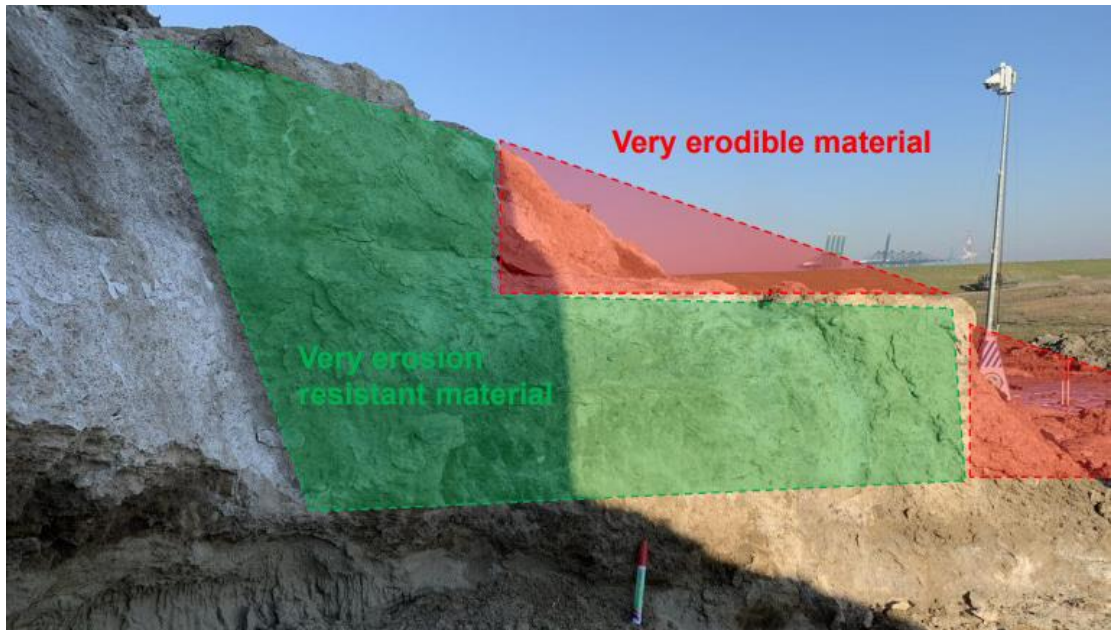
Figure 8-4 The division between very erosion resistant material and very erodible material as observed on site (courtesy Lhoist).

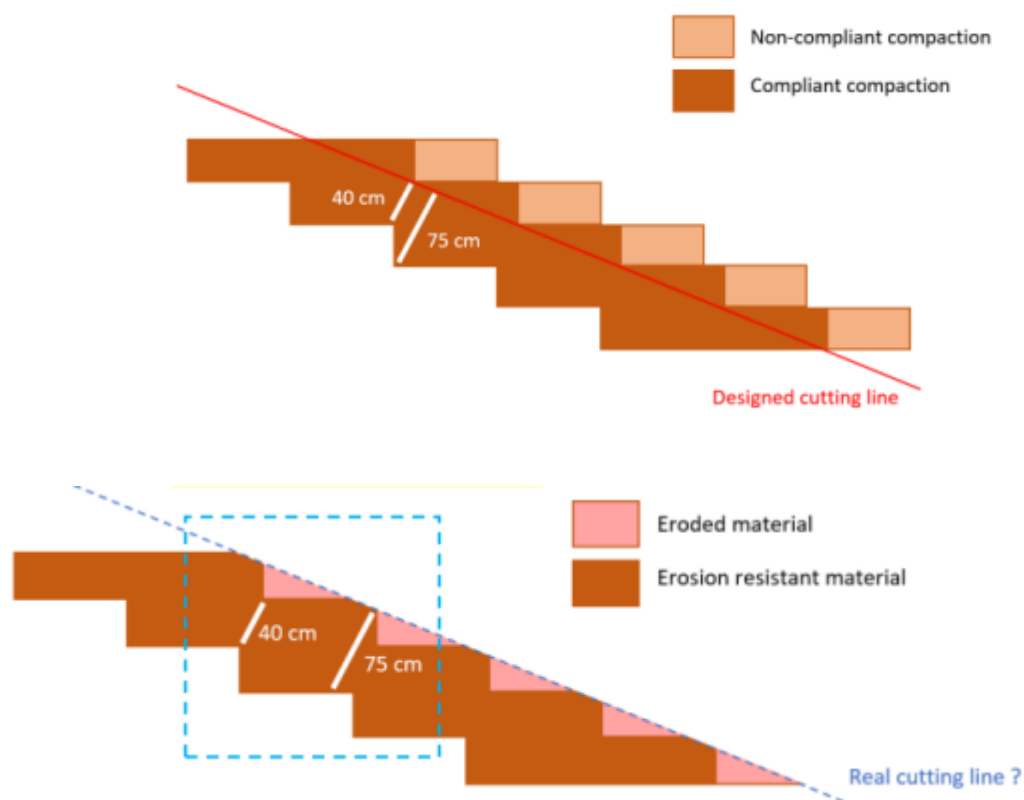
Figure 8-5 The difference between correct cutting line (above) and incorrect cutting line (below) (Courtesy Lhoist).

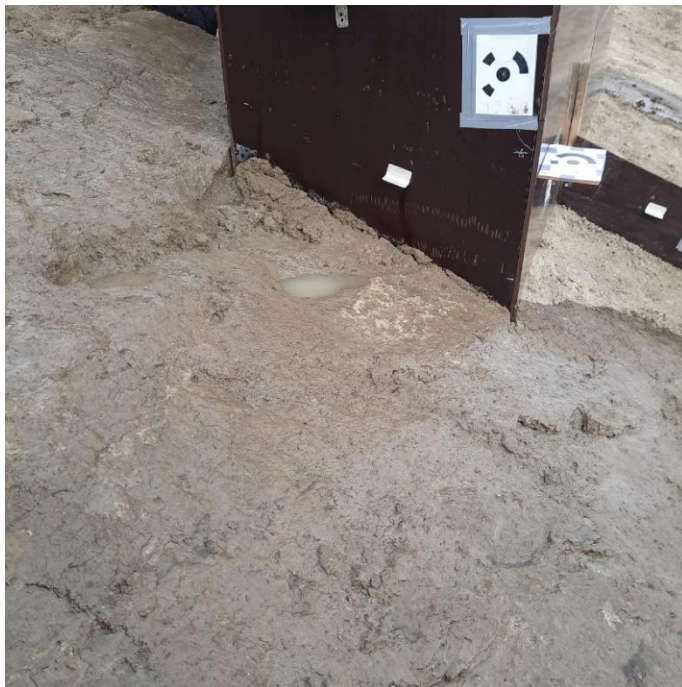
Figure 8-7 After the first tests: a maximum erosion depth of about 20 cm next to the obstacle.

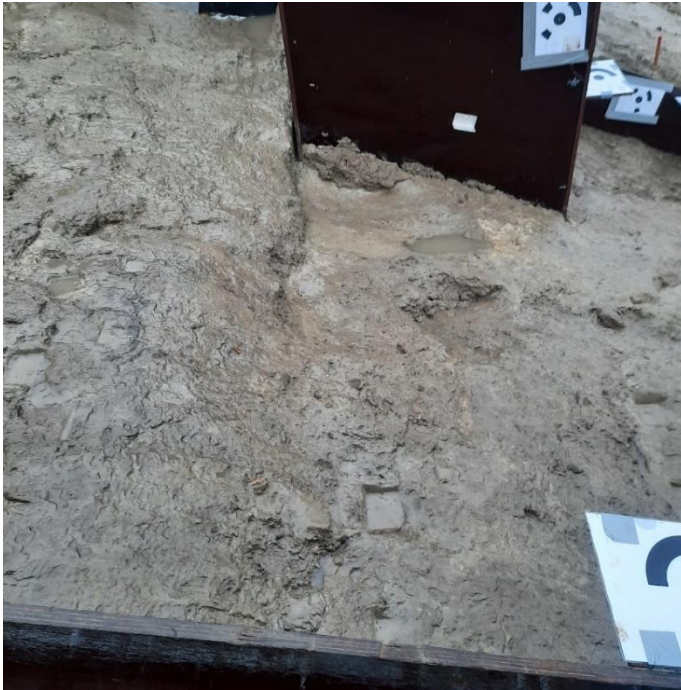
Figure 8-8 Shortly before the construction failed; the erosion has deepened to a maximum of (locally) 50 centimetres.

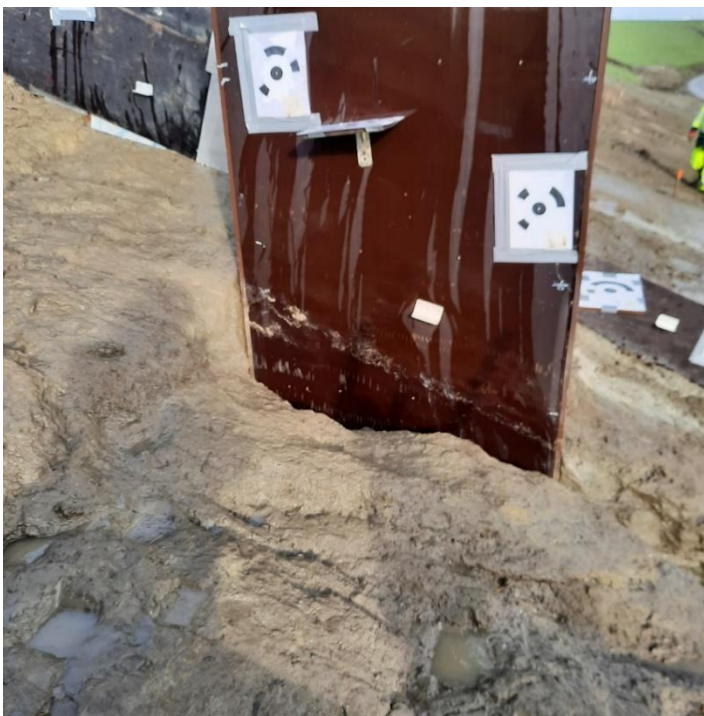
Figure 8-9 Shortly before the construction failed; the erosion has deepened to a maximum of (locally) 50 centimetres (Please observe that the layer thickness on the upward stream side of the object is more than 40 cm of thickness, which was the minimum thickness of the cover layer).

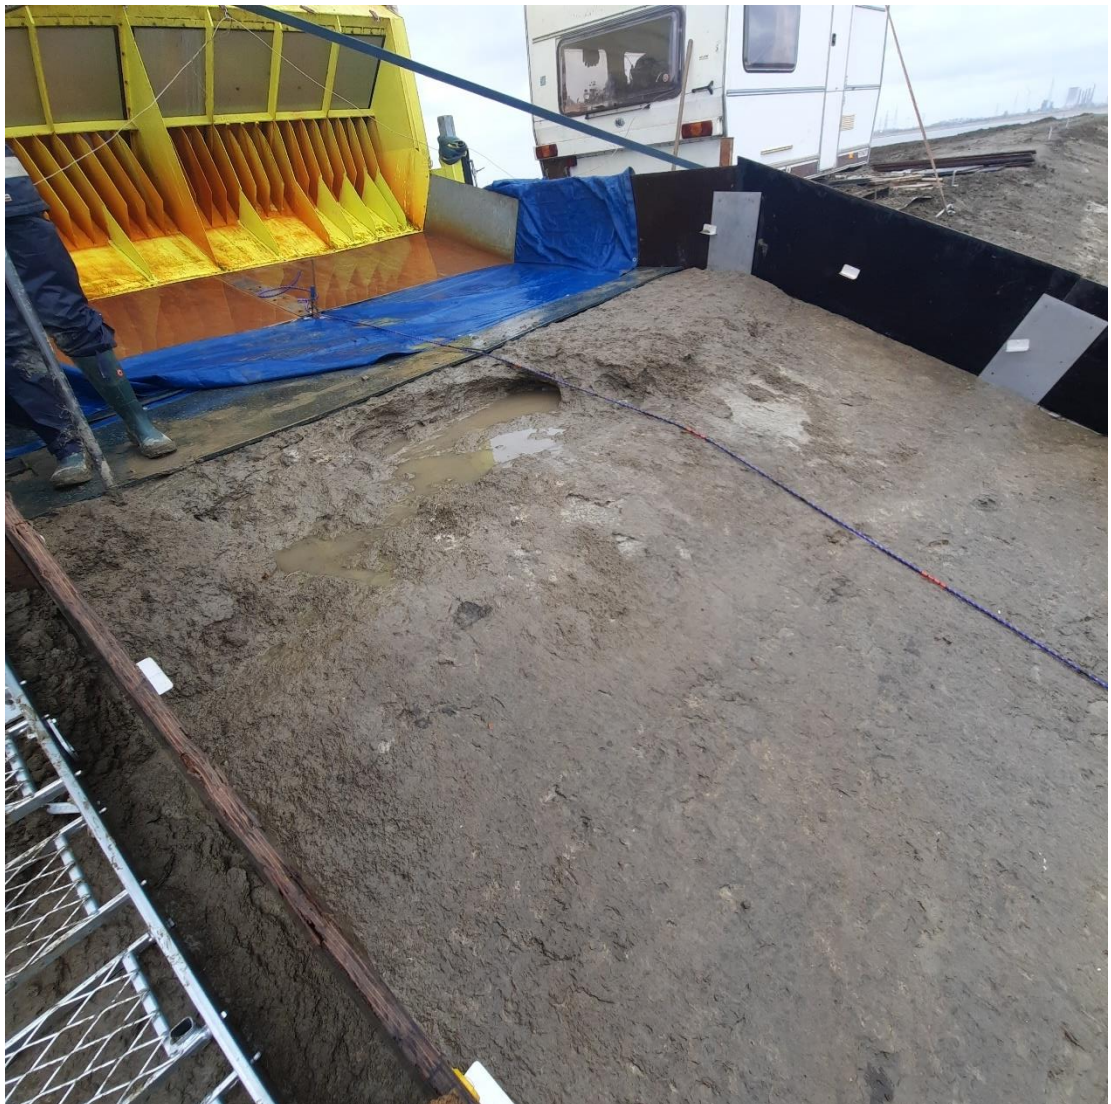
Figure 8-11 Erosion near the crest in section 1A.

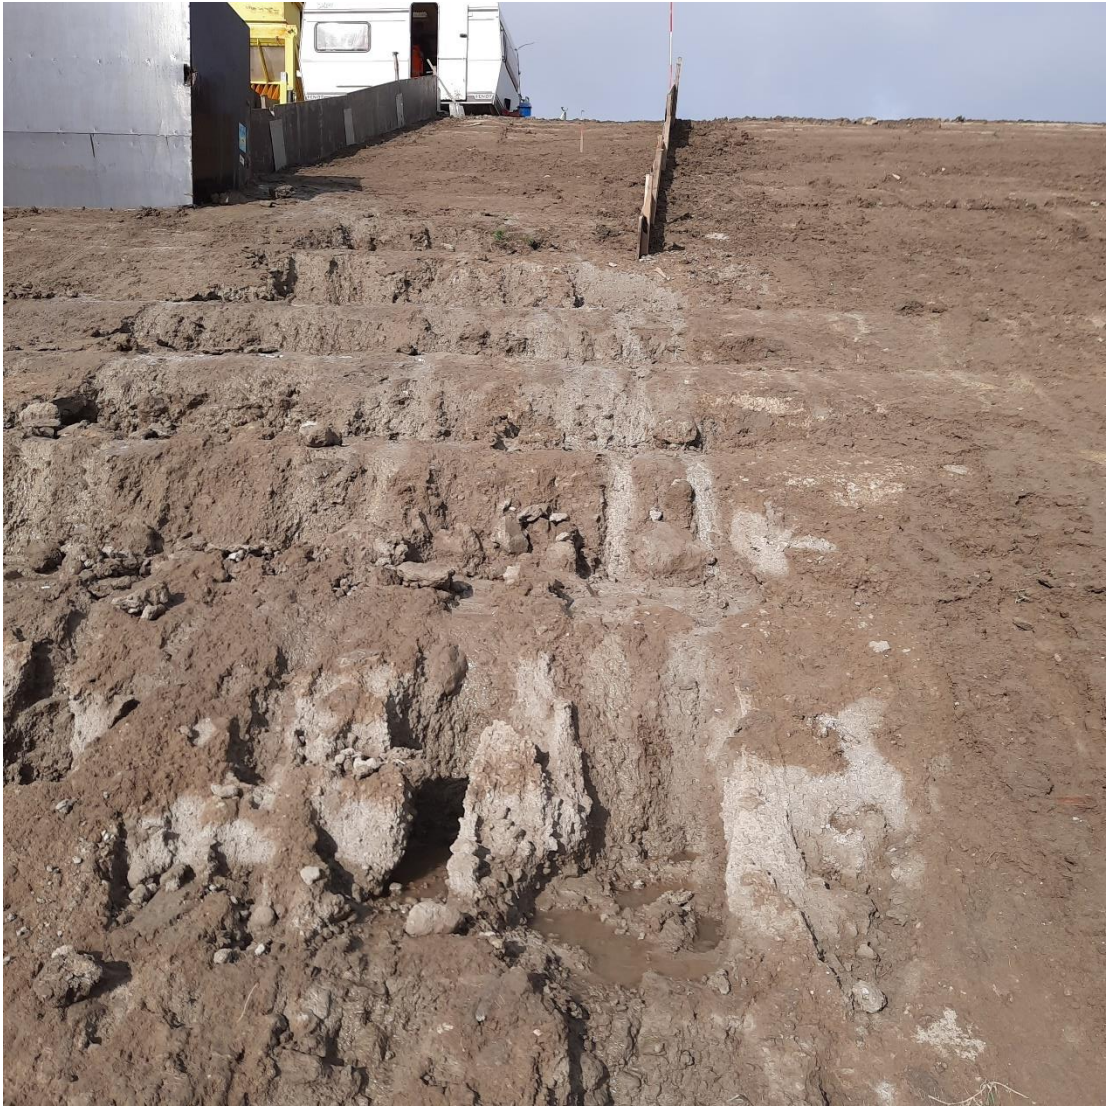
Figure 8-12 Erosion in the lower part of Section 2B.

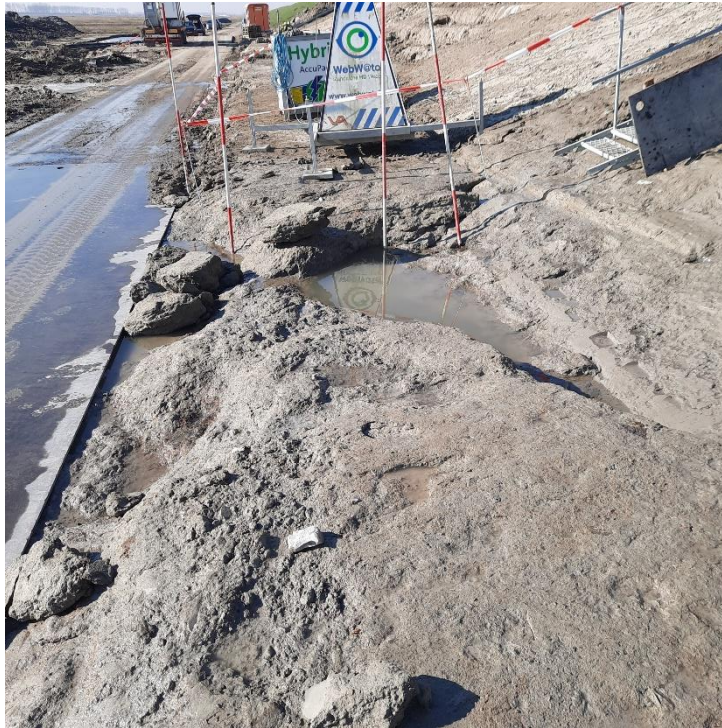
Figure 8-13 Erosion on the berm in section 2B.

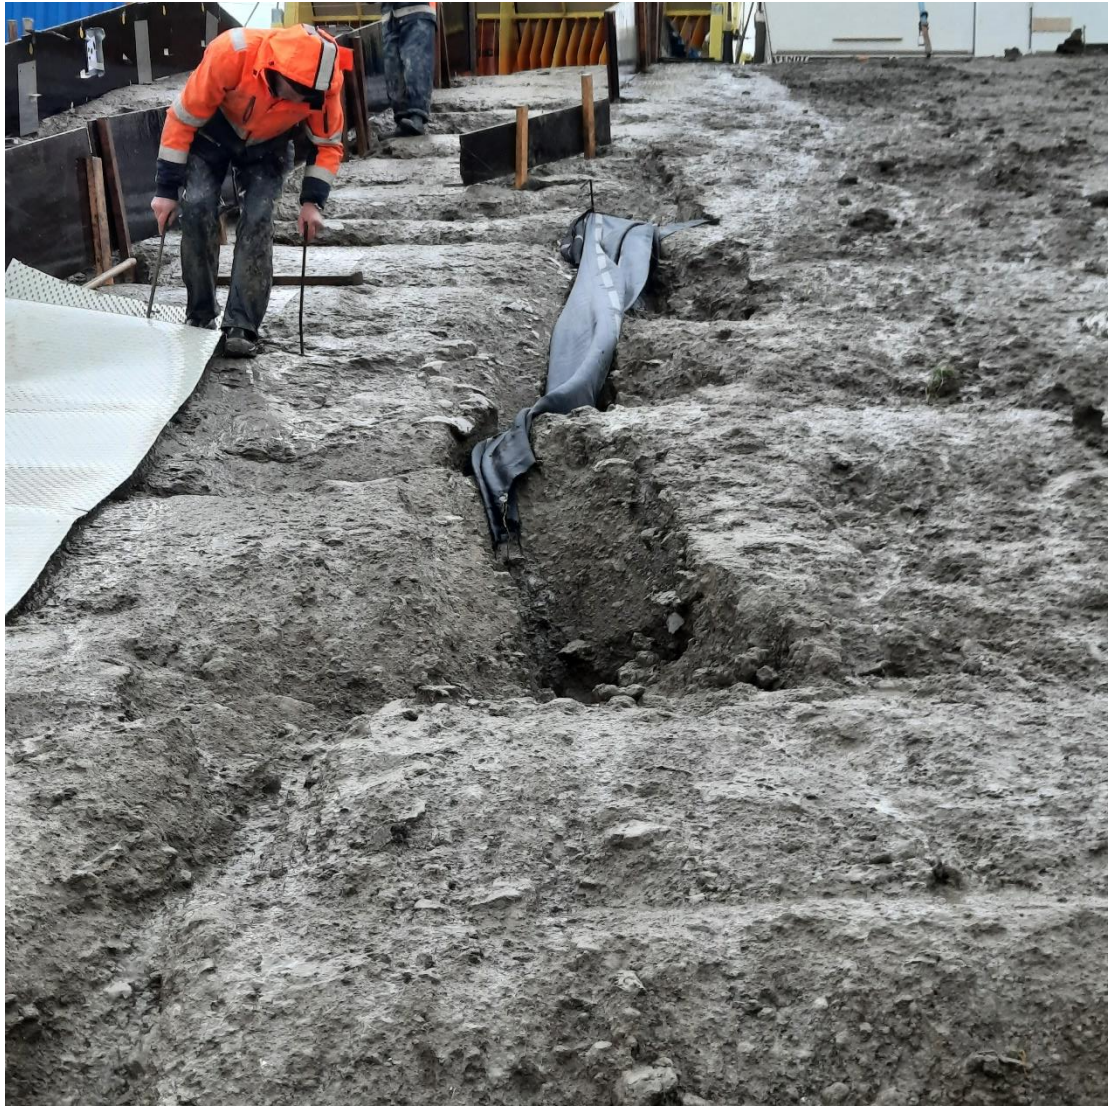
Figure 8-14 The difference between compacted treated clay and non compacted treated clay: the large erosion gaps are on the boundary between treated and densified material and material from the transition zone where no compaction took place. The erosion gullies are not the result of very large amounts of water flowing down the slope, but result from leakage water underneath the boarding of the test section.
