Morpho-dynamics of supply limited rivers with weirs: case study of the River Meuse

Sediment balance and morphological processes

Hermjan Barneveld, 21 September 2021

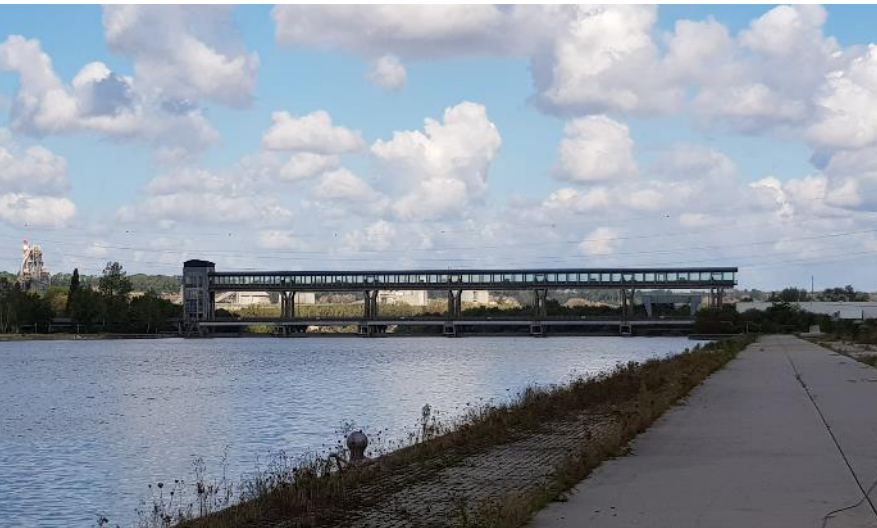
Key factors controlling longitudinal bed

1. Influence of weirs, sediment management, sediment mining and natural processes on the morphological system and sediment connectivity?
2. Establish the key factors controlling longitudinal bed profile development at a decadal scale.

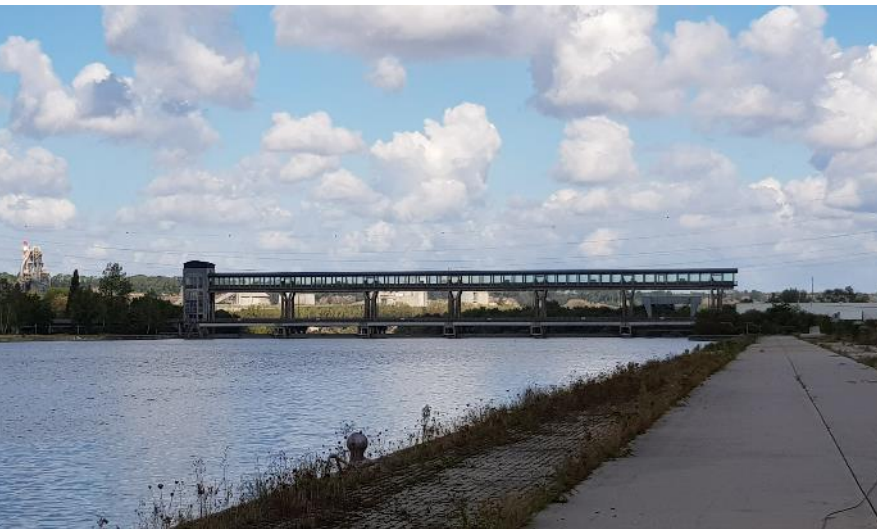
Key factors controlling longitudinal bed

1. Influence of weirs, sediment management, sediment mining and natural processes on the morphological system and sediment connectivity?
2. Establish the key factors controlling longitudinal bed profile development at a decadal scale.

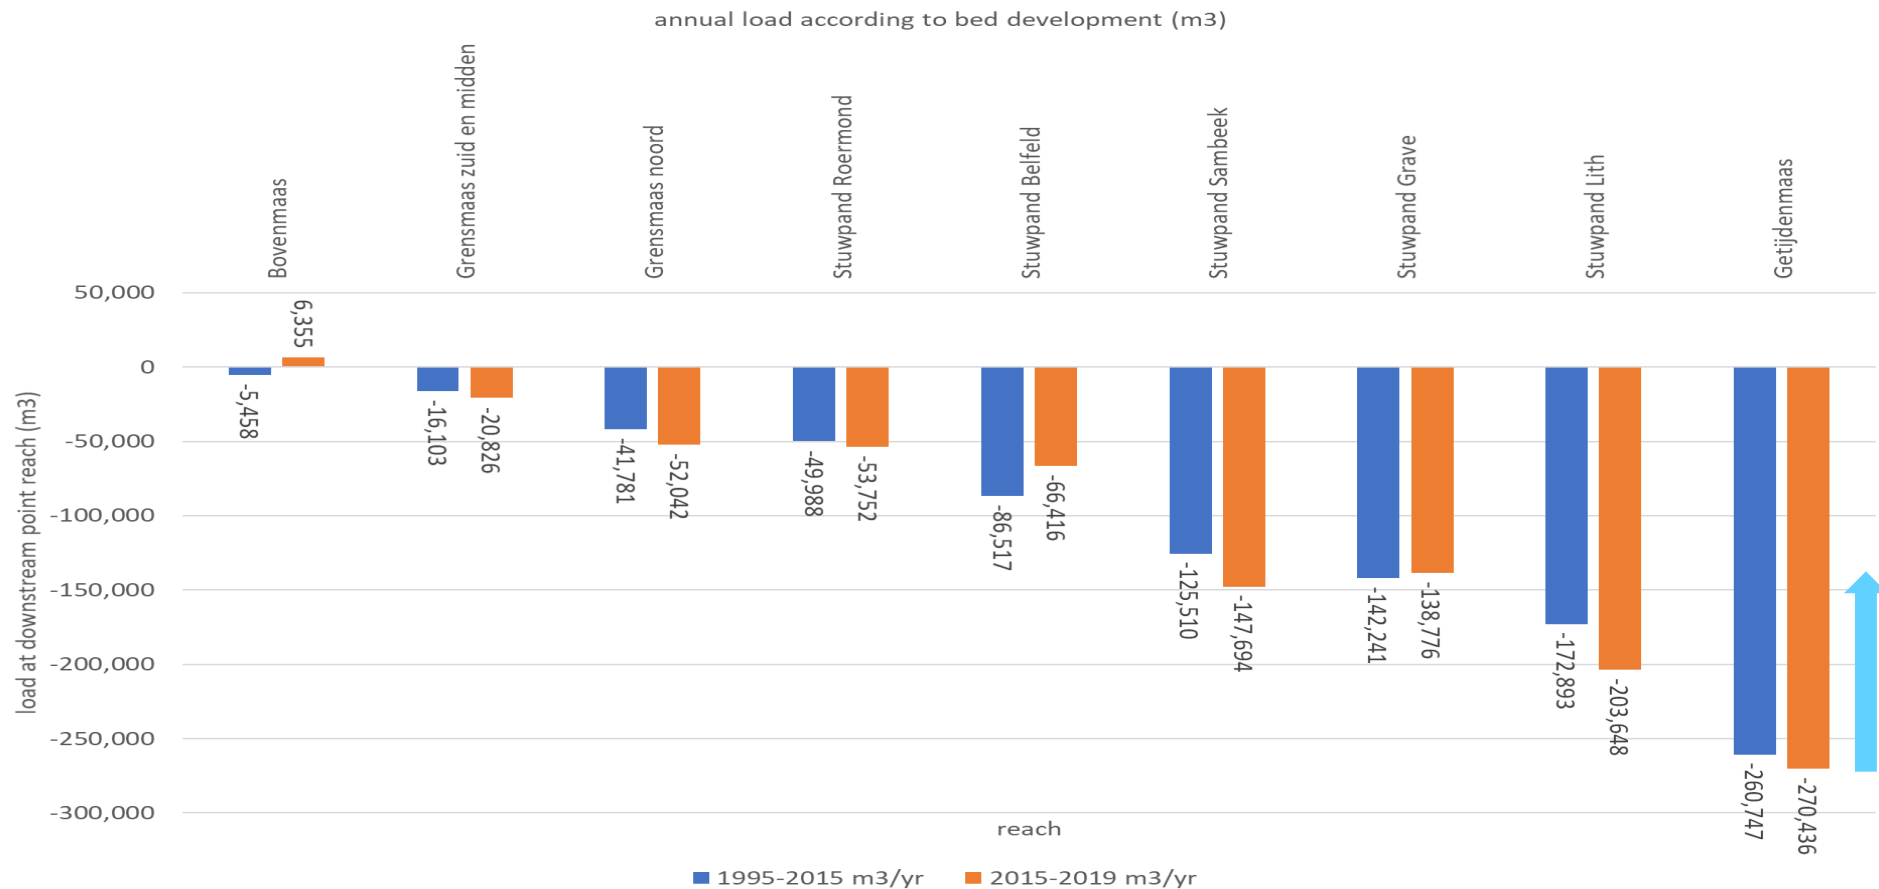
- Include impact of dredging, aggradation floodplains, tributaries, eroding banks, missing bed level information

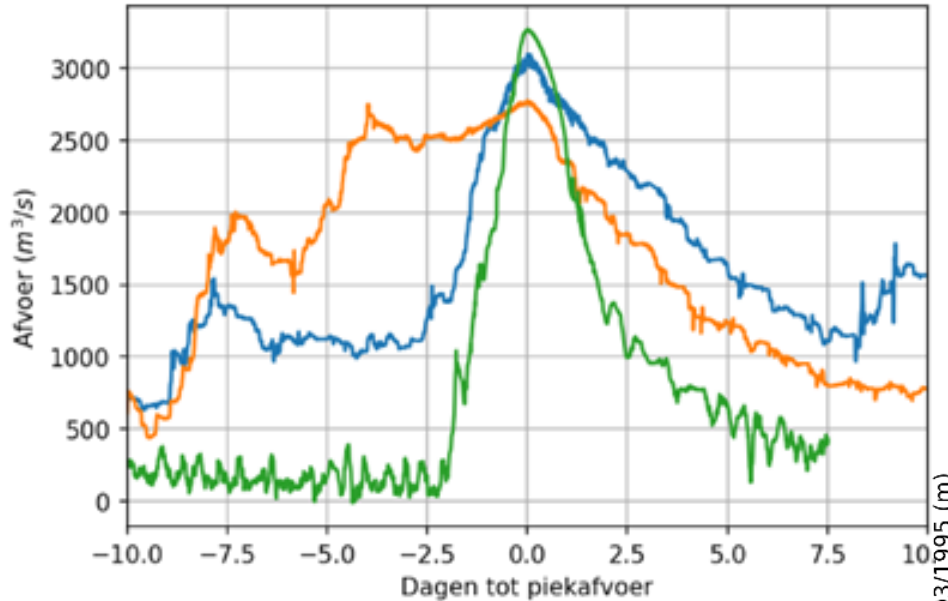
Source: Hoogwater 2021 Feiten en Duiding (Flood 2021 Facts and Figures), Sept 2021

- 1:100 – 1:200 flood at border
- For summer much lower frequency
- Downstream less extreme in peak discharge and water level (1:5-1:10)

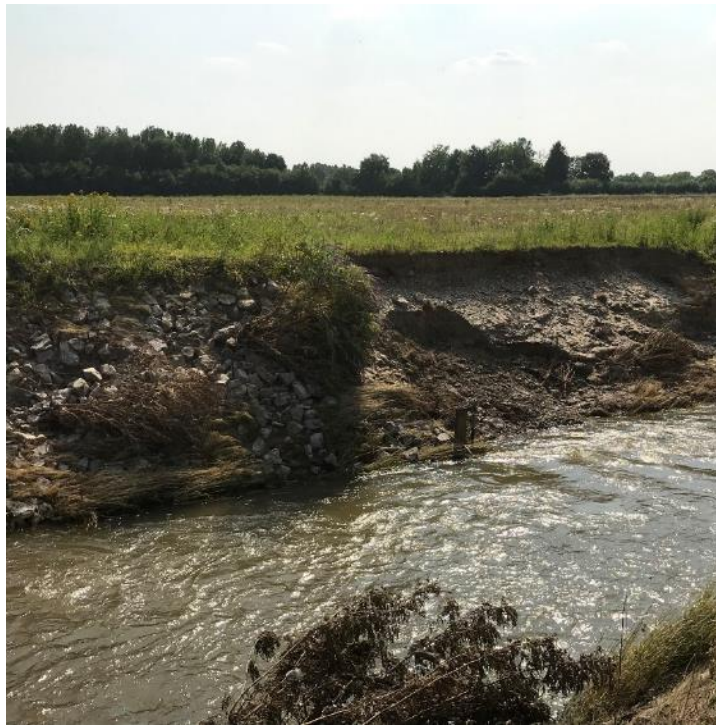
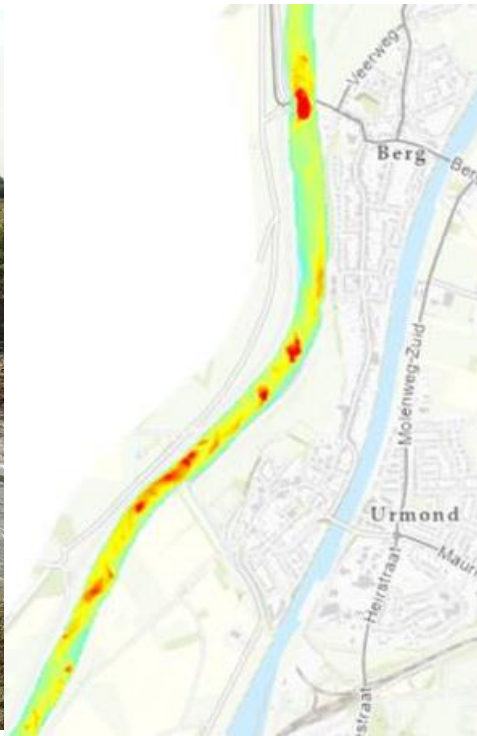
Flood July 2021 – morphological changes

Source: Data RWS-CIV

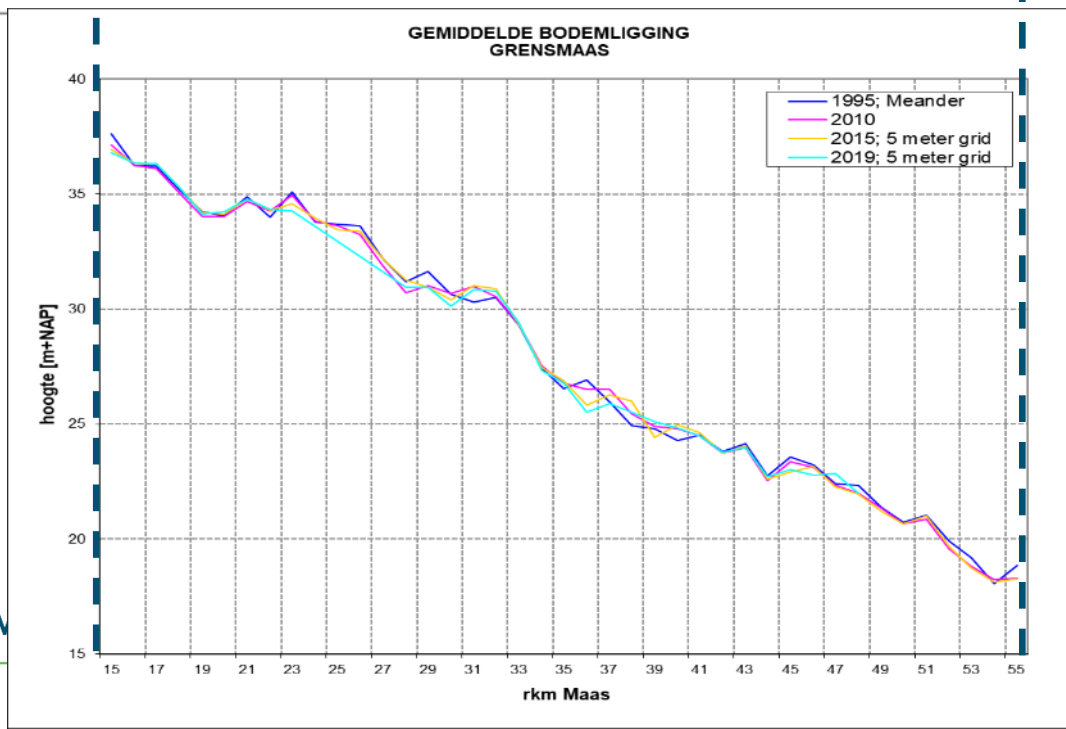
Source: Meijer D.G., J. Lambeek en J.D. van der Werff ten Bosch (2011): Inventarisatie en interpretatie ondergrondgegevens Maas.

Bed erosion ≈ 2 cm/yr

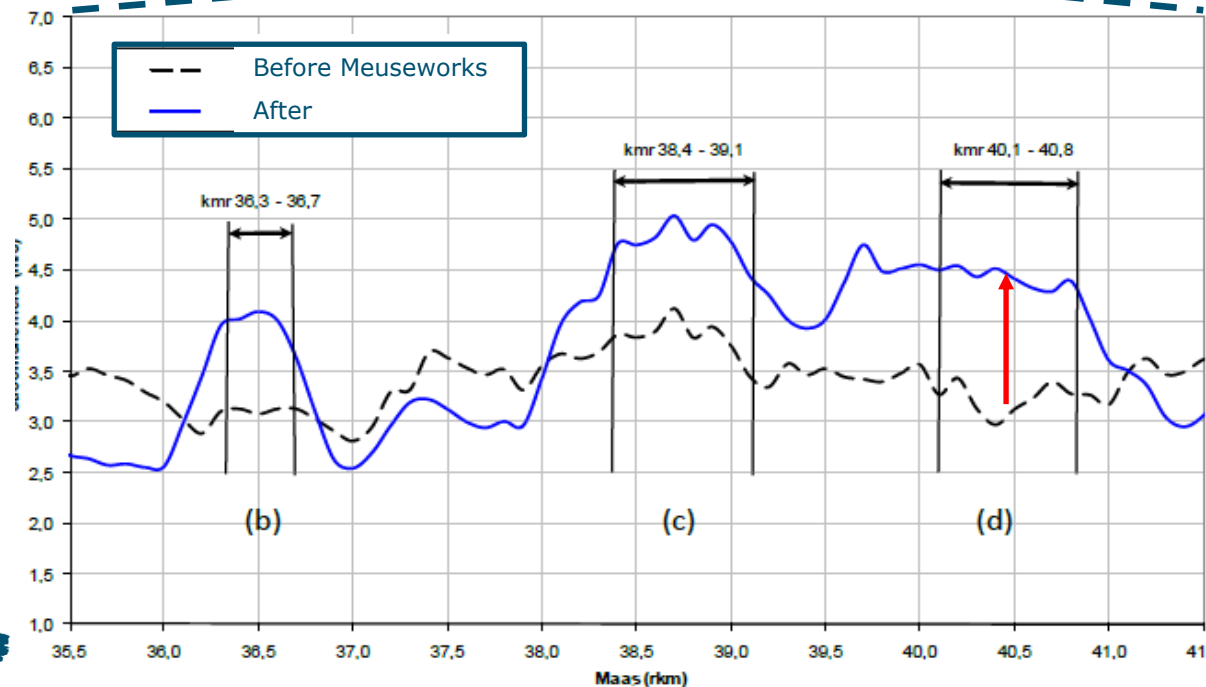
High and increased flow velocities.
 Source: Meijer D.G. en J. Vieira da Silva (2007):
 Gemeenschappelijke Maas te Lanaken en Maasmechelen: Zuidelijke sector, Rivierkundige en grondwaterstudie van de geplande ingrepen.

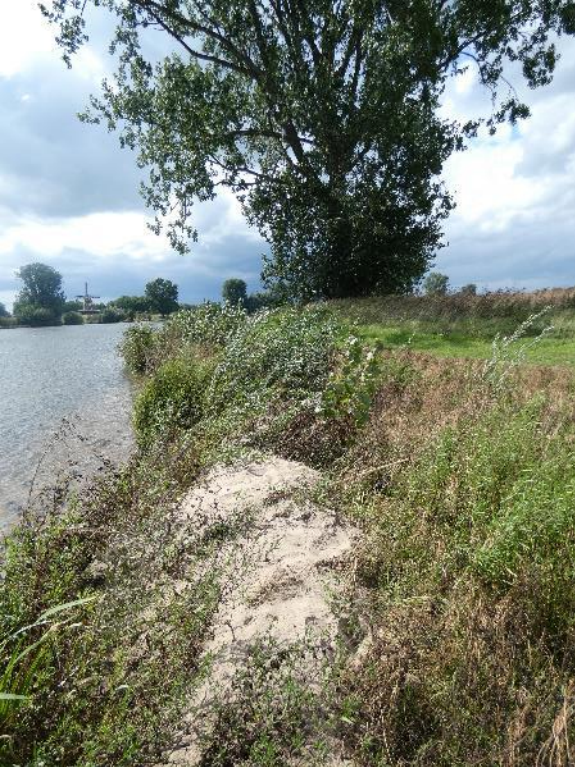
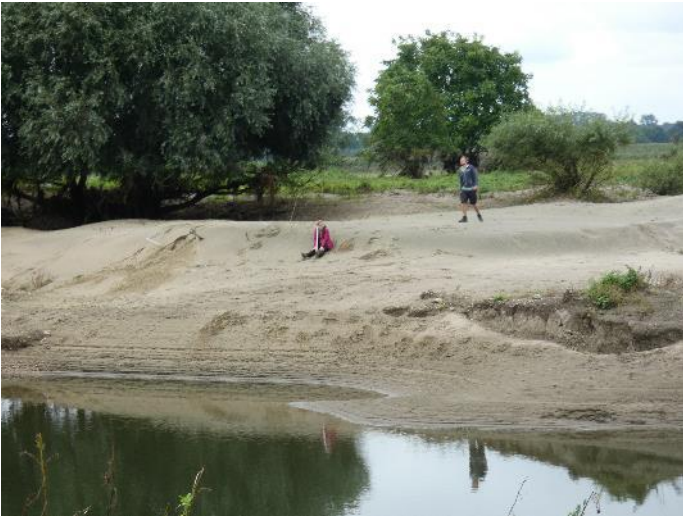
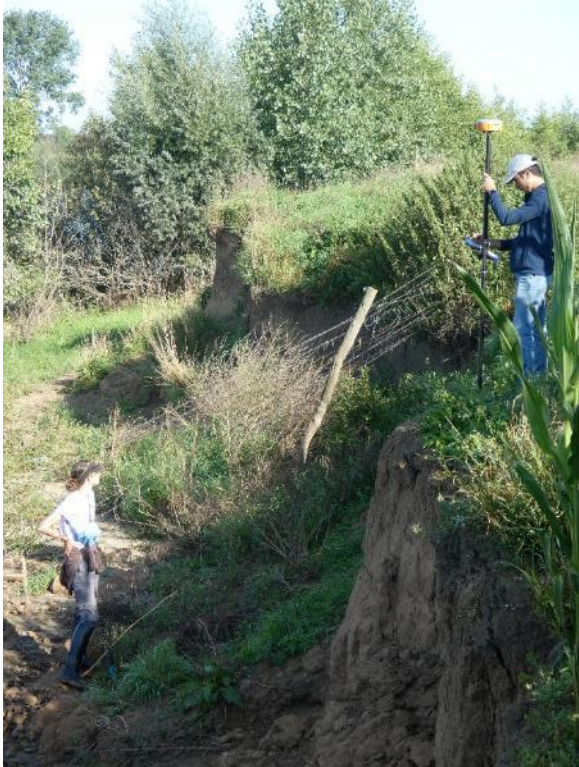
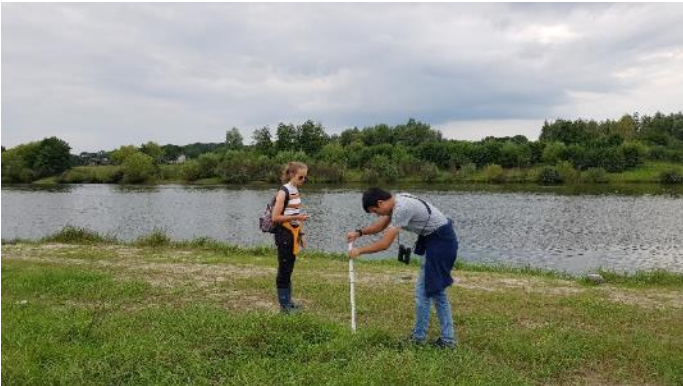
Fieldwork August 2021 – floodplain sand deposits
