Morphodynamics of sand nourishments (sand engines) in eroding sections of the Rhine-Meuse Delta

C.J. Sloff^{1,2}, D. Jumelet³, and L. Baars⁴

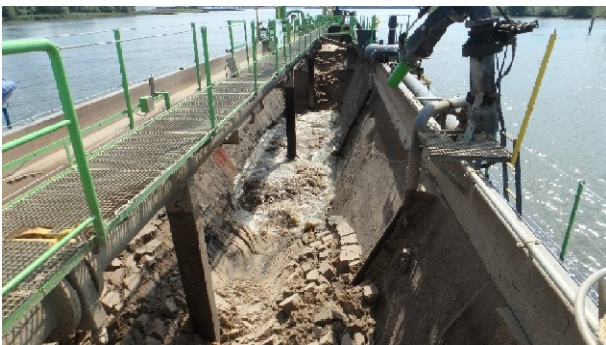
Figure 1. Nourishment operation, unloading above a deep scour hole in the ‘Oude Maas’ River, June 2022

The nourishments were executed in the first months of 2022 in two deep scour holes in the Oude Maas River (Figure 1). This sand was dredged in a river section about 20 km upstream. From each load of the trailing hopper suction dredger a sediment sample was taken, and its grain-size
