The July 2021 flood in the Geul catchment

System Analysis and Rapid Assessment

Klaas-Jan van Heeringen

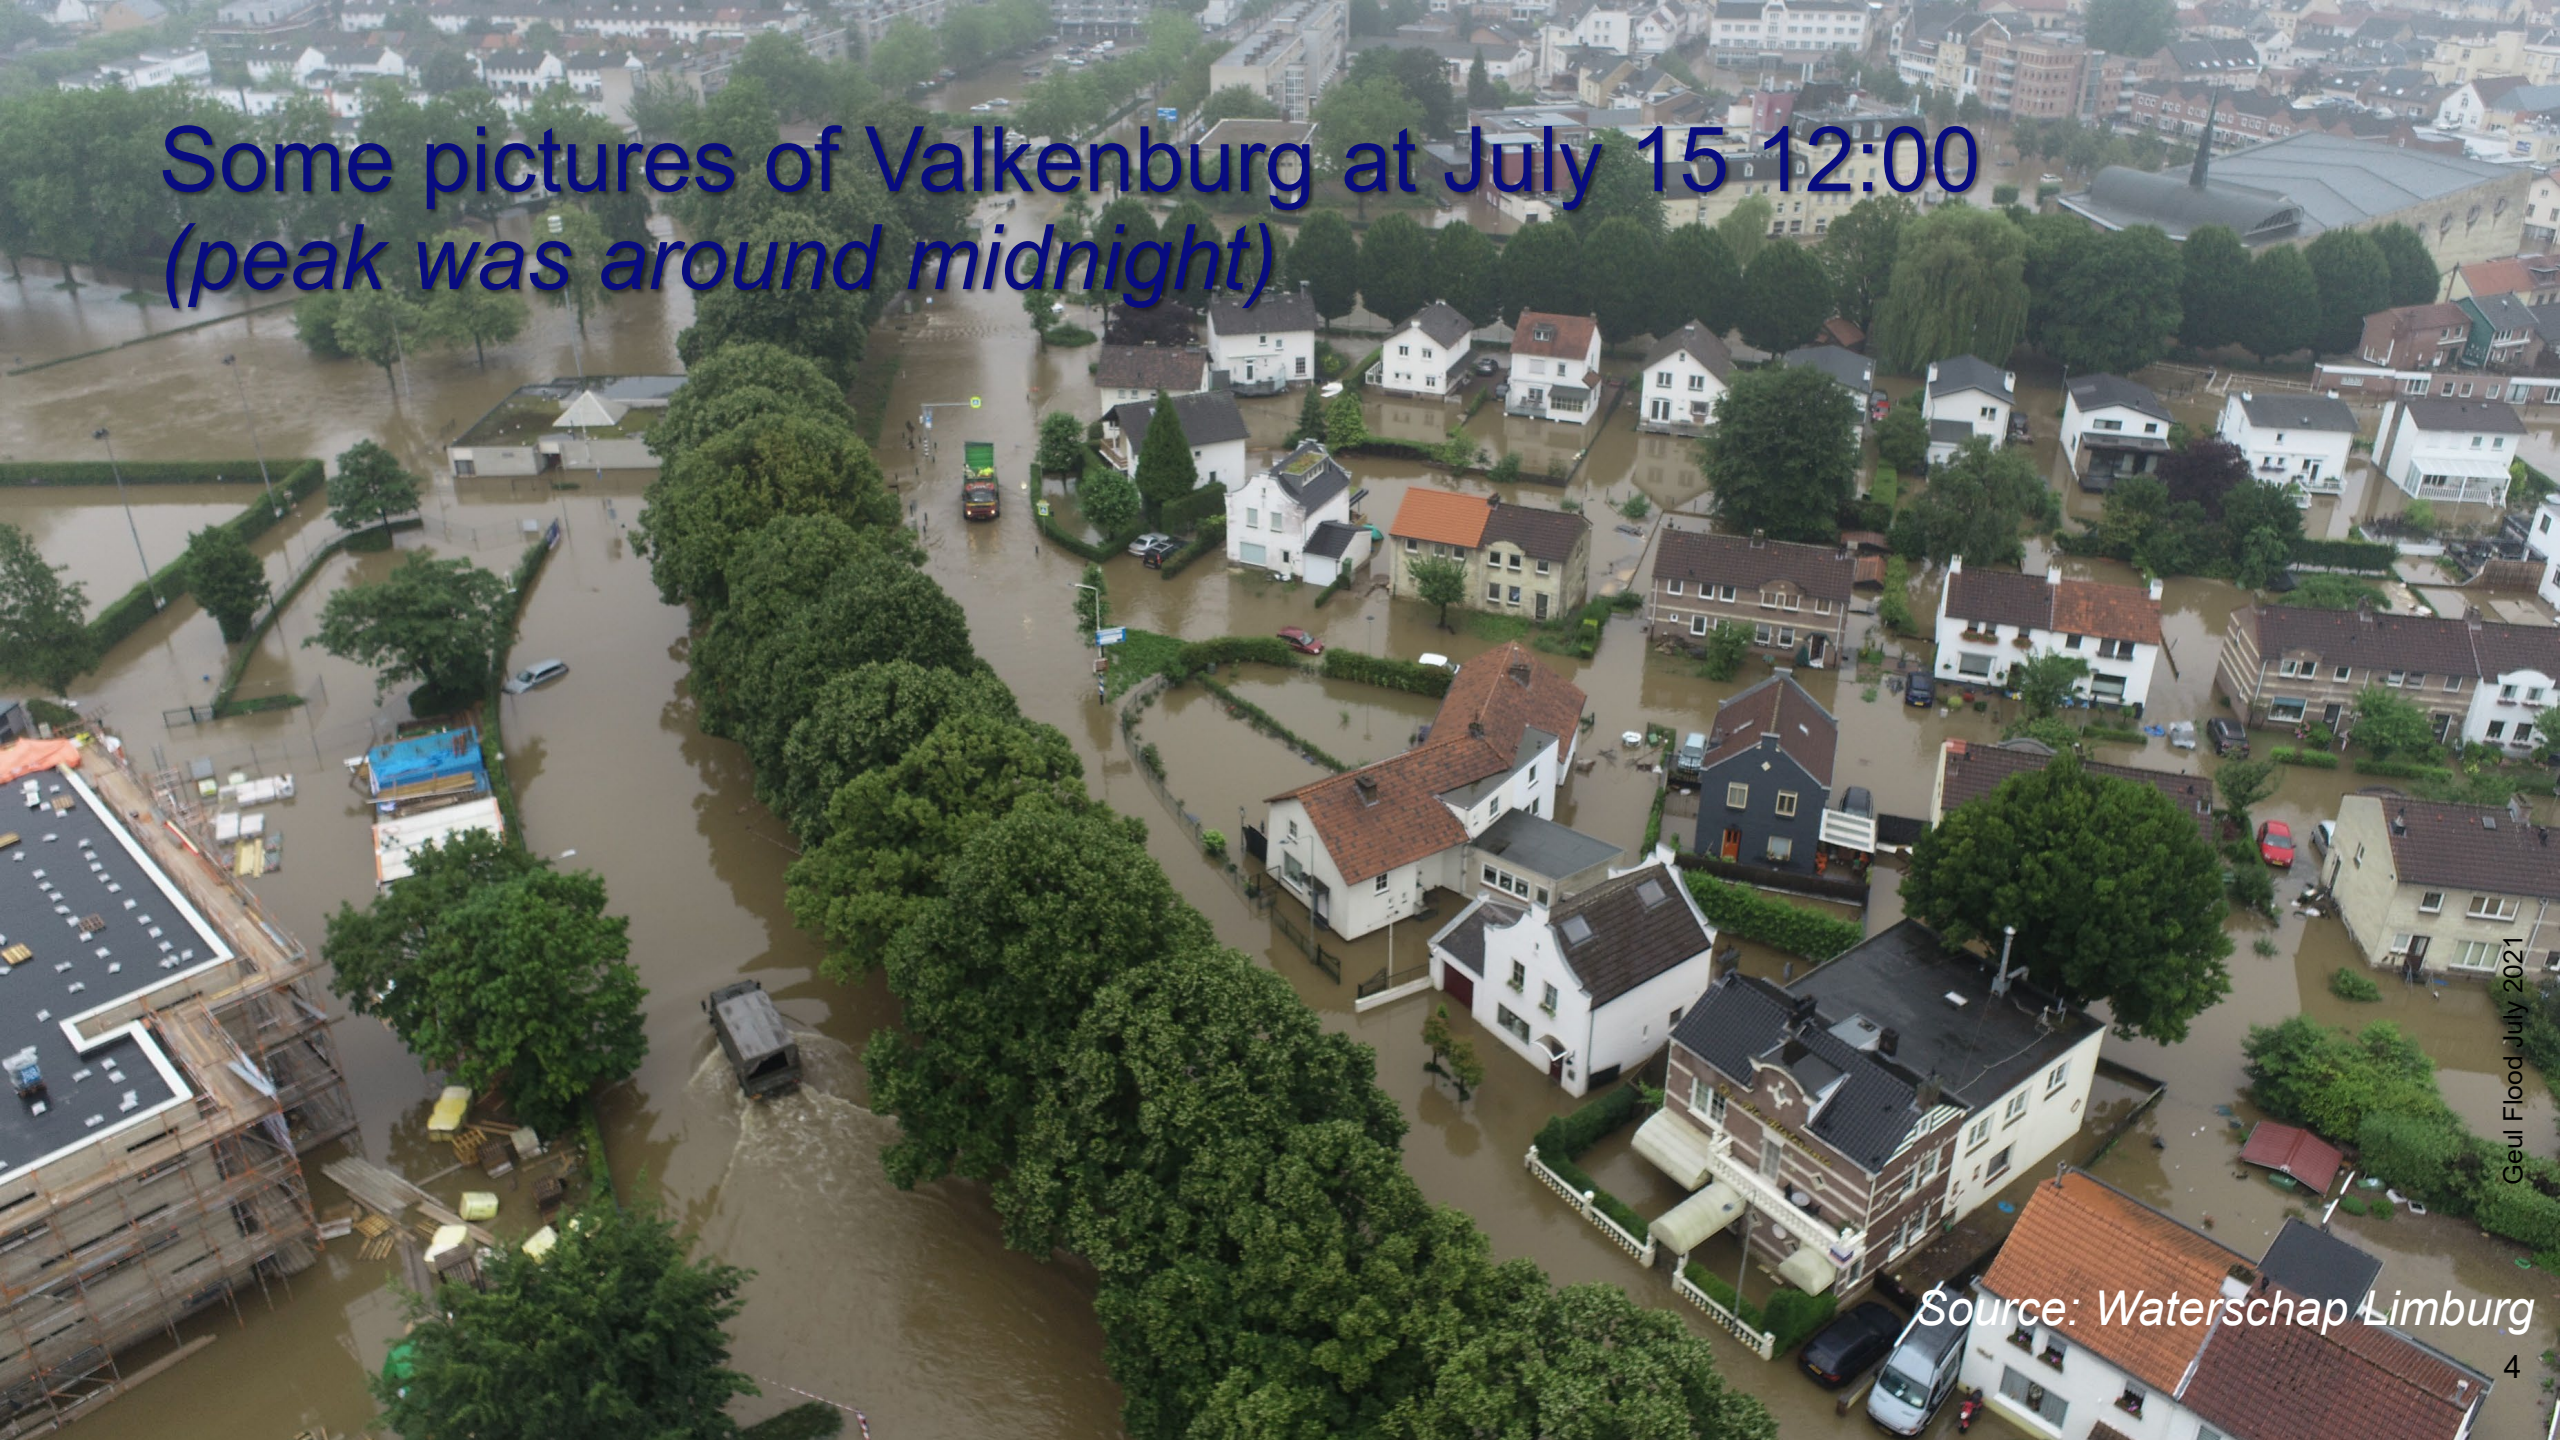
Some pictures of Valkenburg at July 15 12:00
(peak was around midnight)

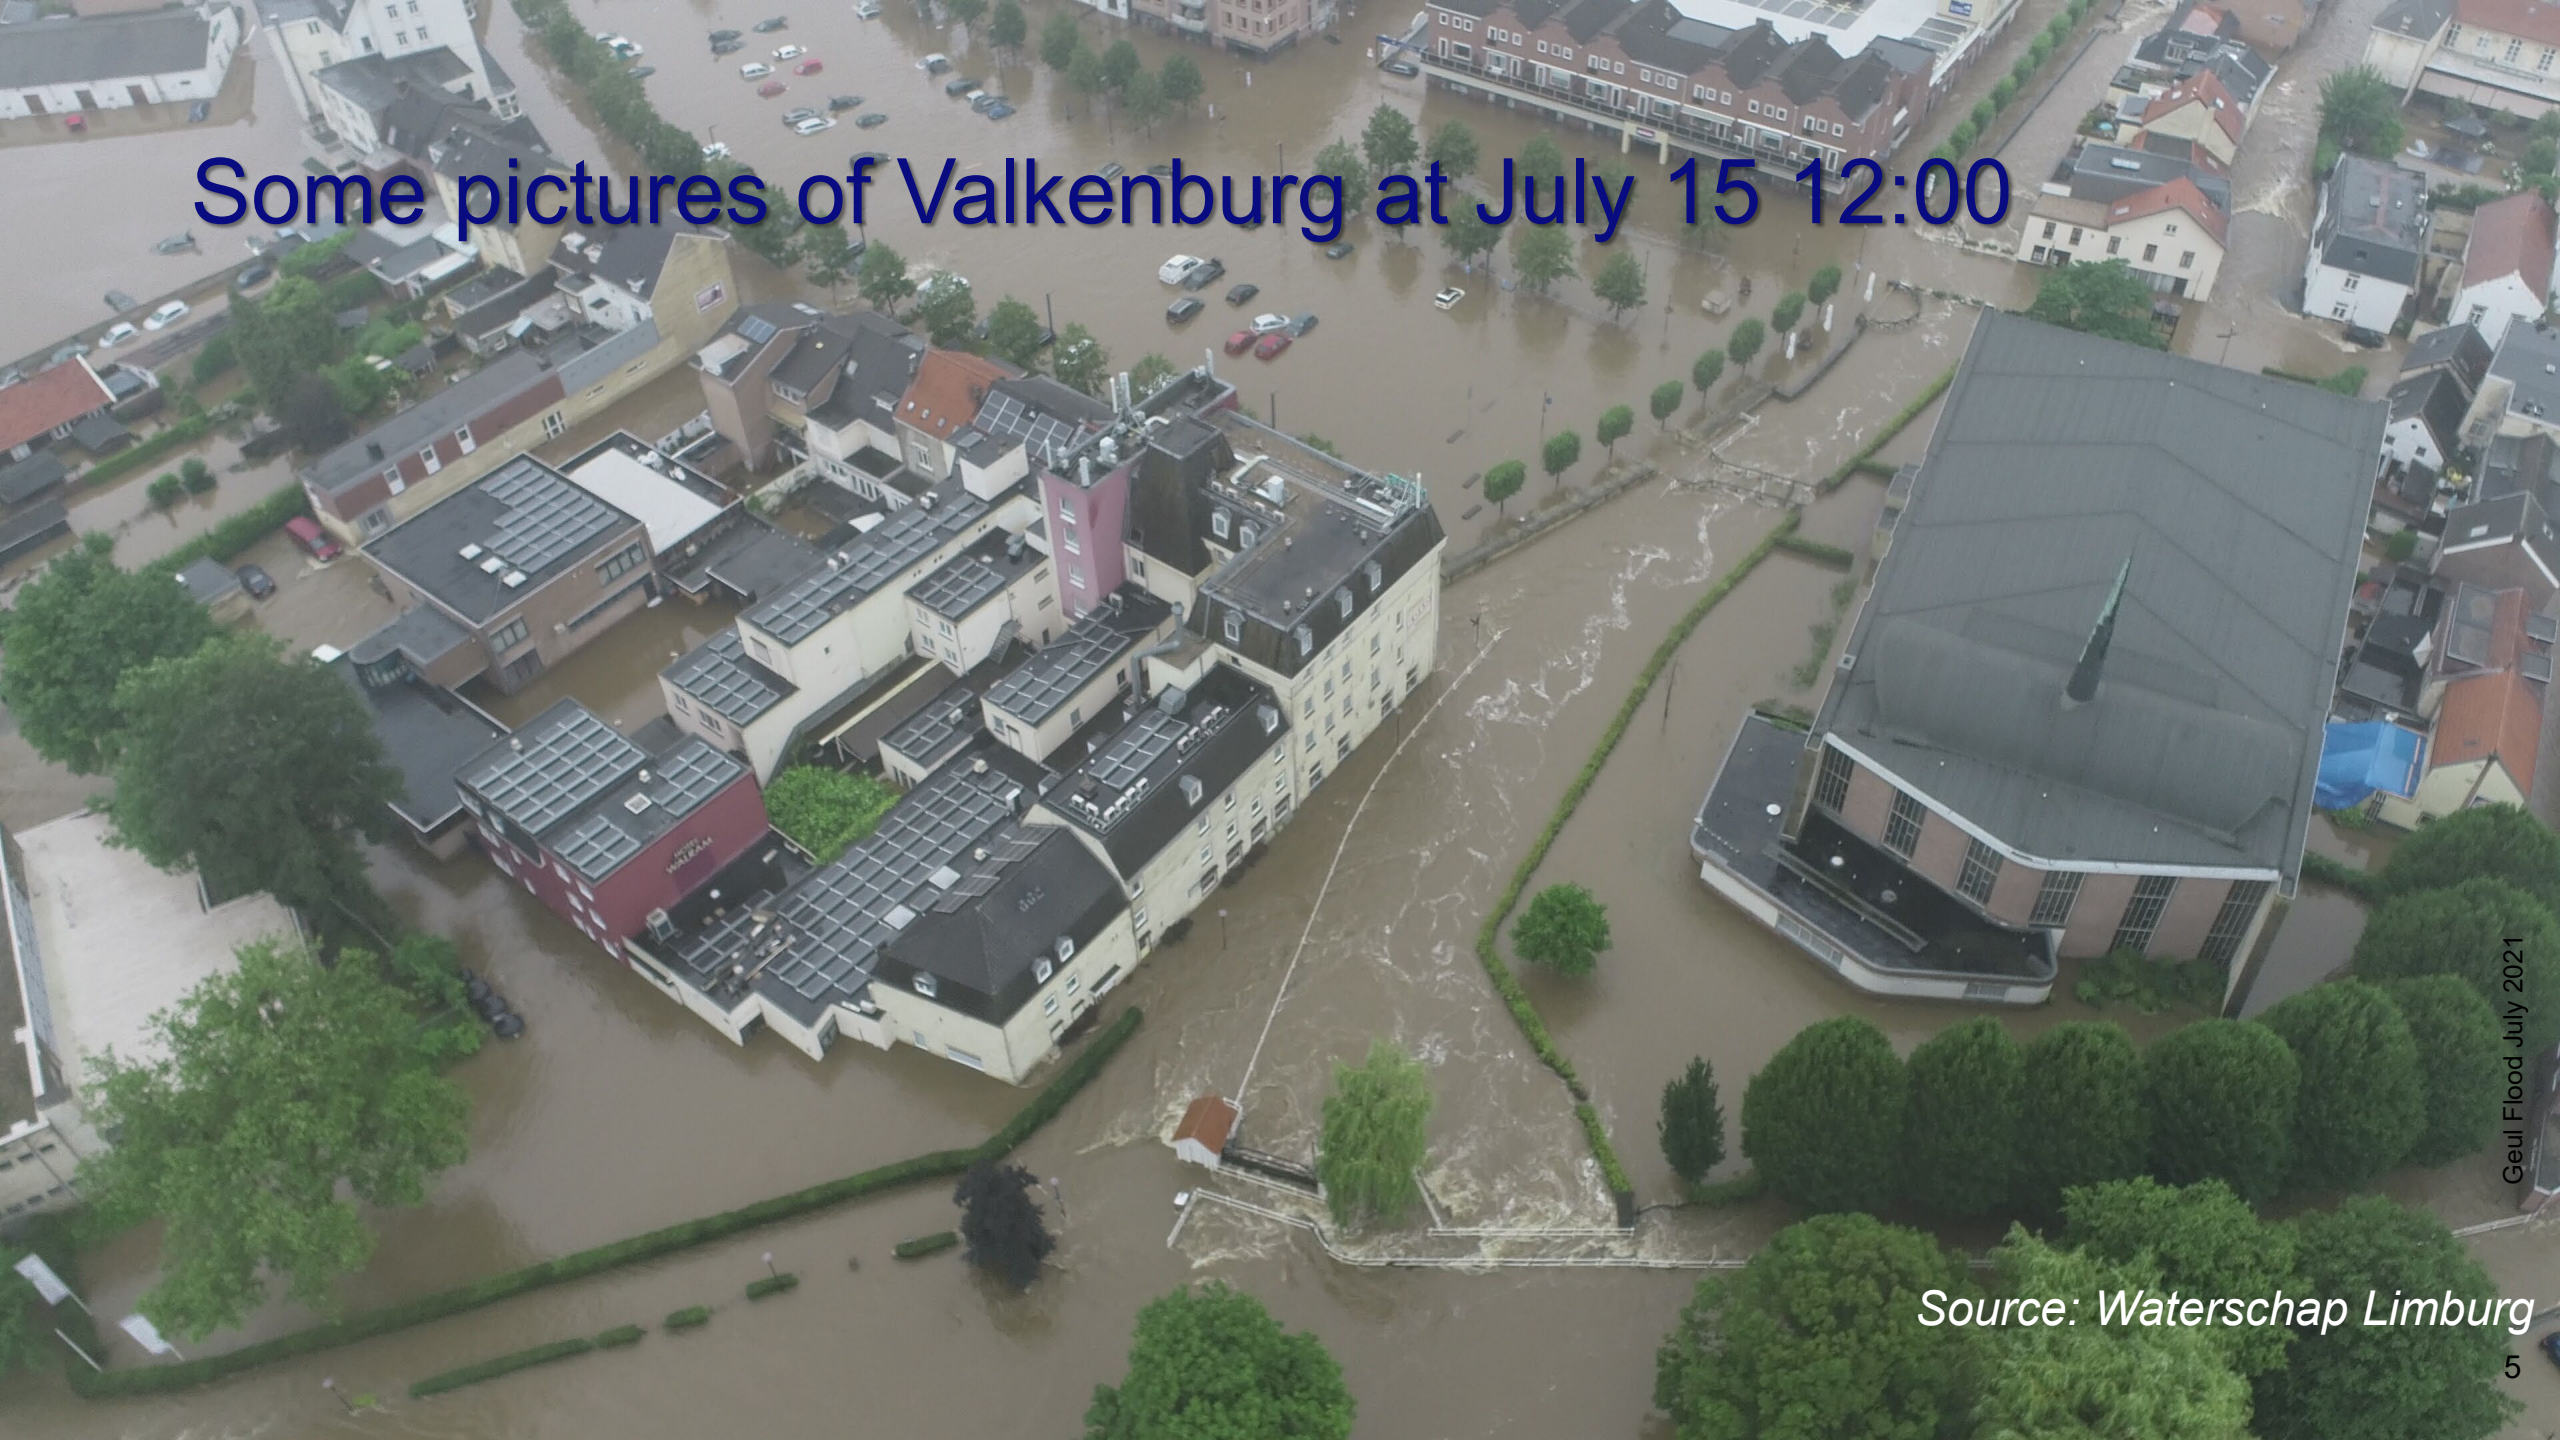
Some pictures of Valkenburg at July 15 12:00

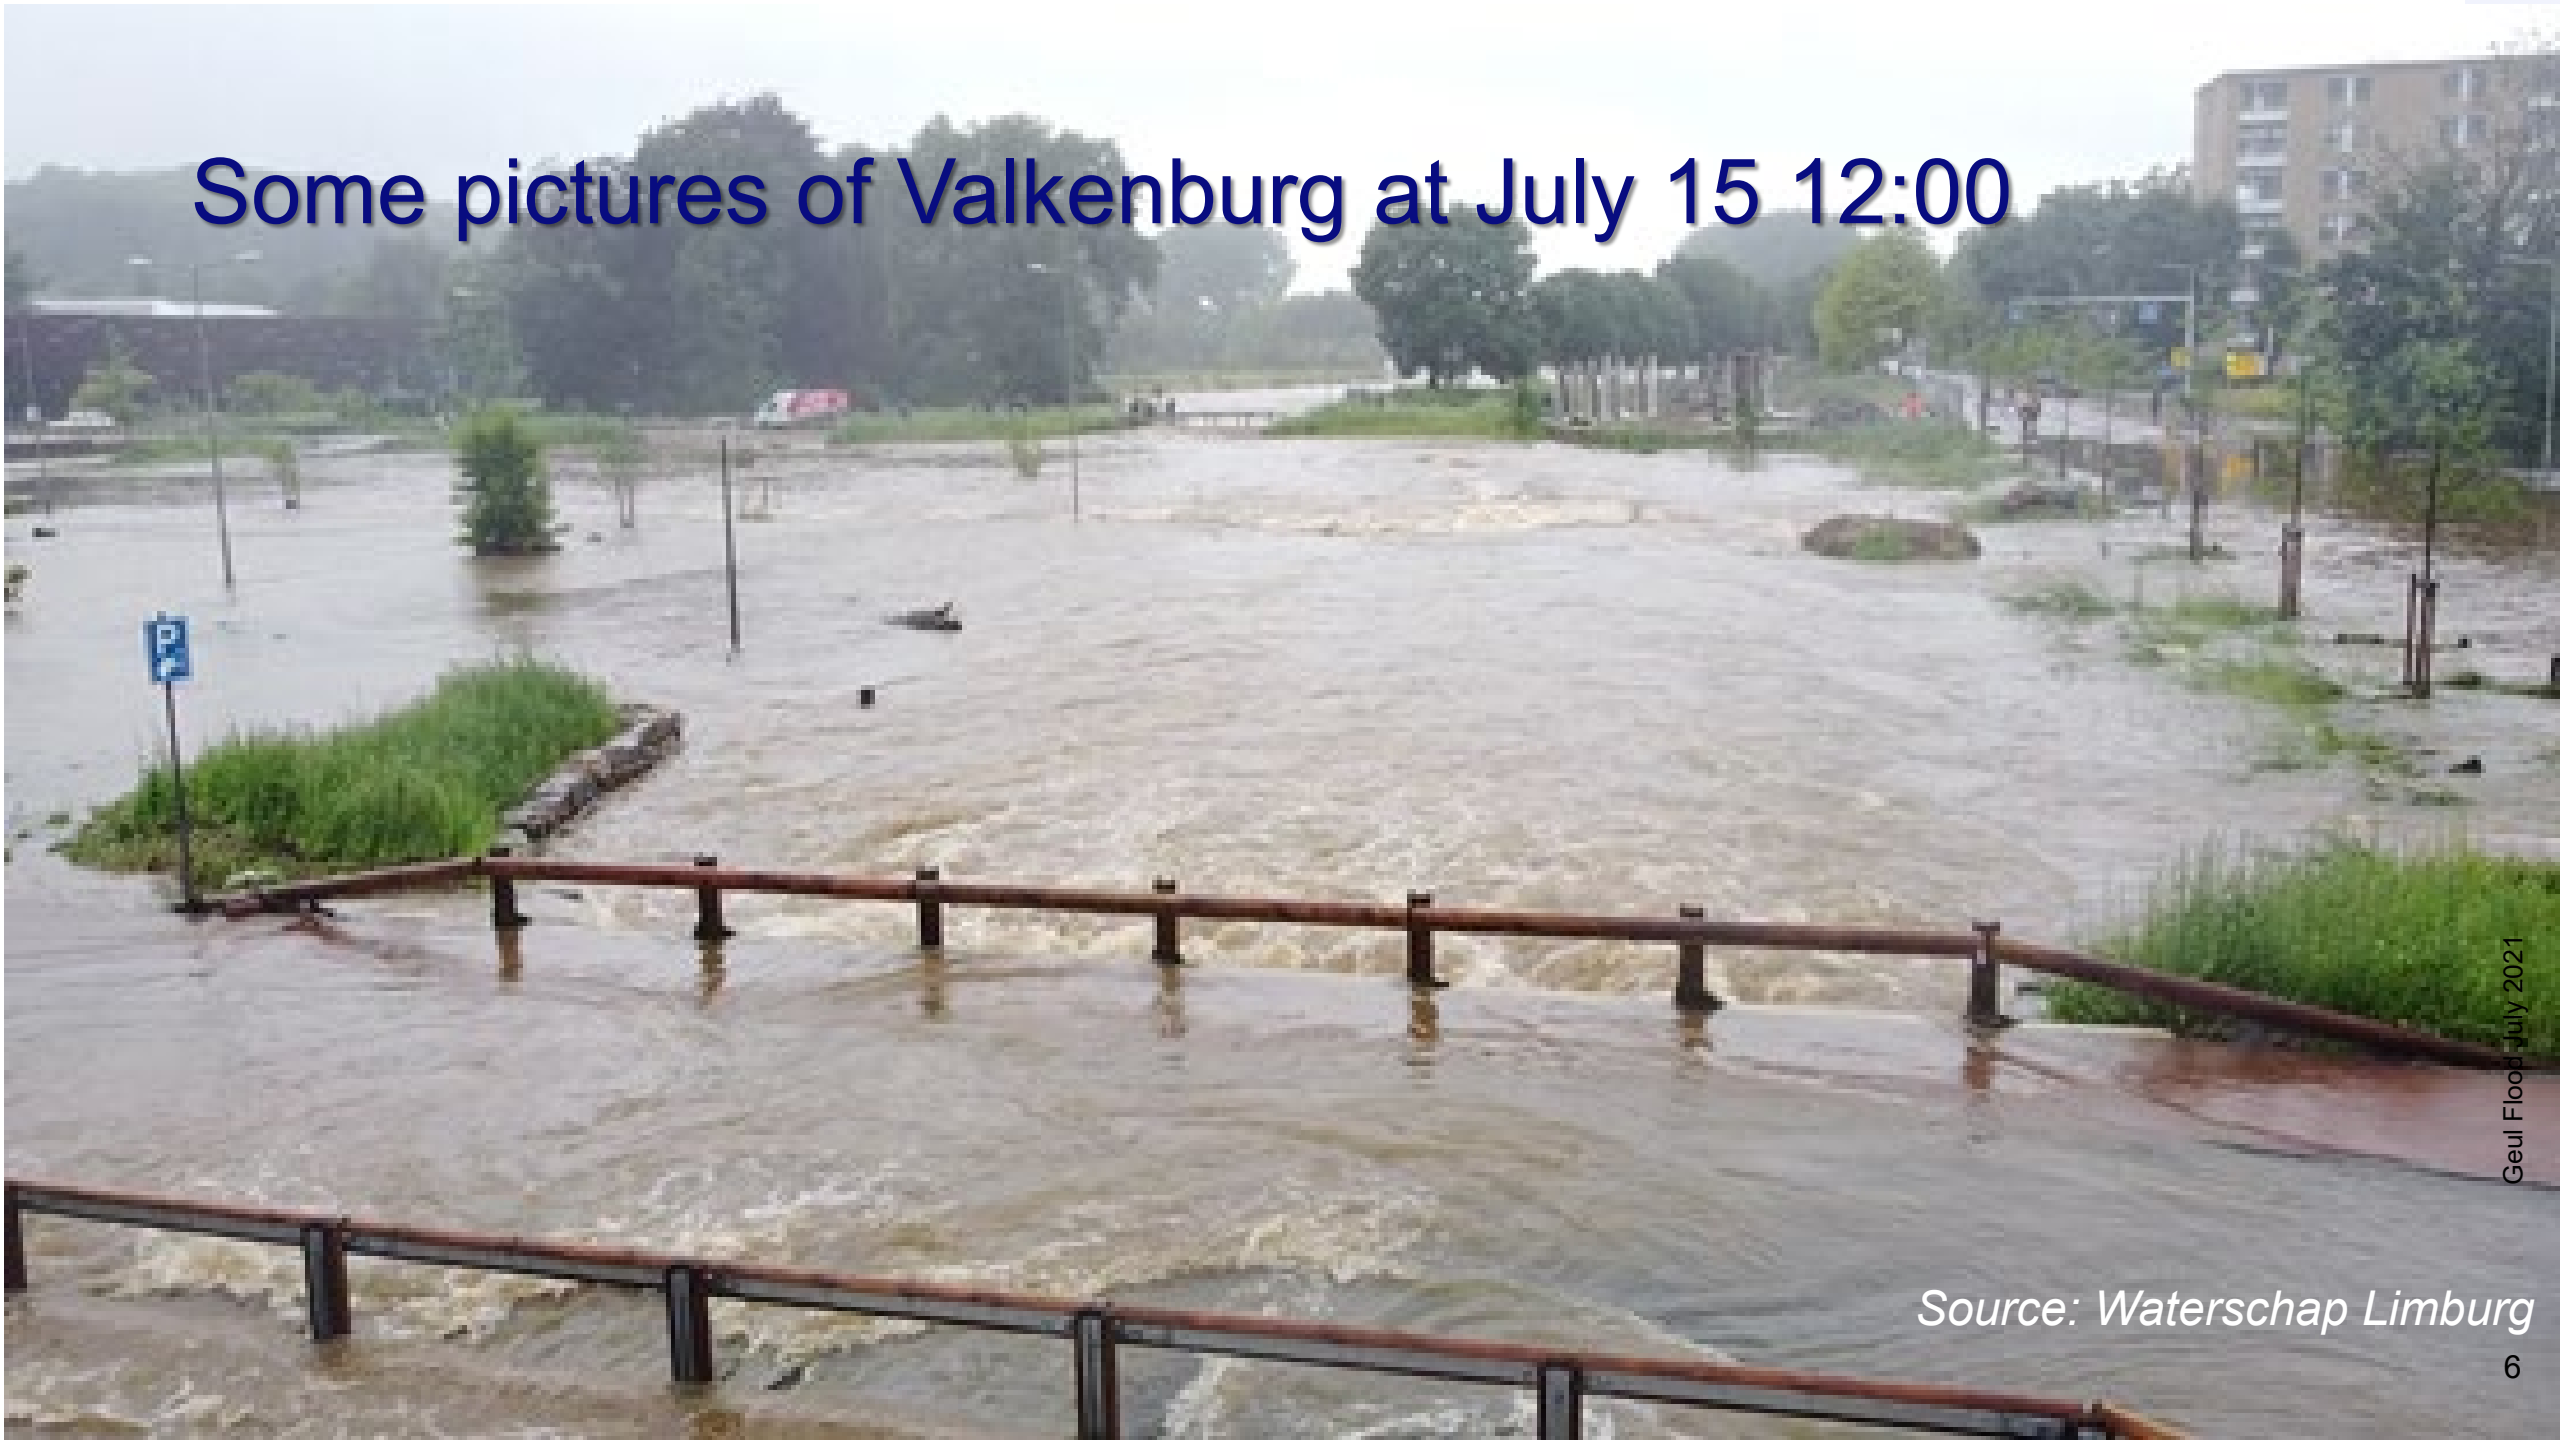
Some pictures of Valkenburg at July 15 12:00

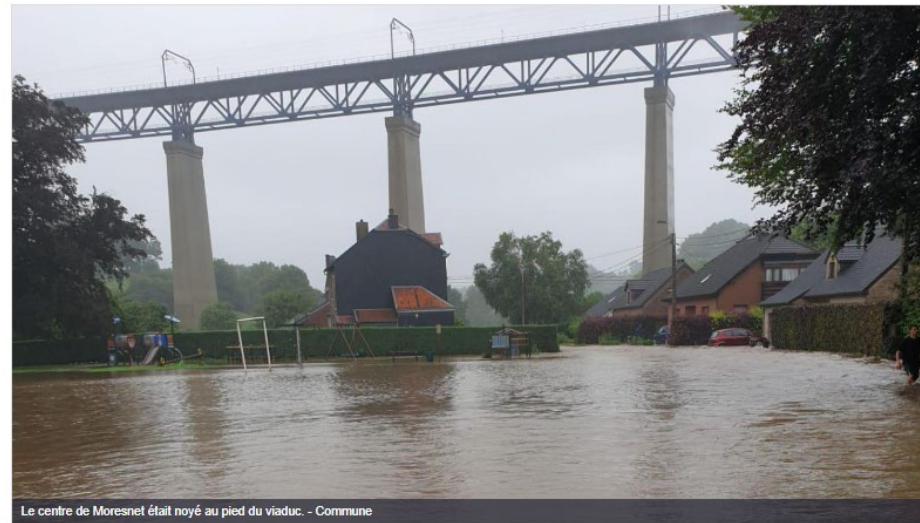
Moresnet sous eaux, mais le Pays de Herve a moins écopé

Le centre de Moresnet était noyé au pied du viaduc. - Commune

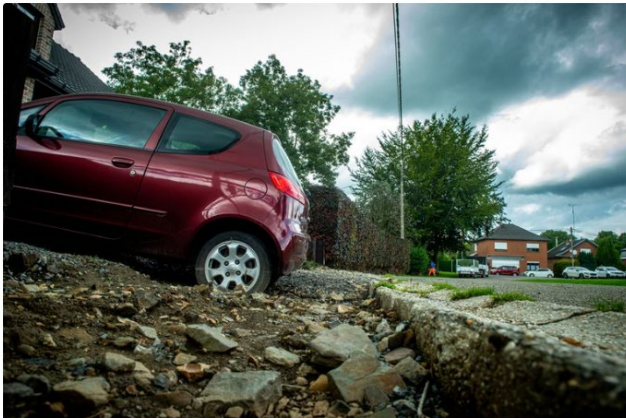
Une centaine de ménages touchés par les inondations et des dégâts aux structures. Plombières ne fut pas épargnée non plus...

Les ouvriers de Plombières sont intervenus à Dolhain, sans oublier les dégâts chez eux. ©EdA LABEYE Philippe

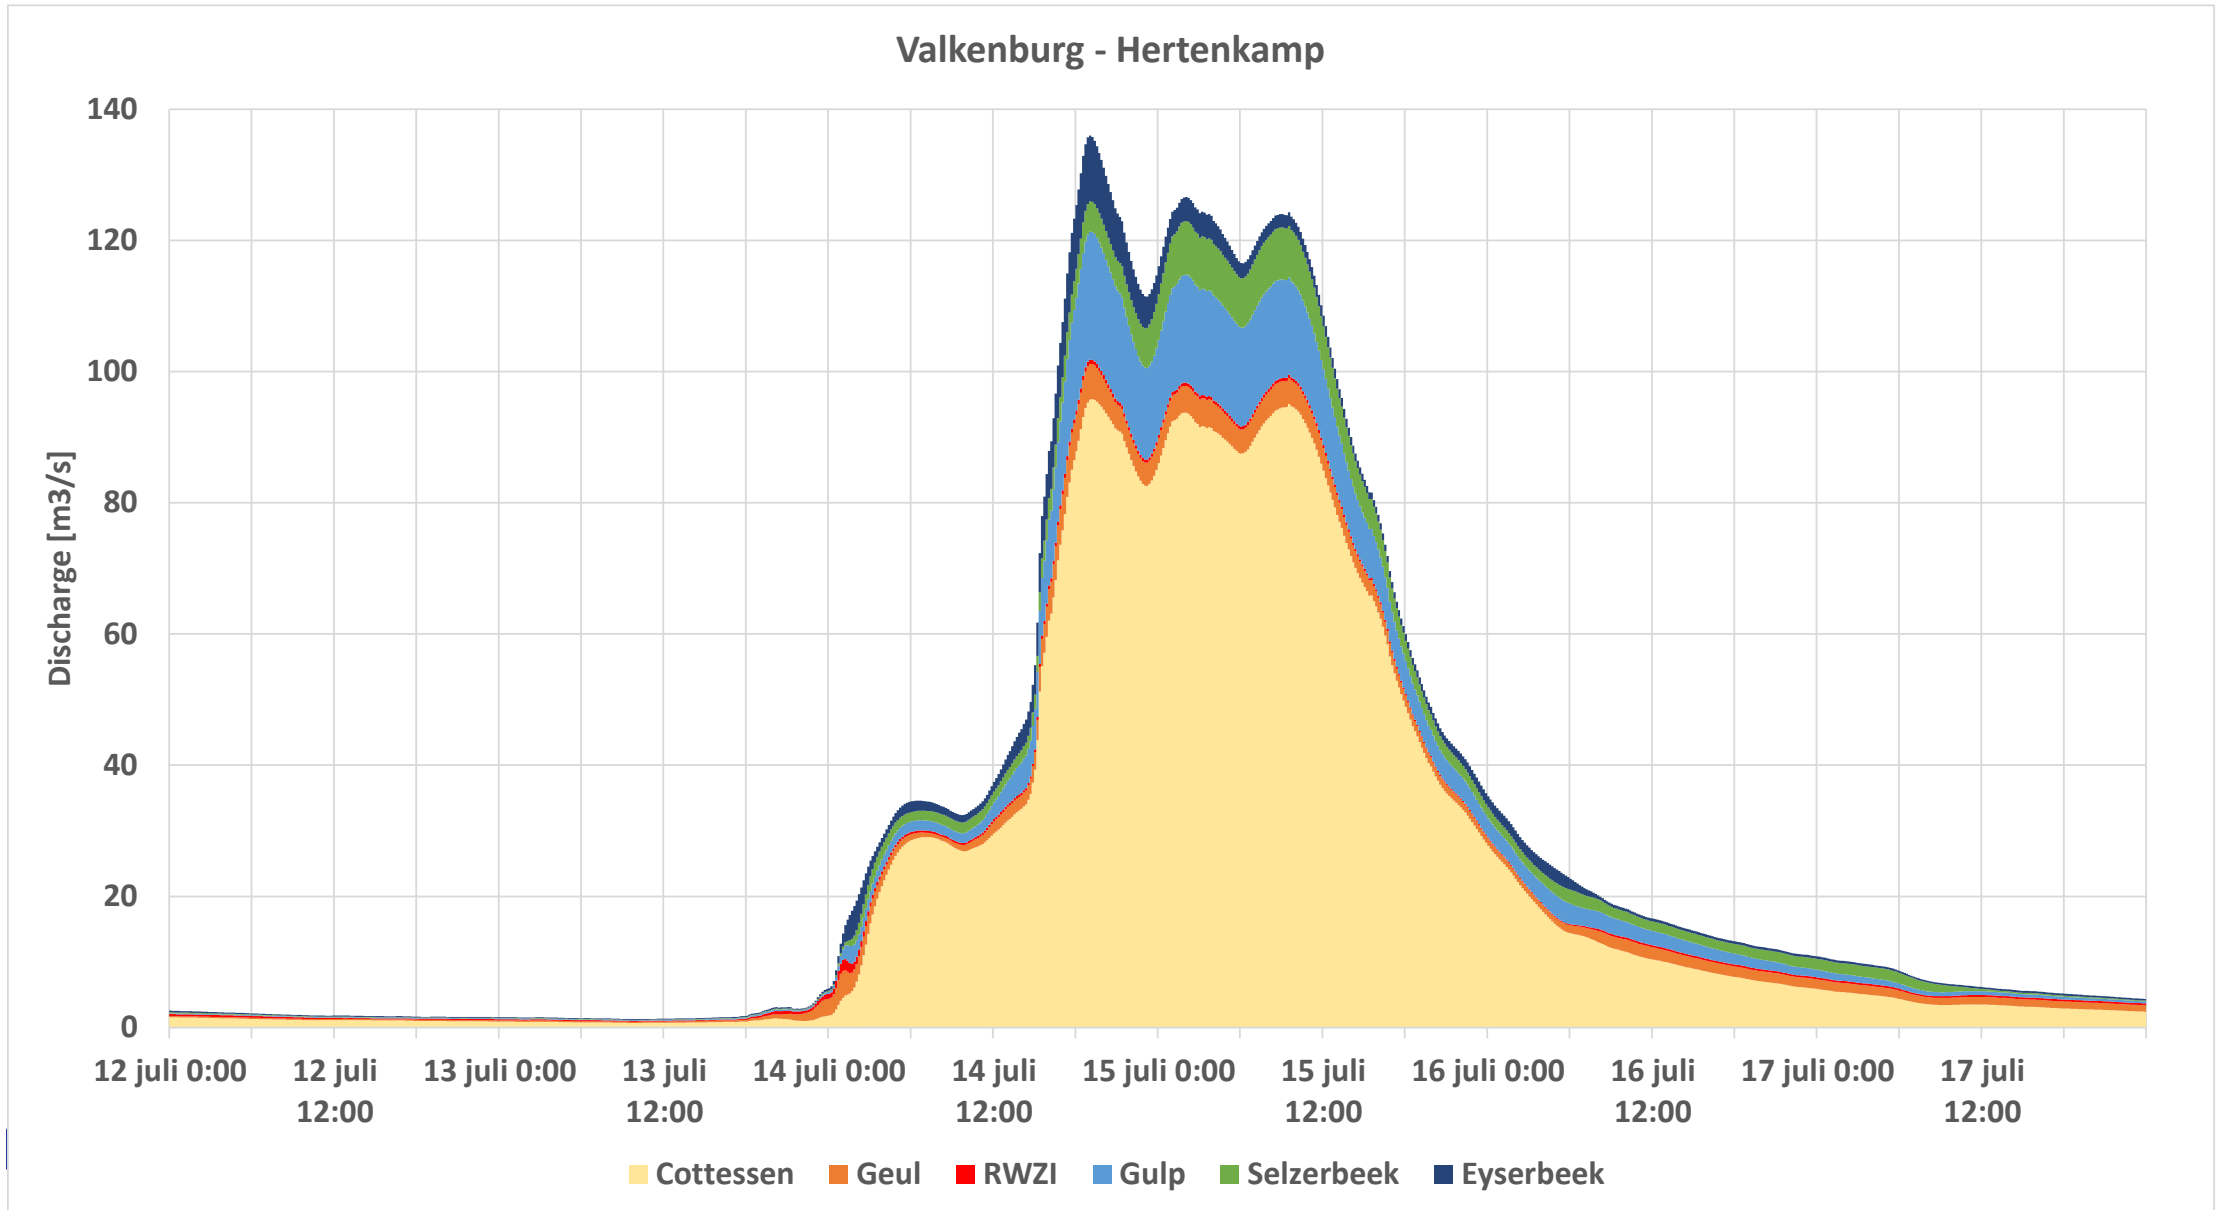
Discharges and run-off coefficients

Sub-basin	Precipitation (mm)	Discharge ¹ (%)	Run-off coefficient
Boven Geul Wallonië	180	41 %	0.45
Beneden Geul Wallonië	150	14 %	0.41
Boven Gulp België	130	5 %	0.21
Totaal België	160	60 %	0.58
Boven Geul Nederland ²	150	23%	0.40
Beneden Gulp Nederland	130	5%	0.21
Selzerbeek	130	6%	0.21
Eyserbeek ³	130	7%	0.23
Totaal Nederland	130	40%	
Totaal upstream of Schin		100 %	0.33

Where did it come from?

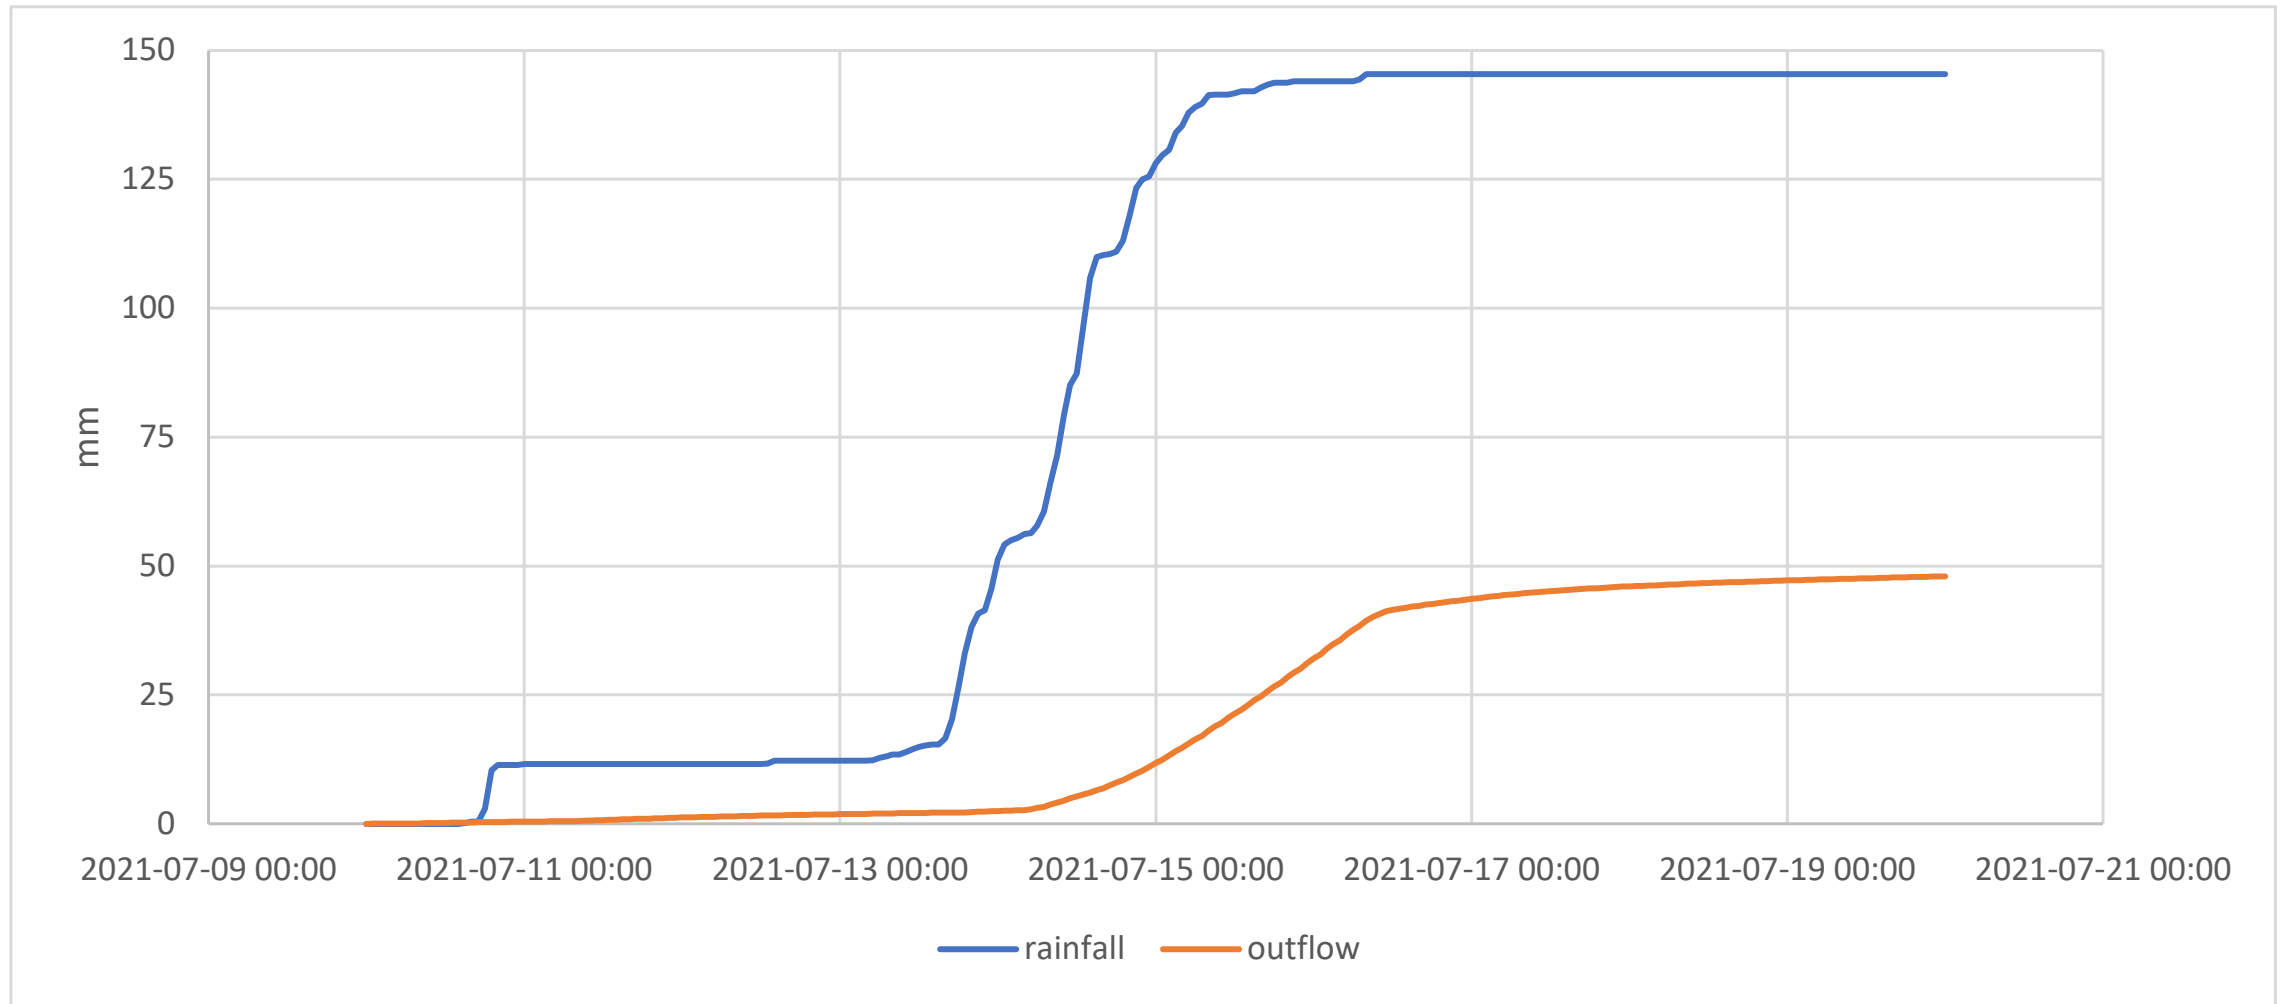
Some more details: rainfall and runoff details

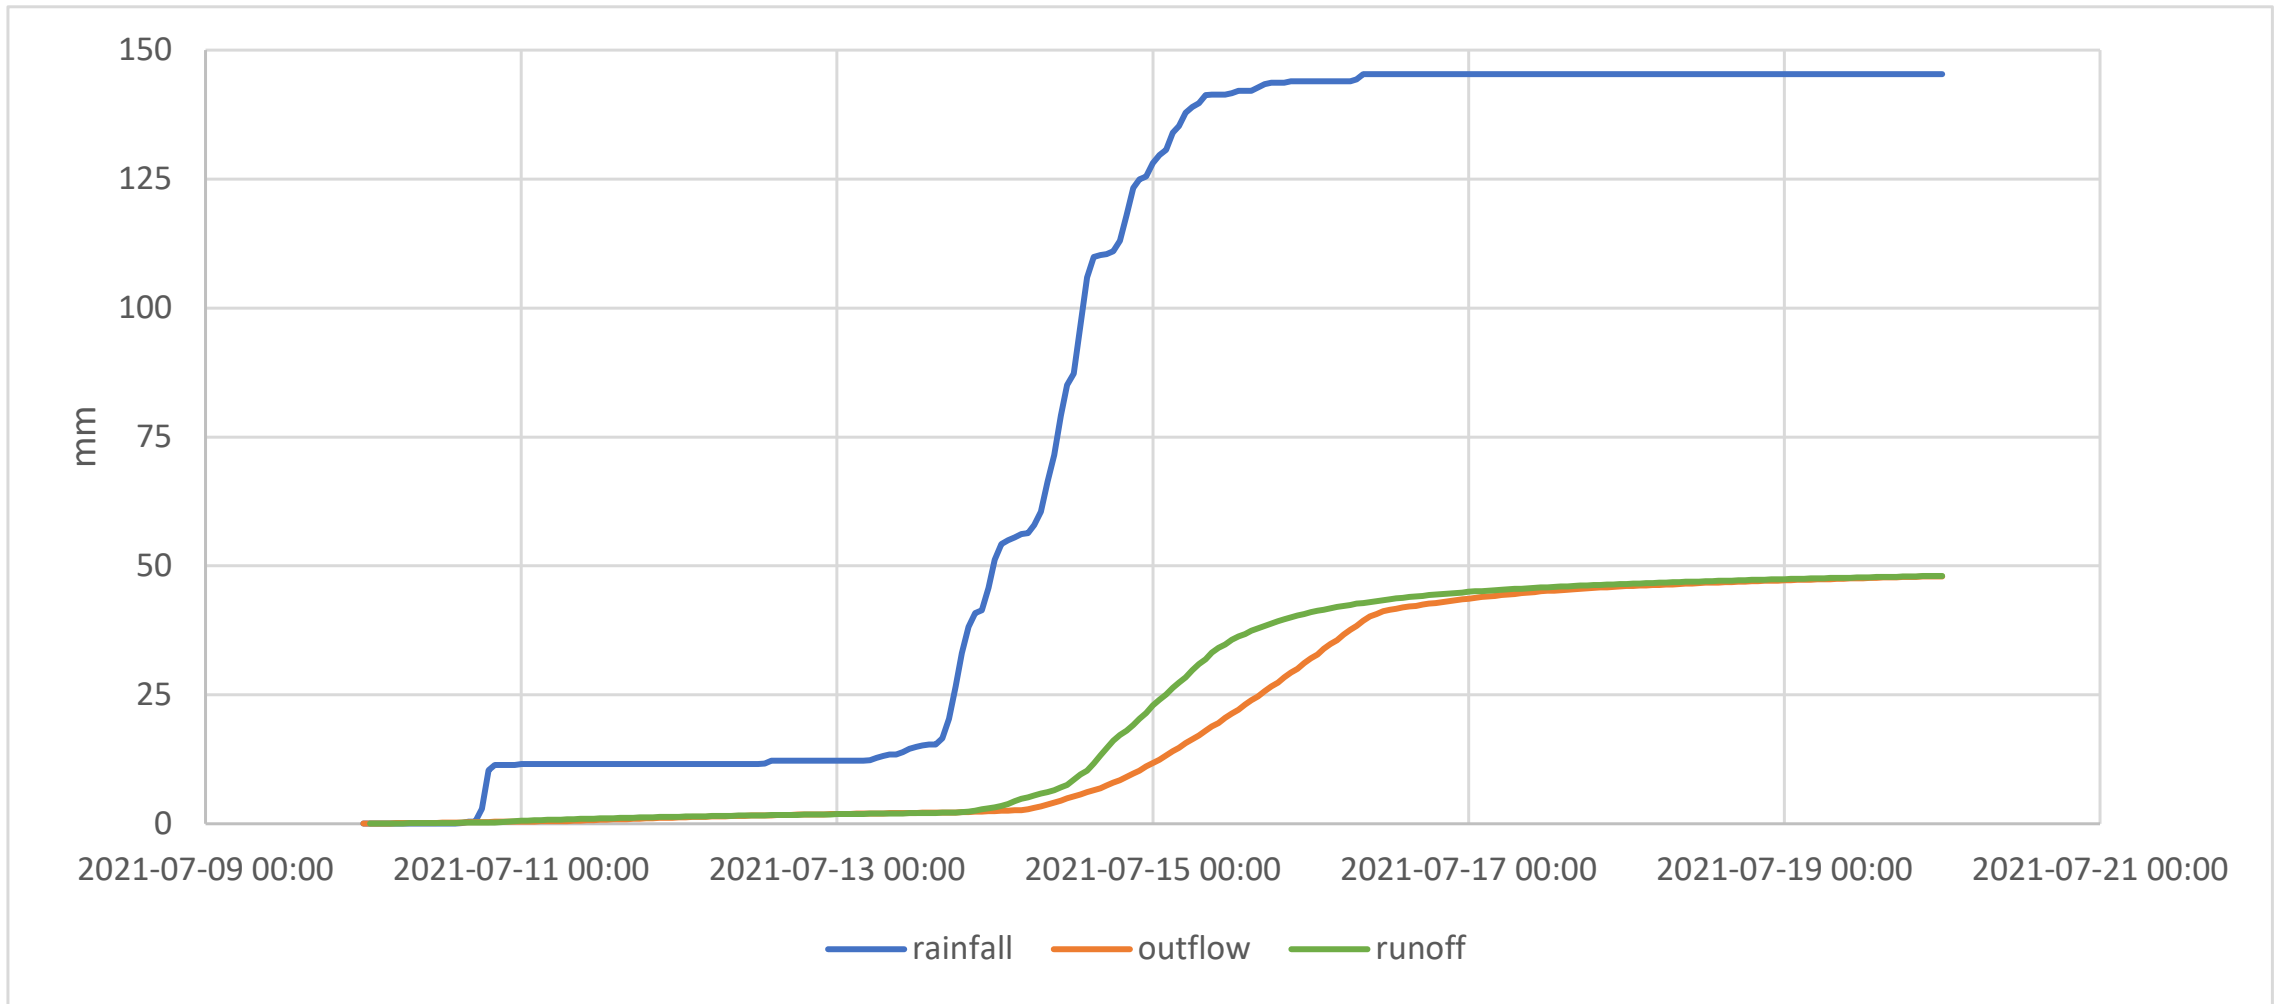
Some more details: rainfall and runoff details

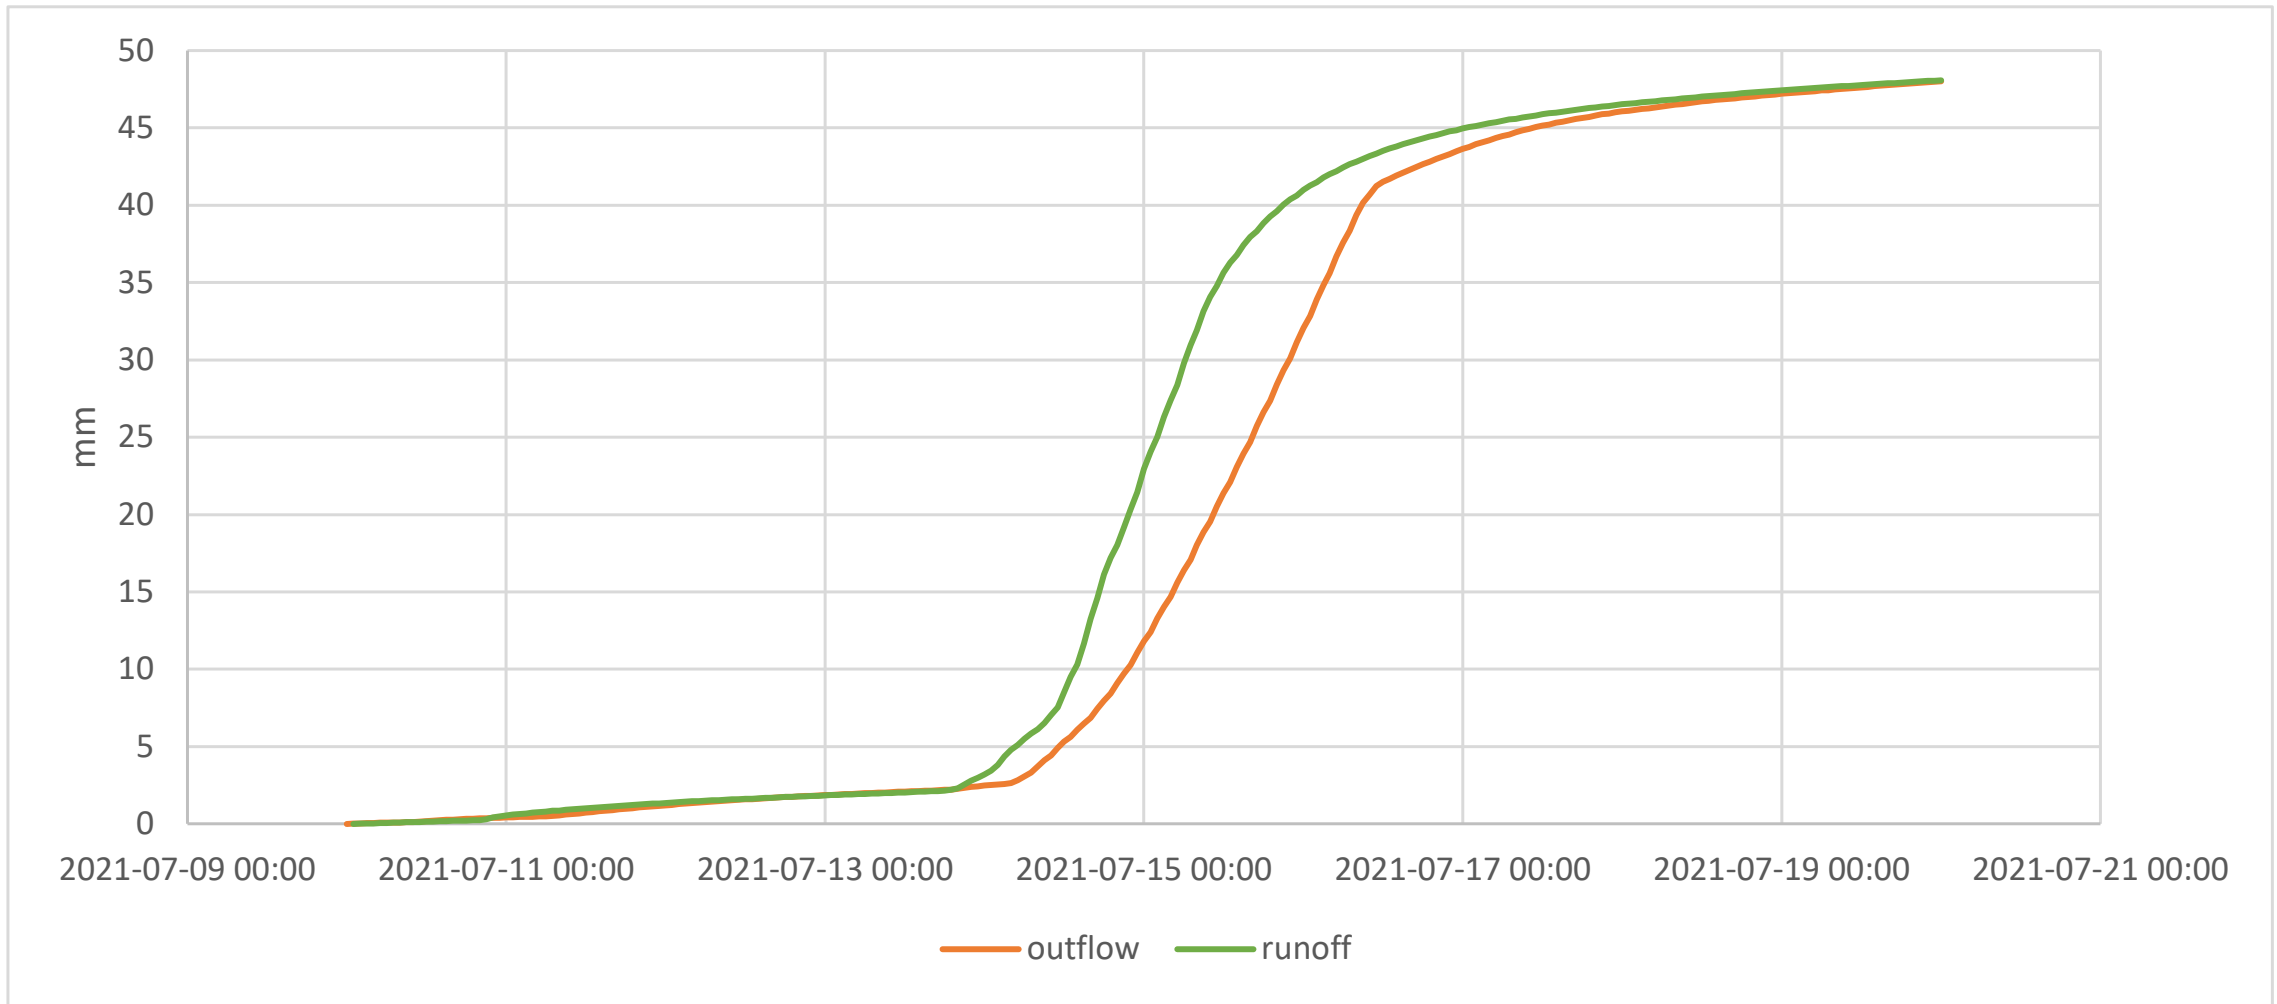
Some more details: rainfall and runoff details
