The July 2021 flood in the Geul catchment

System Analysis and Rapid Assessment

Klaas-Jan van Heeringen

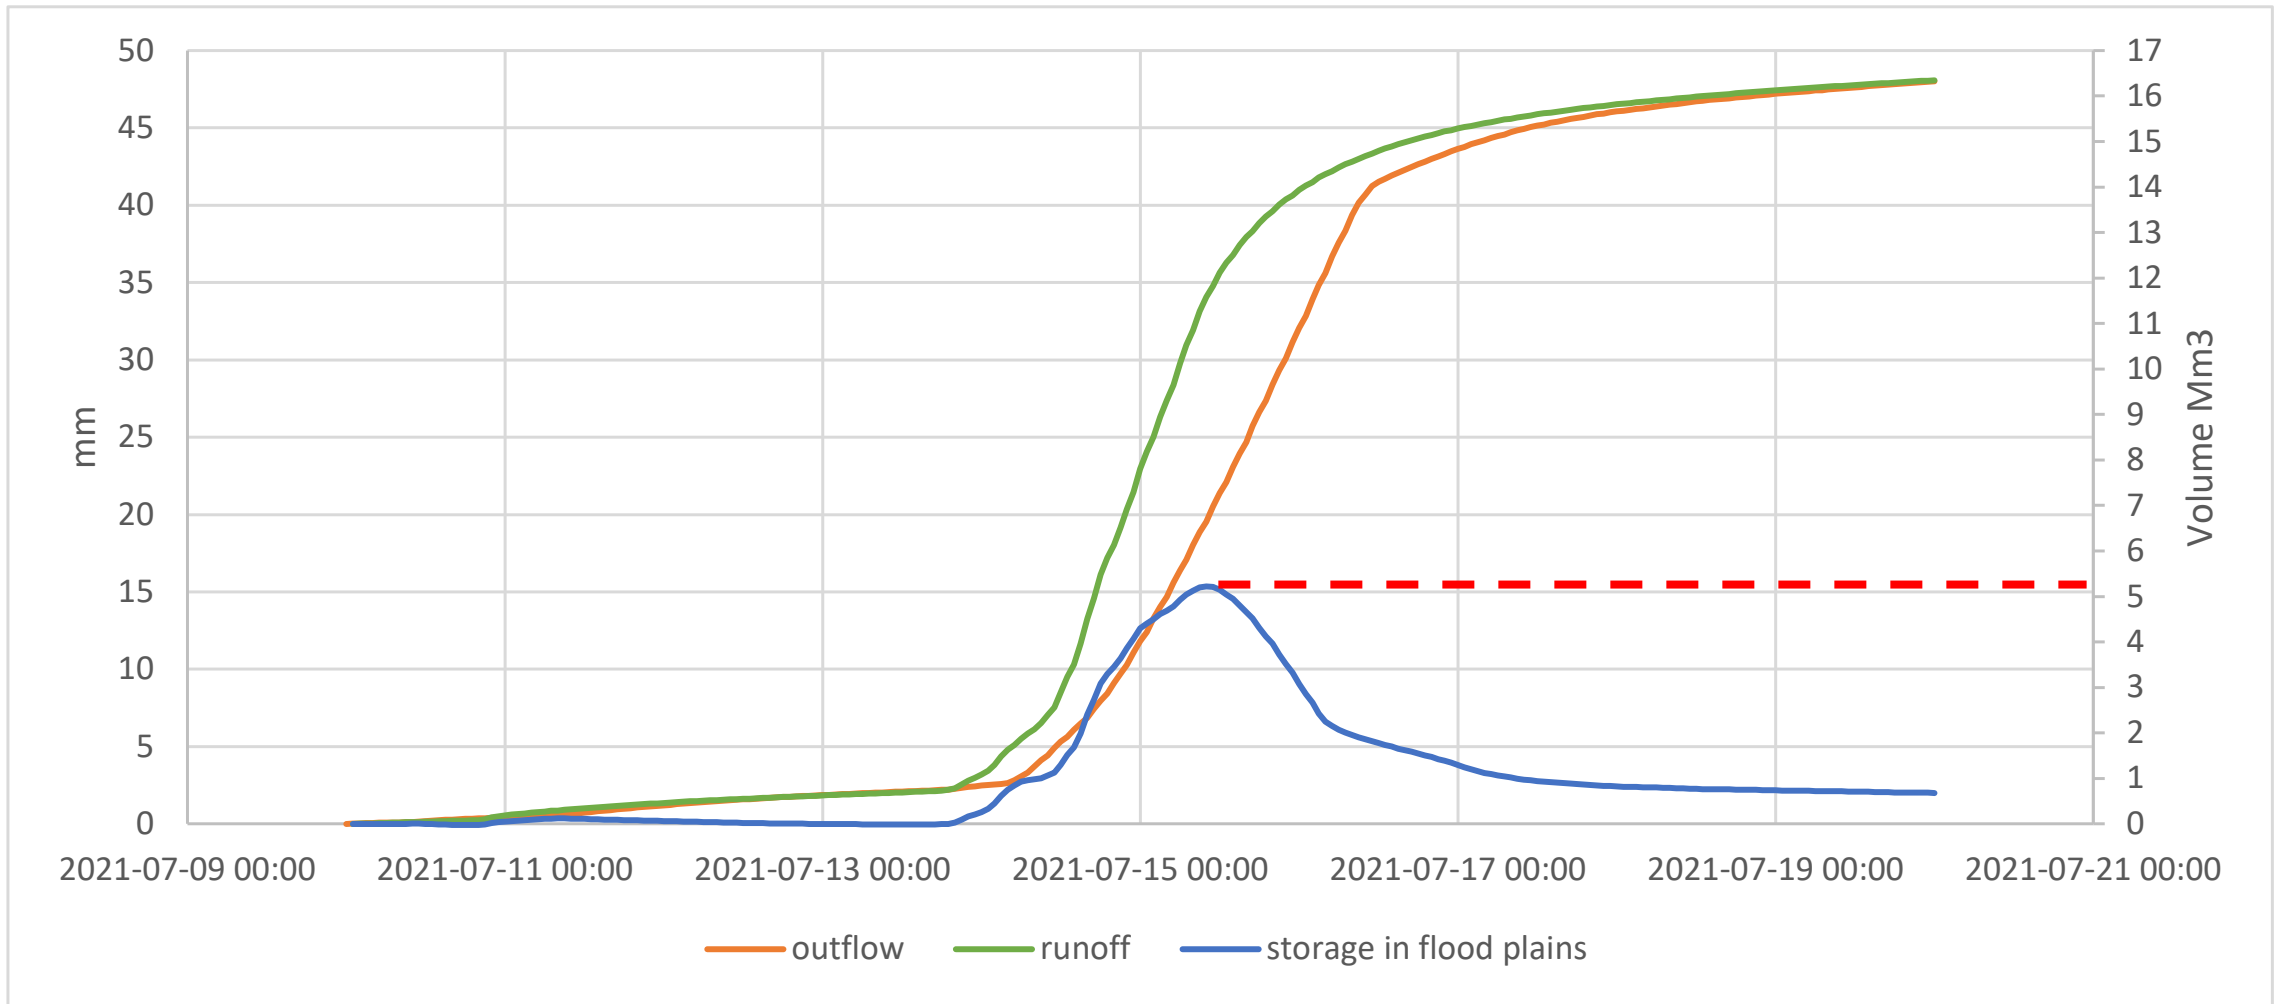
Some more details: rainfall and runoff details

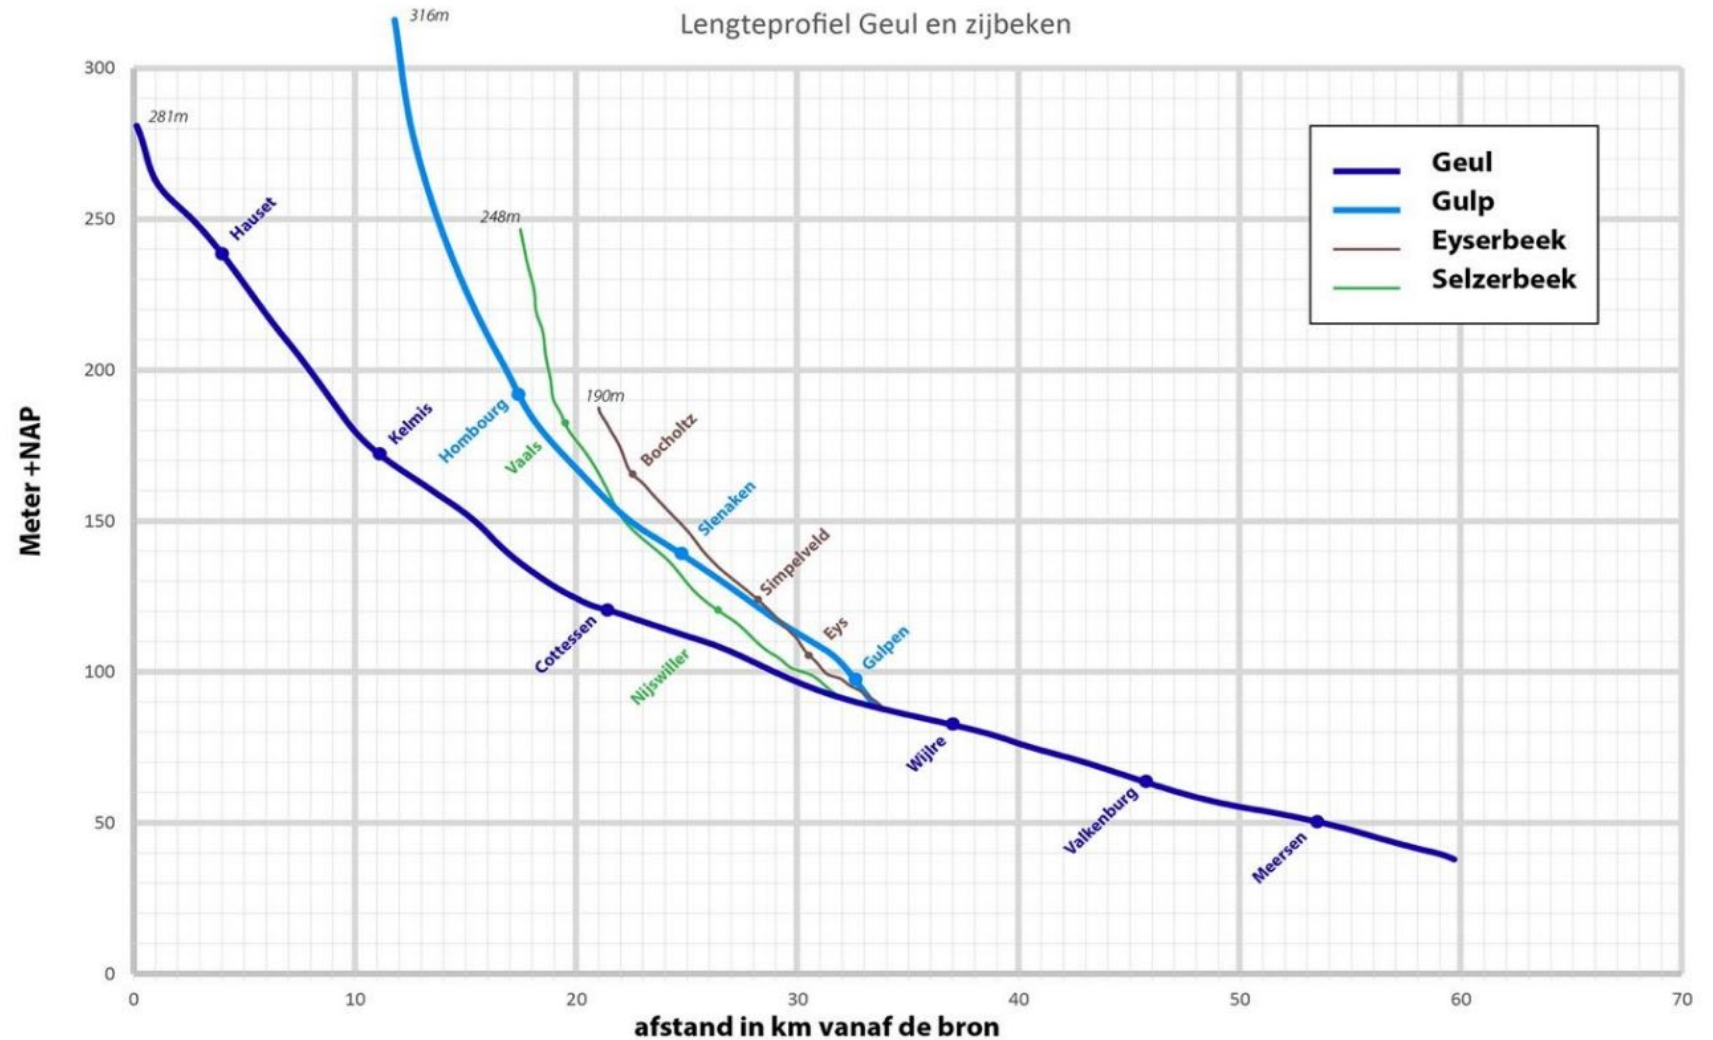
Looking for the why

- Slopes
- Land-use
- Soil-types

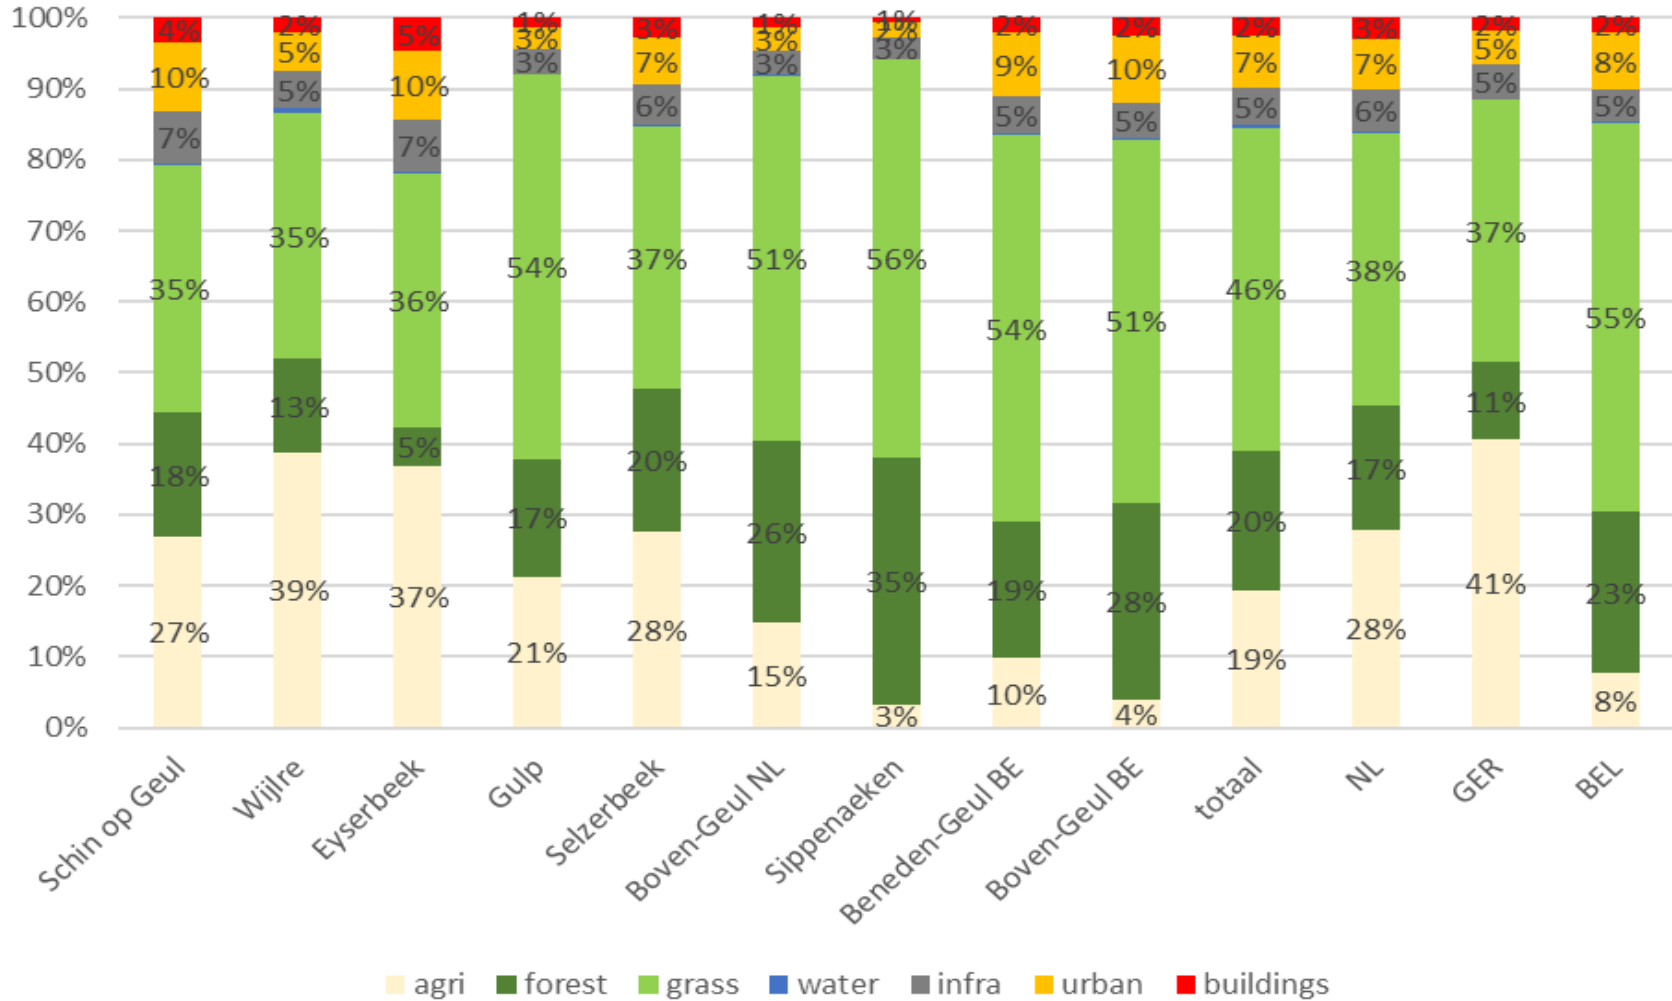
Land cover Geul Catchment

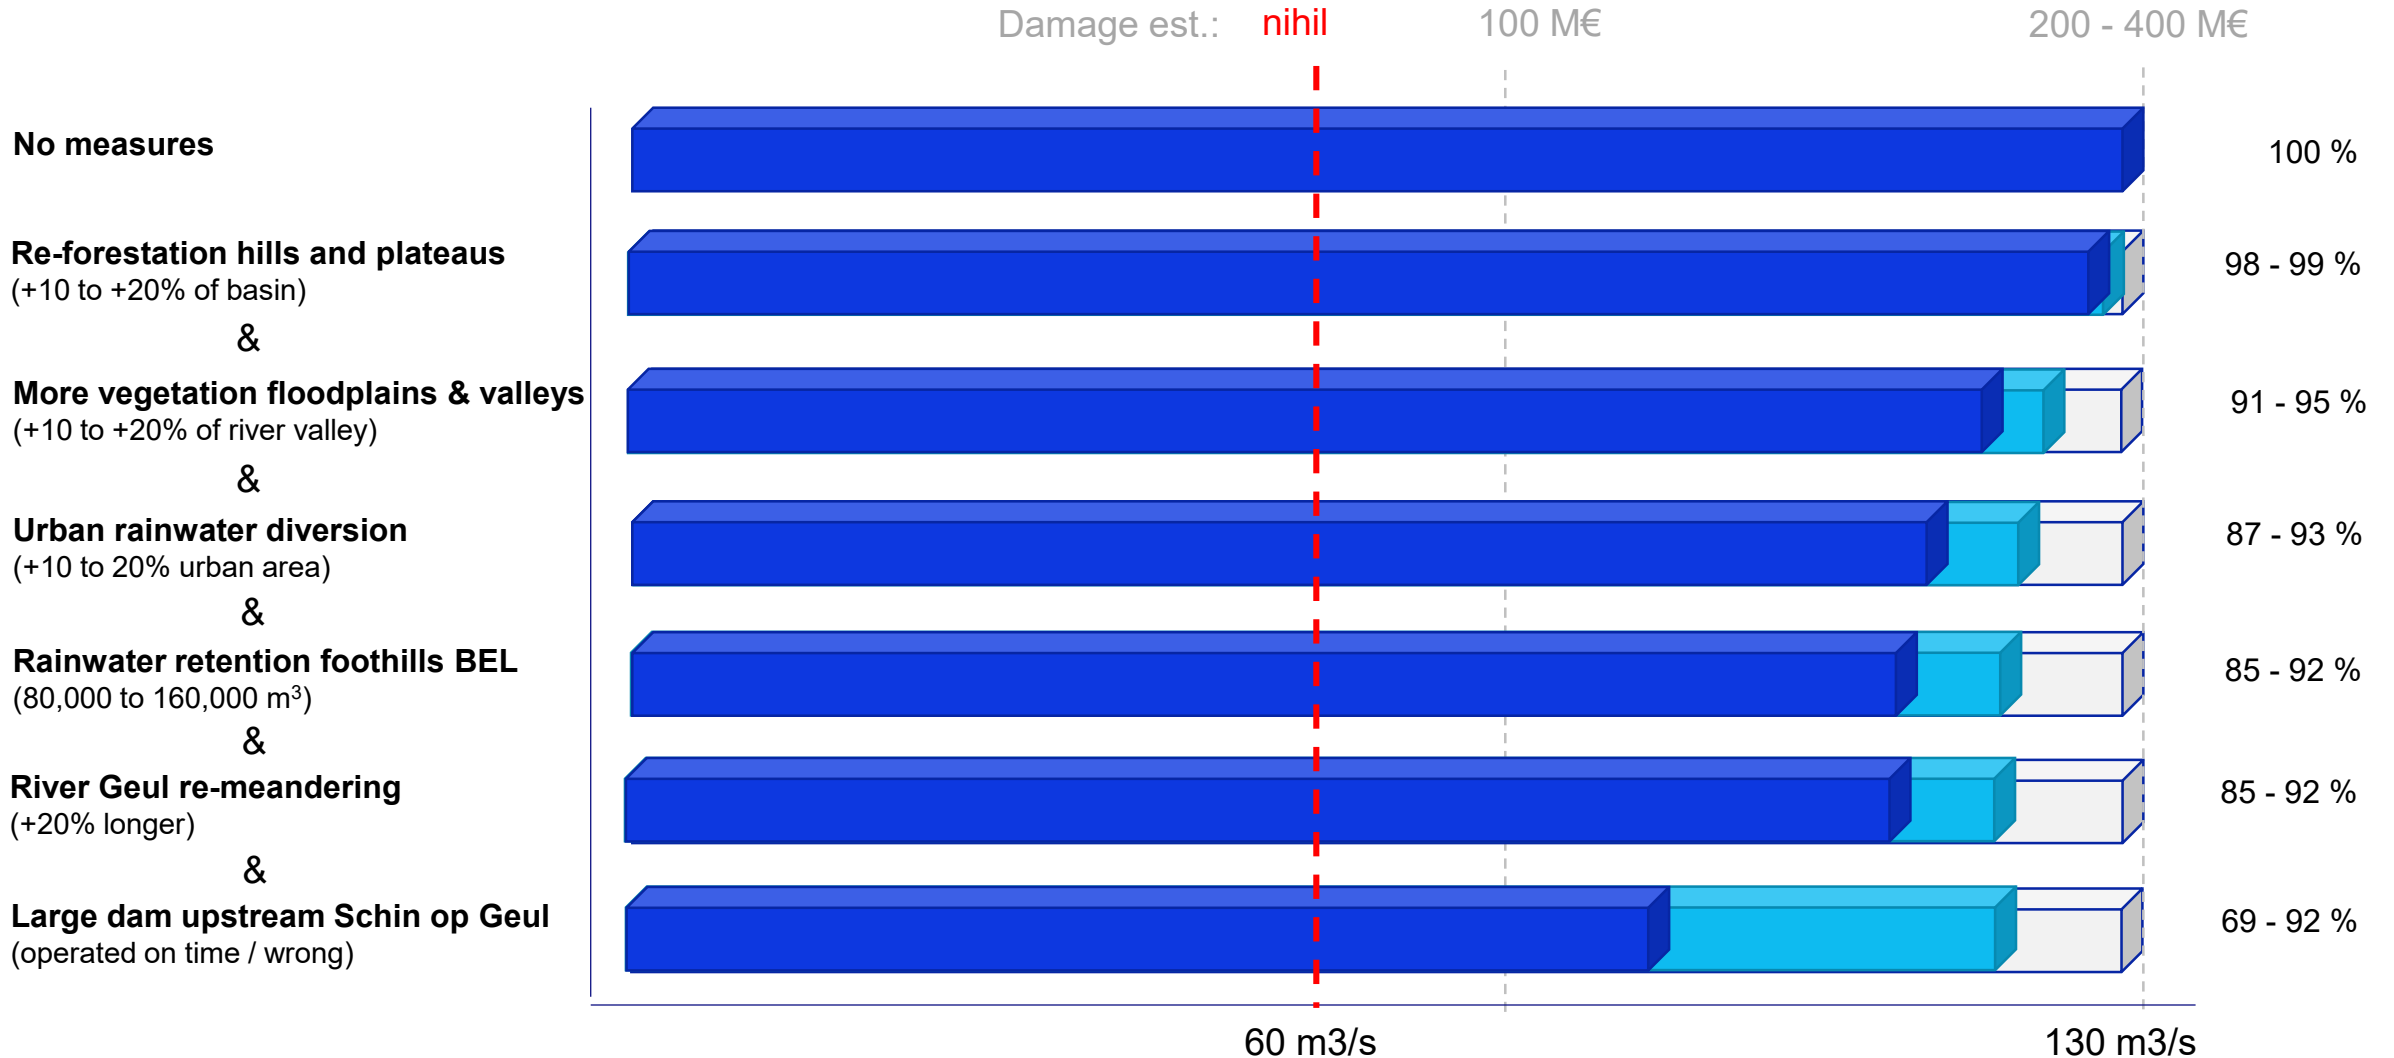
Potential of combined measures on July 2021 discharge at Valkenburg
