HWBP
voor sterke dijken

HWBP-DIV

Insights erosion tests Hedwige-Prosper, impacts of droughts and animal burrowing

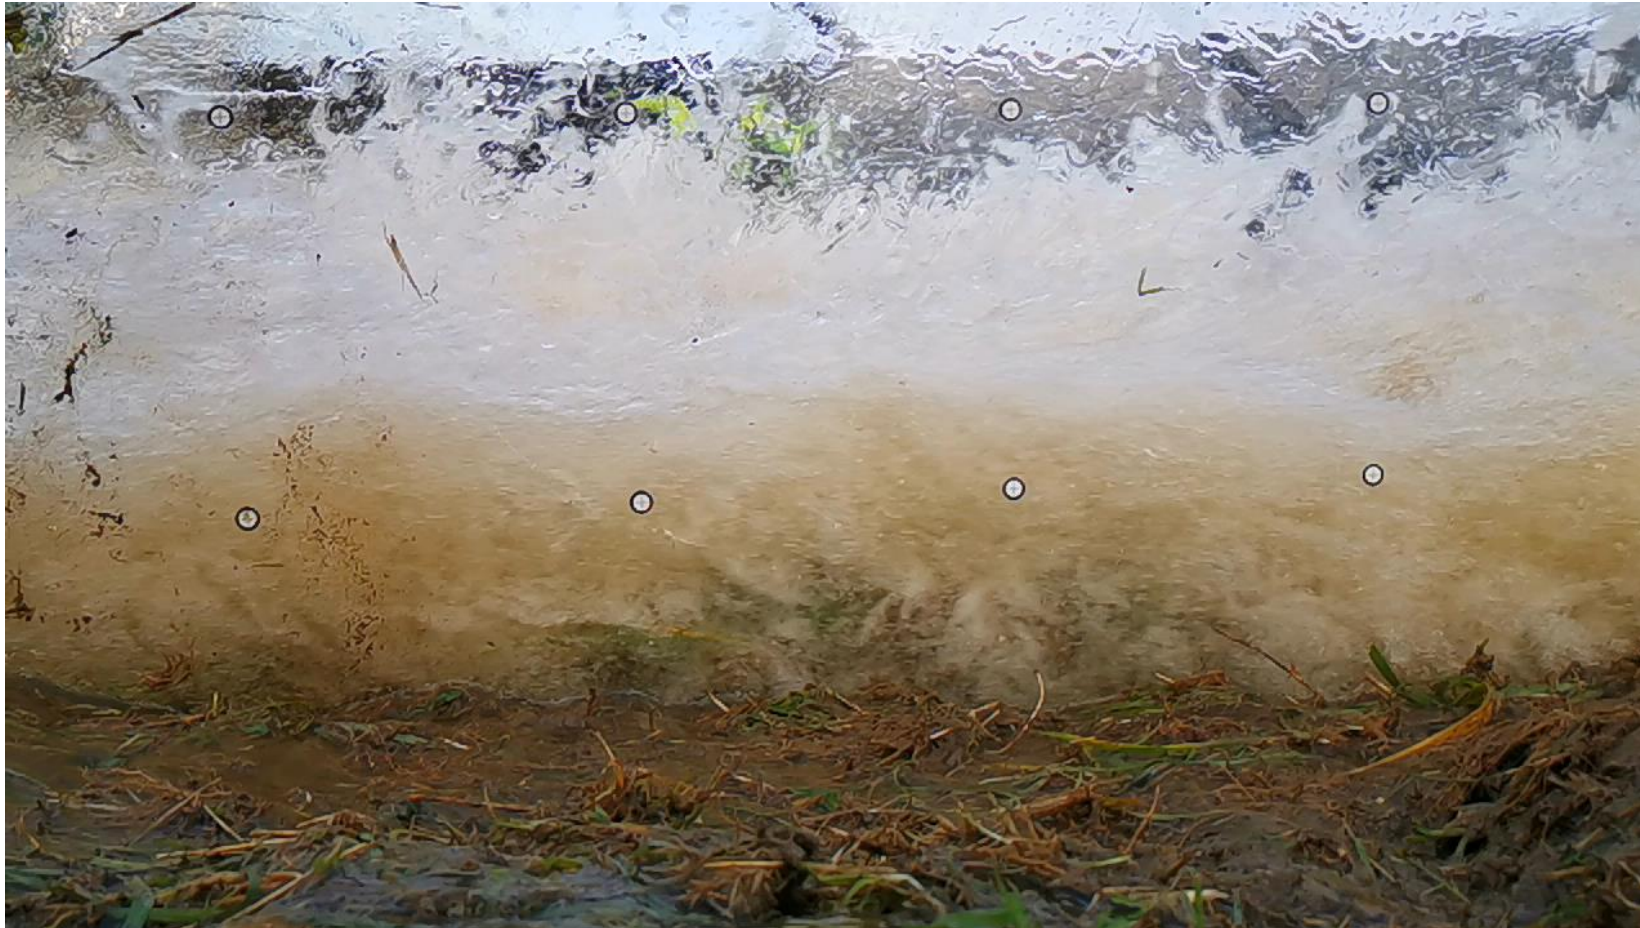
Loading due to overflow.

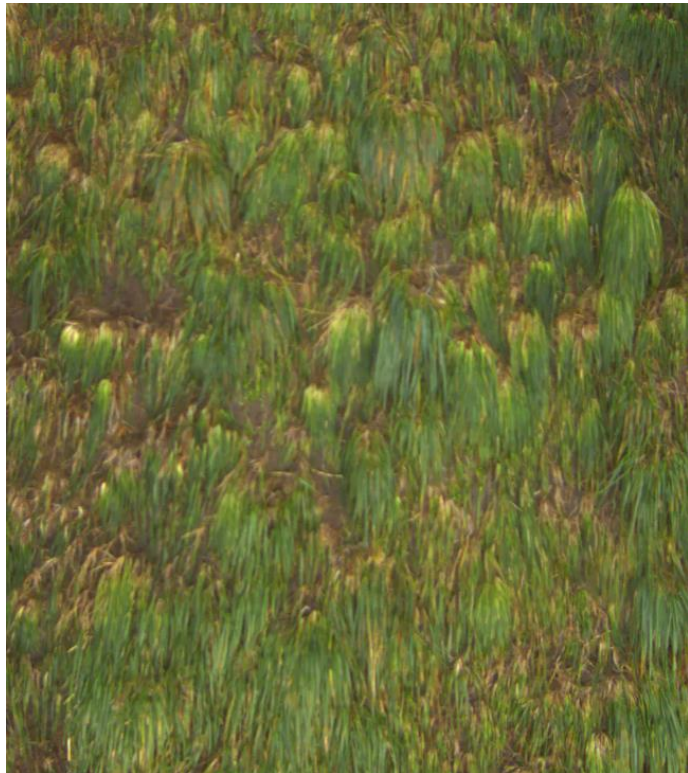
Response of grass at given flow velocities

- › Vegetation is flattened
- › Some bare spots
- › Some local erosion of clay
- › No large scale erosion

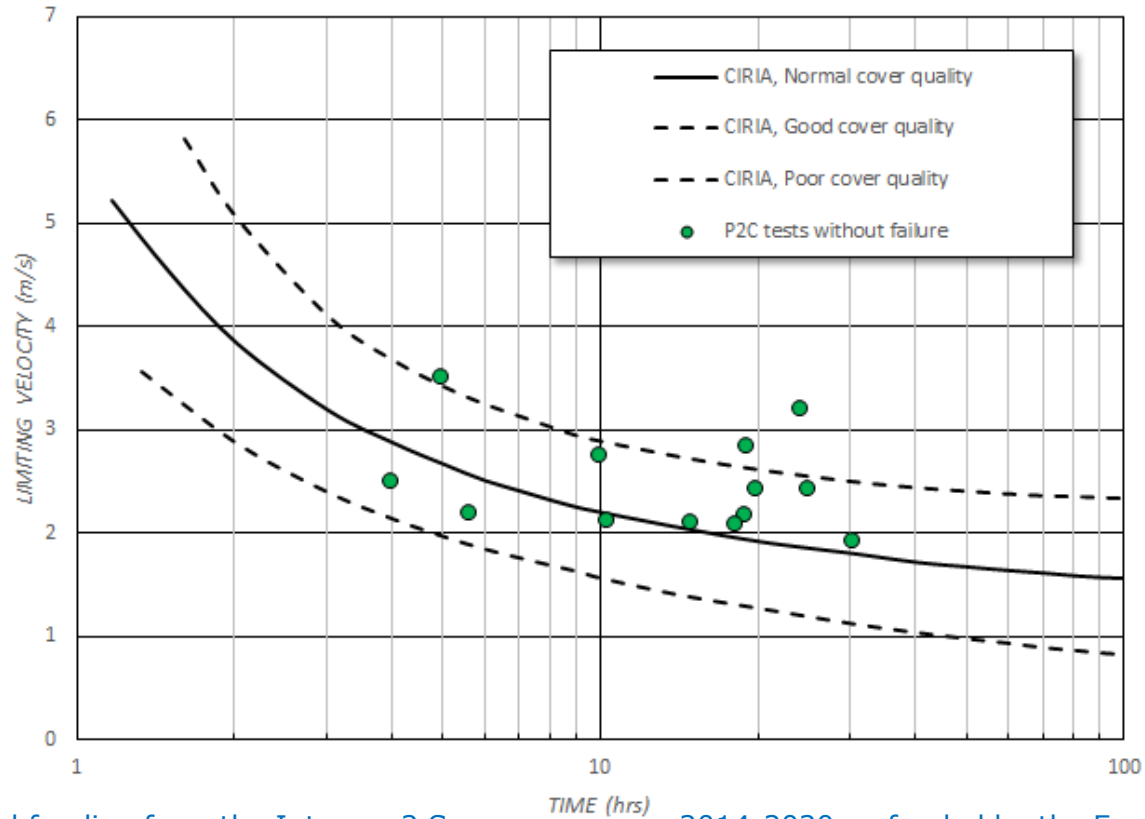
Erosion resistance of grass (CIRIA, 1976)
and Polder2C's test results

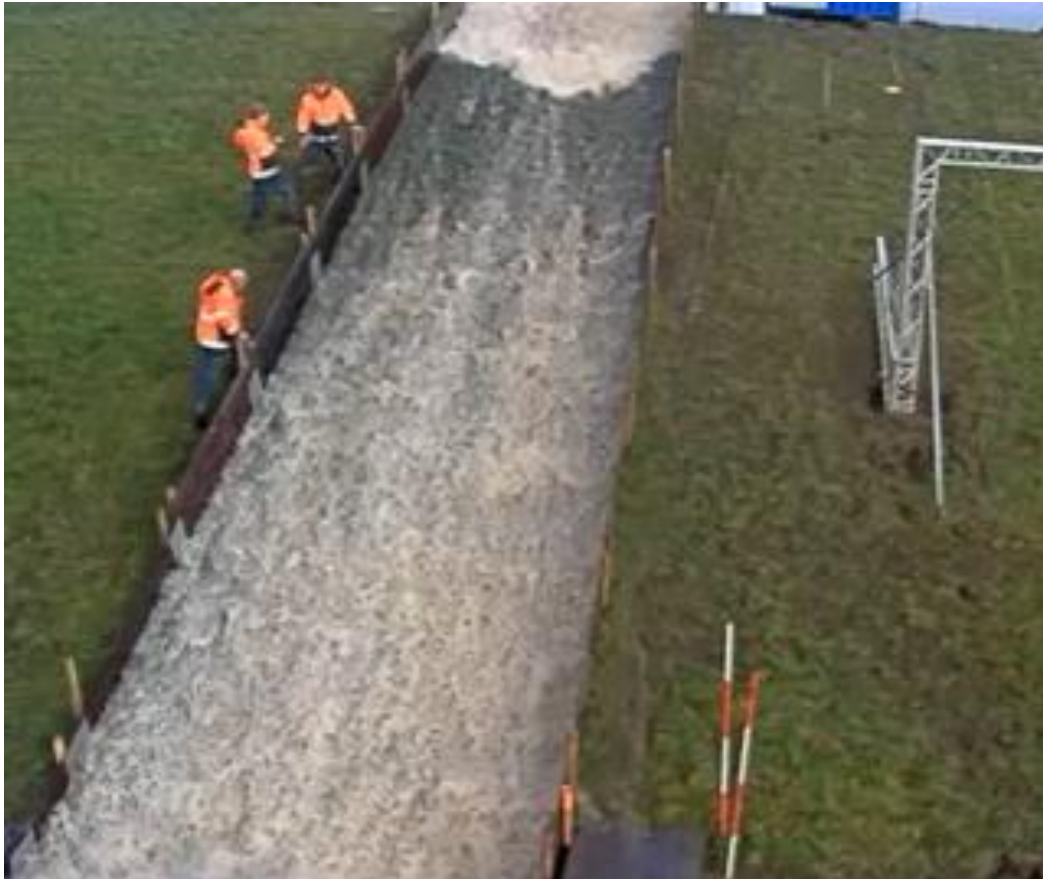
Wave overtopping

- > Average overtopping discharges varied from 50-200 L/m/s
- > Sign. wave heights tested: 50, 100, 200 cm

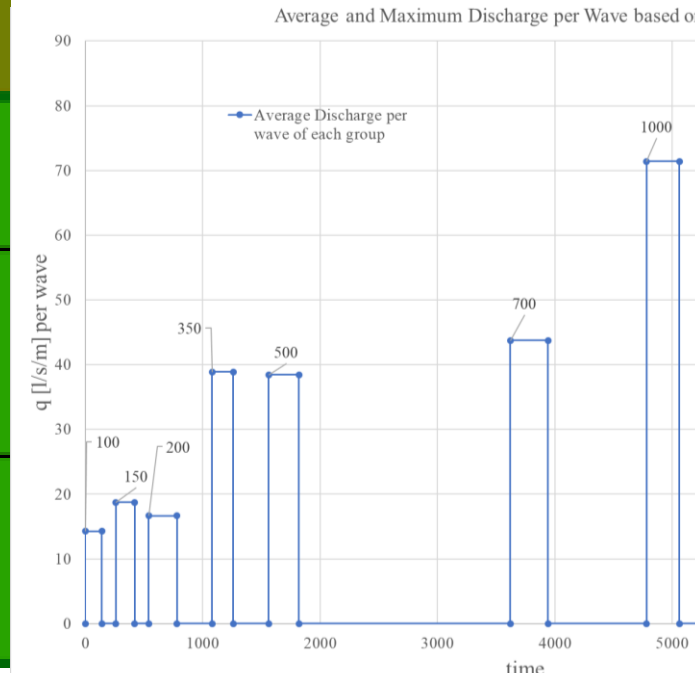
- Tests executed on Prototype scale
- Sections of exposed clay 4x4m
- 5 sections tested
- 3 sections regular waves, 2 sections irregular waves

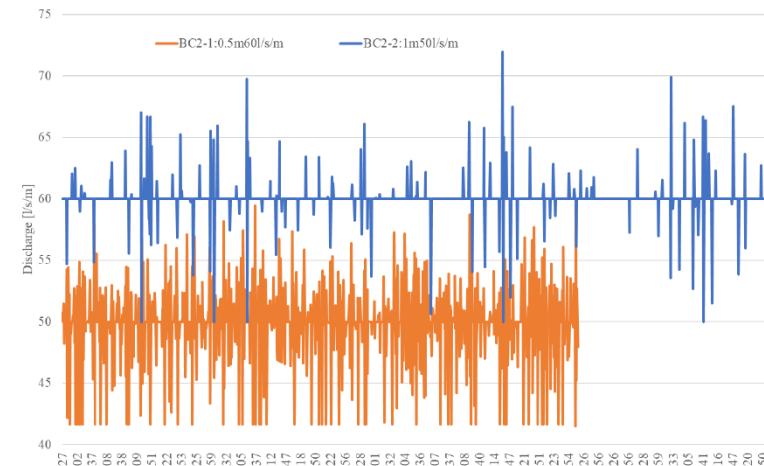
Outflow Hydrograph-Irregular Waves

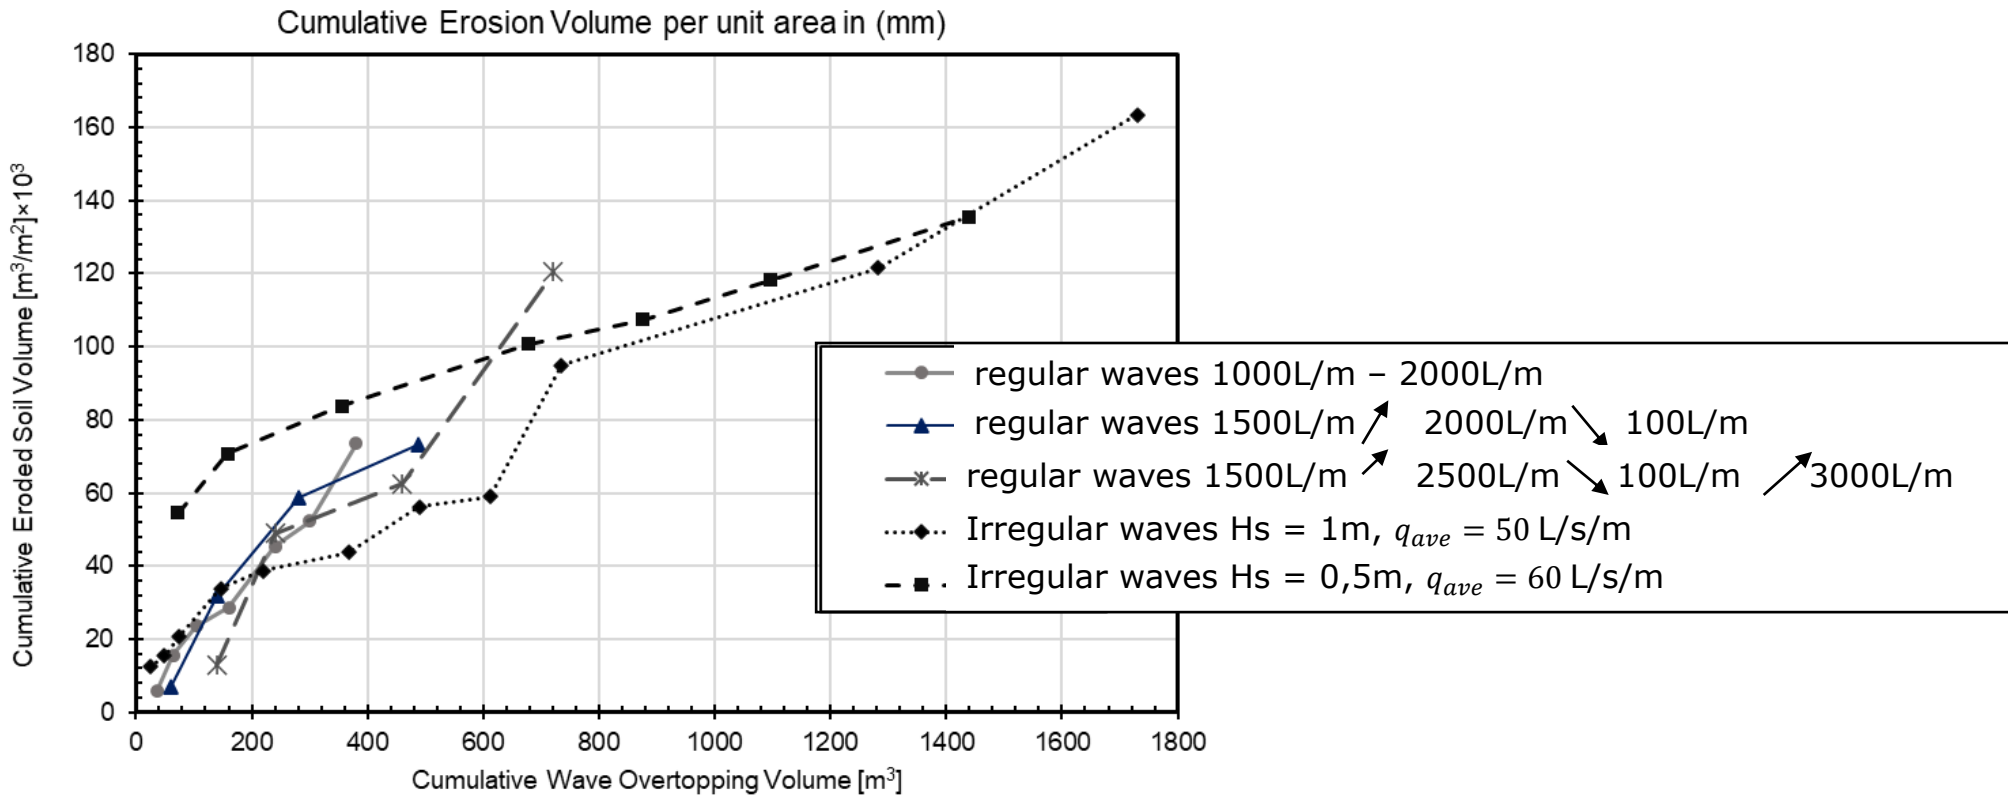
Results

Looking at the gradients, similar cumulative overtopping discharges give similar erosion rates, provided $U > U_c$

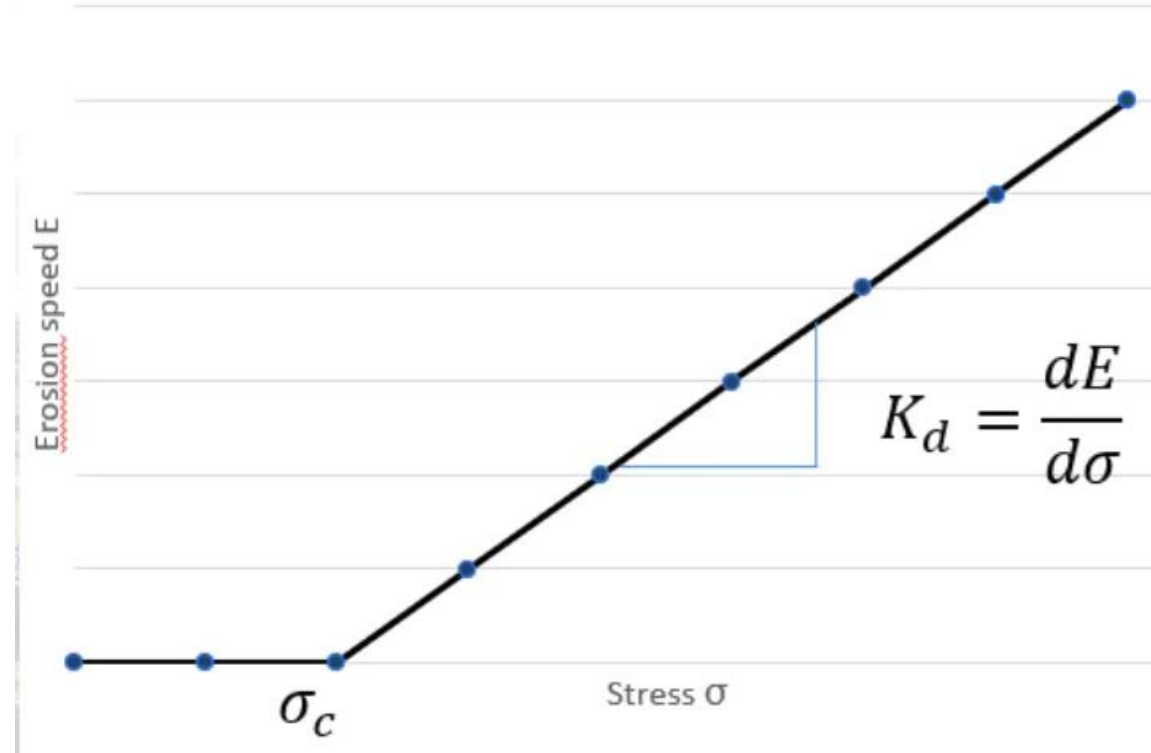
Erosion modelling parameters considered

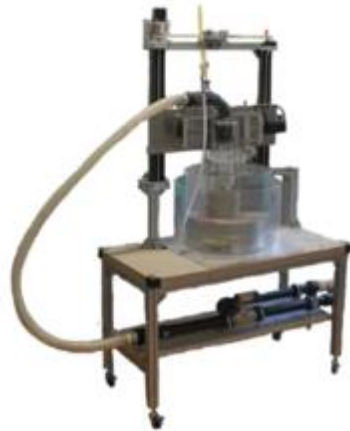
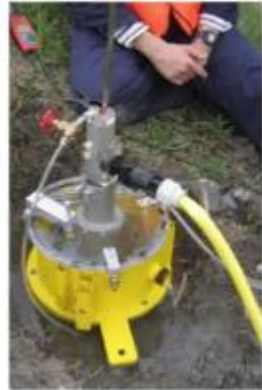
JET and EFA methods

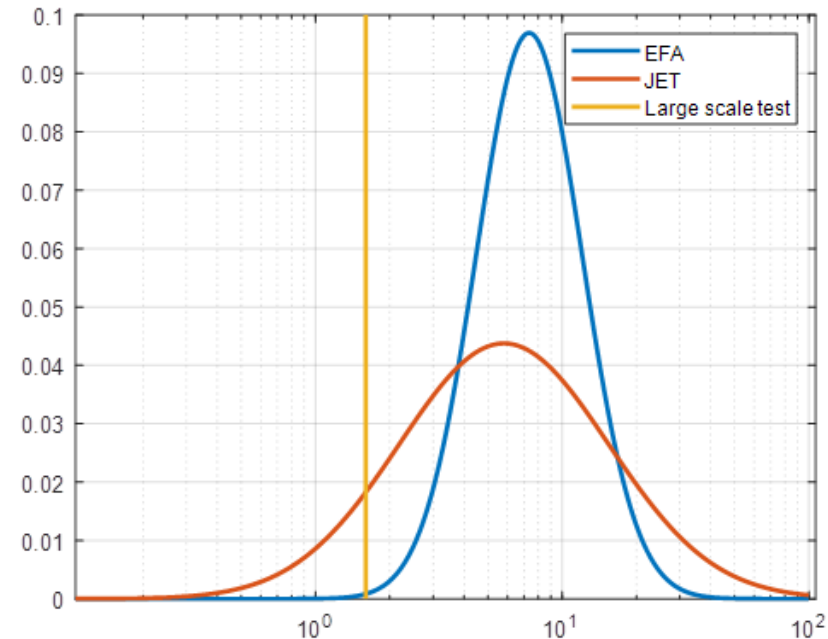
Method comparison

Test	K_d [cm ³ /Ns]	τ_c [N/m ²]
EFA	8	0,325
JET	6	48,4
Real scale	1,6	?

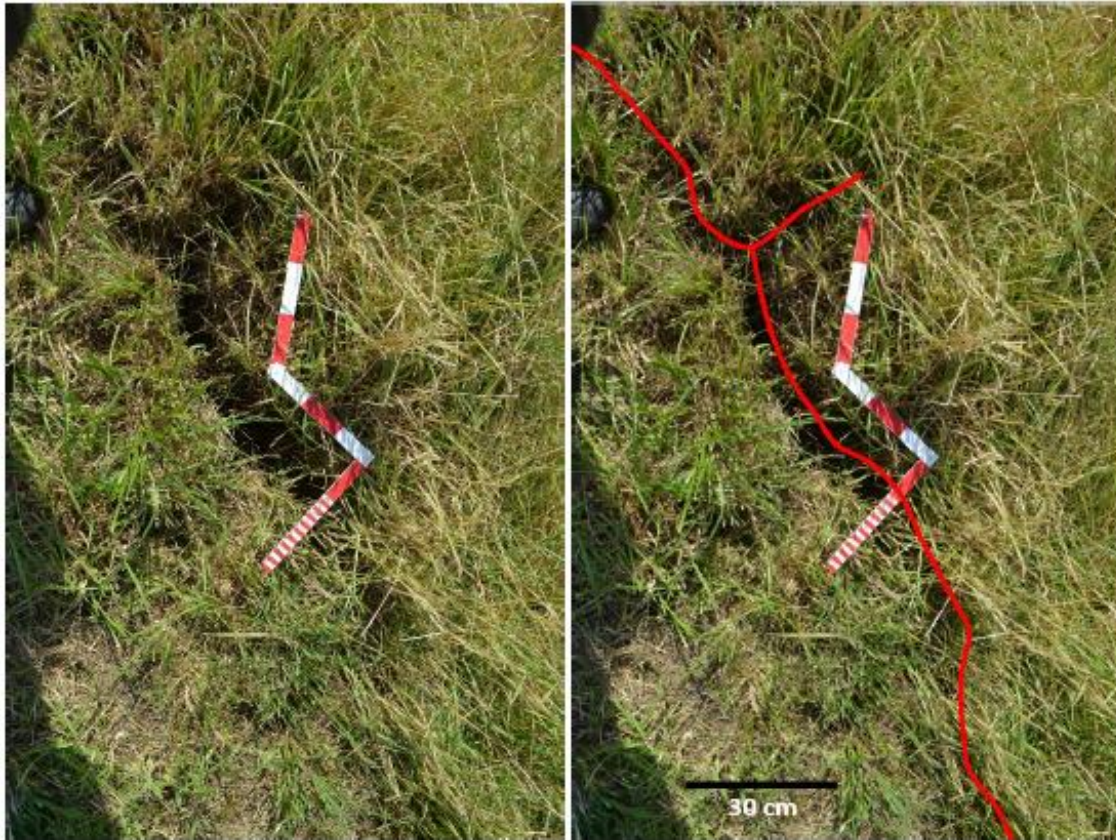
Crack on landside slope of Standhazensedijk

- > Occurred during dry Summer of 2018
- > Didn't disappear afterwards (2022)

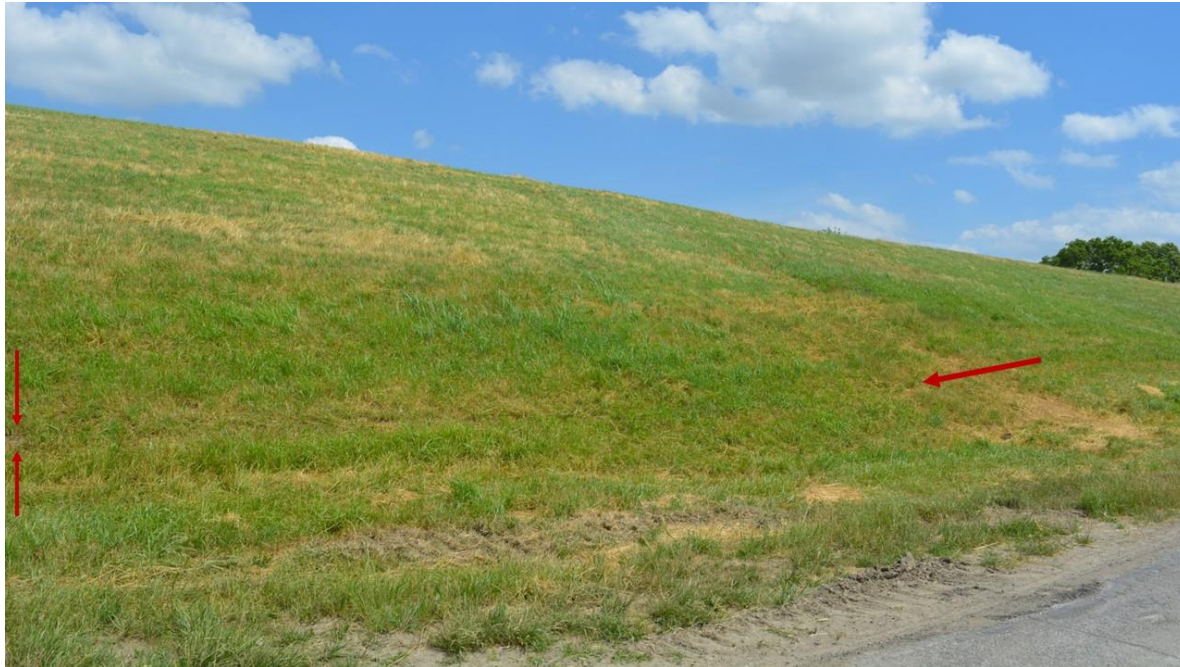
Crack on landside slope of Hedwige

- > Occurred during dry Summer of 2021
- > Partly closed after two weeks of mild rain
- > Disappeared afterwards (2022 – removal of entire levee)

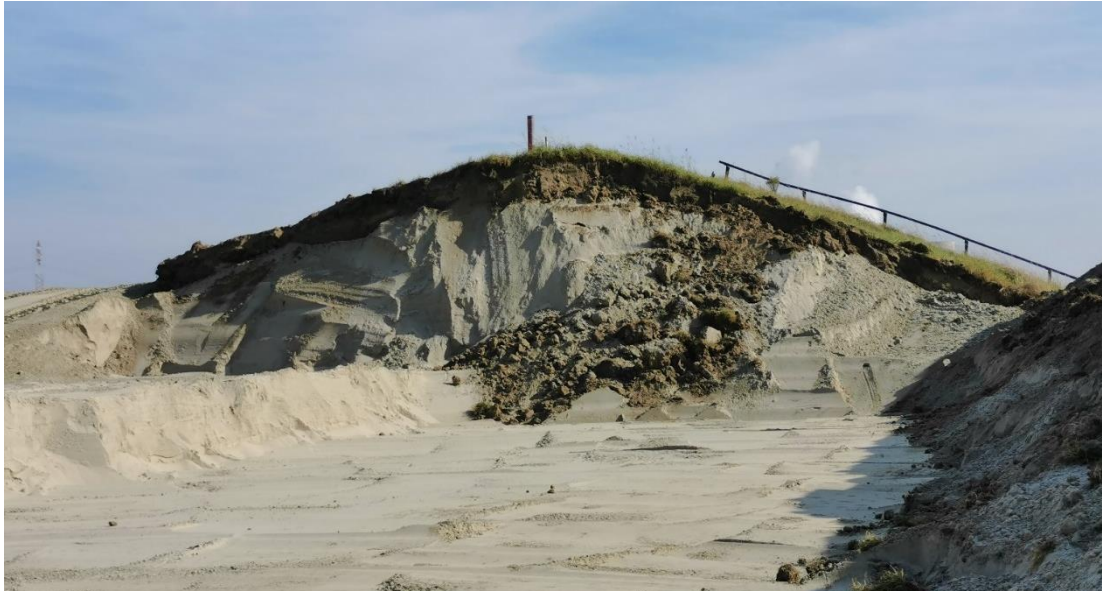
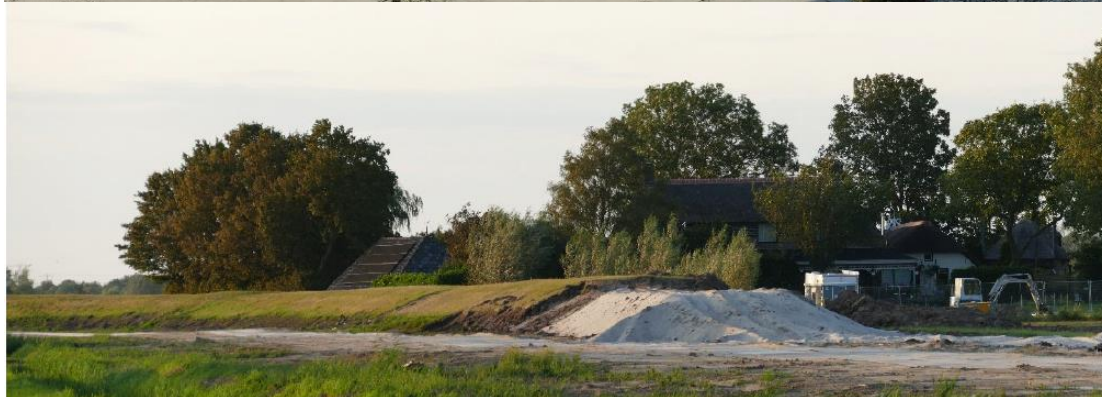
With so many levees in the Netherlands with a clay cover on a sand core ...

- > “Any drought cracks will close before flood conditions arrive” (Dutch guidelines, since about 2000)
- > “The clay cover provides a nearly impervious layer, limiting the phreatic surface inside the levee” (paraphrase of Dutch guidelines regarding slope stability of levees)

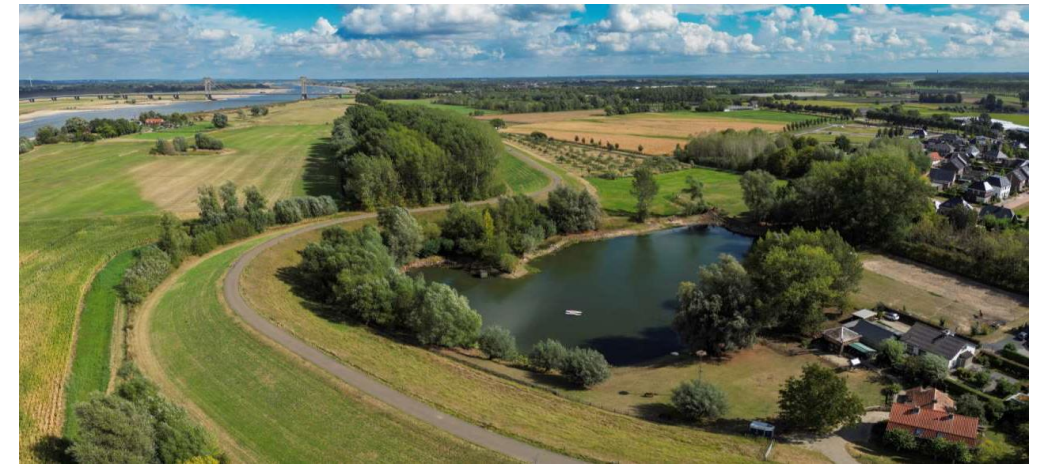
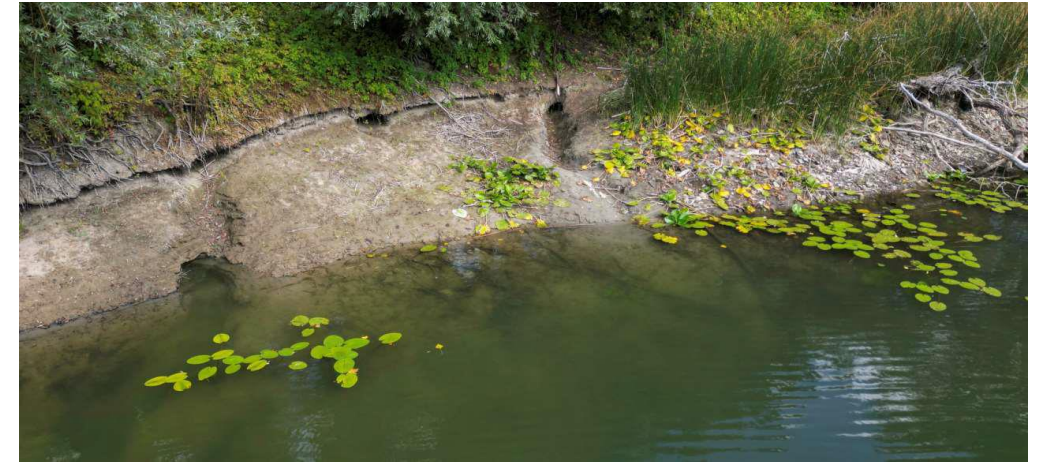
Beaver burrows at Wamel (July 2022)

Impact on safety against flooding
estimated to be **100** to **14,000** times
higher

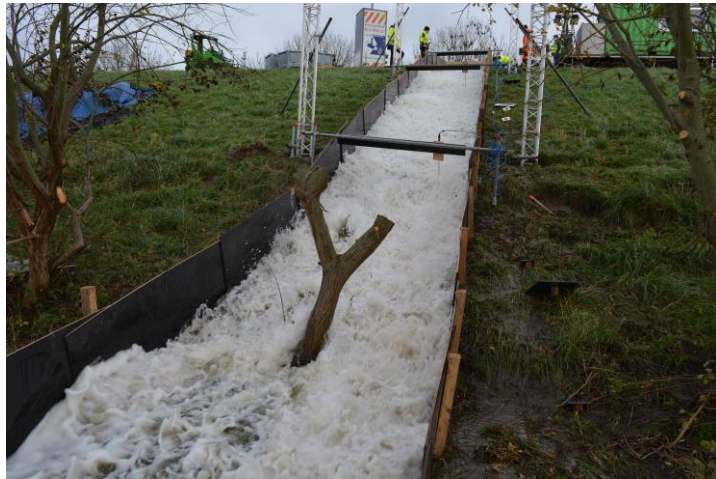
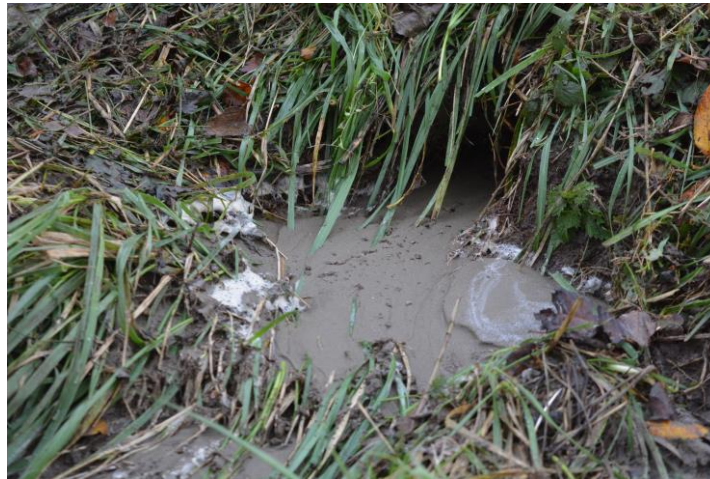
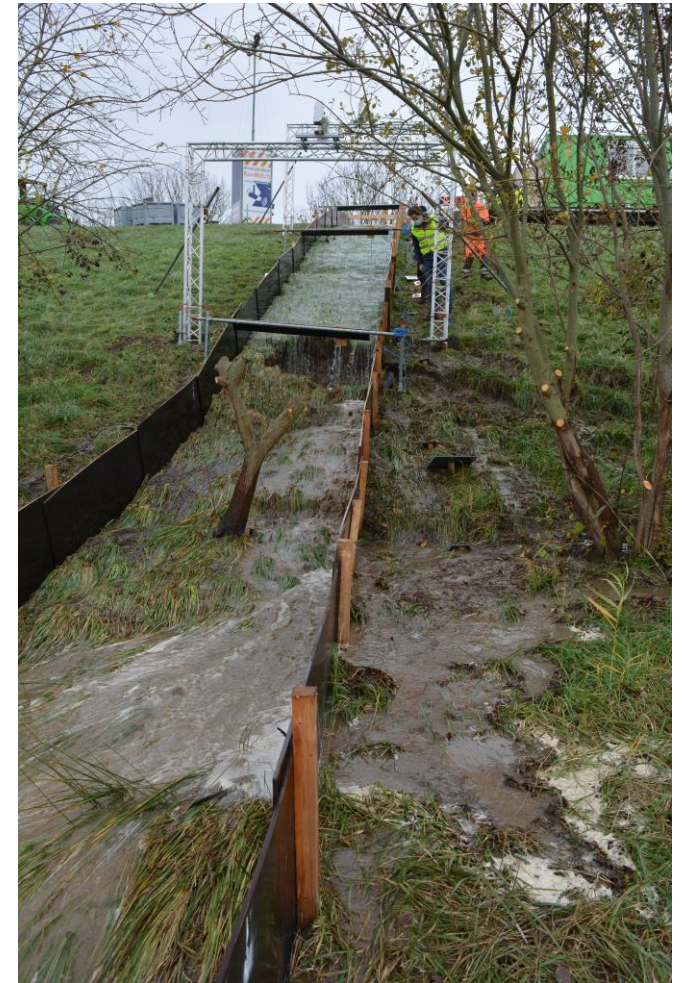
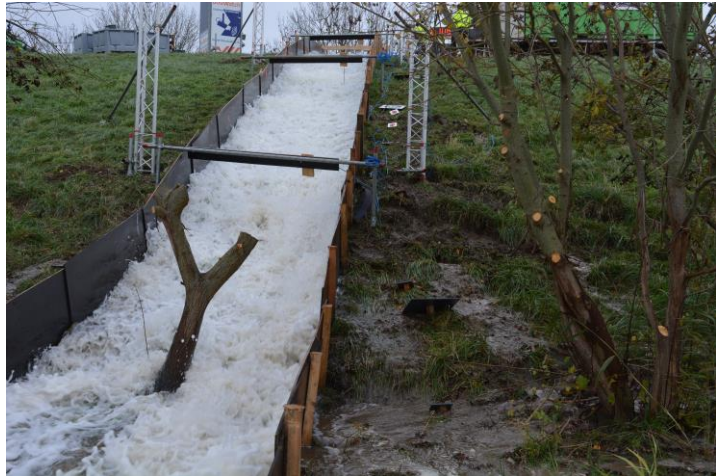
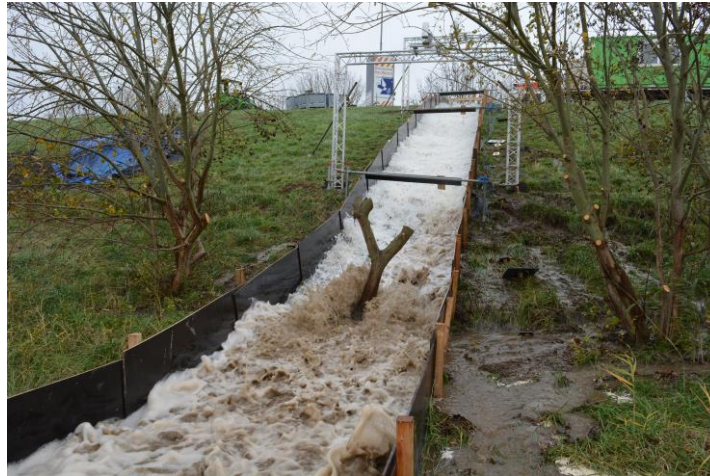
Overflow test on the stability of a tree, with apparent mole burrows (failure after 1 h 7 min)

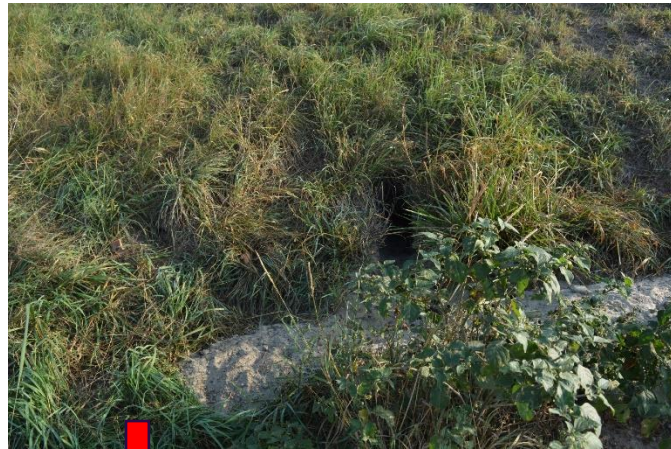
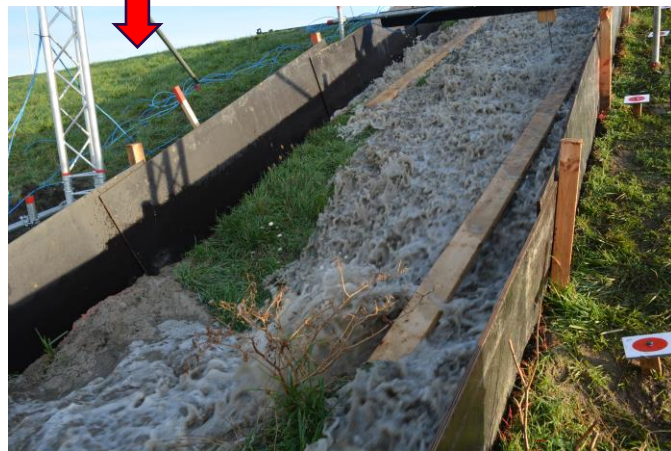
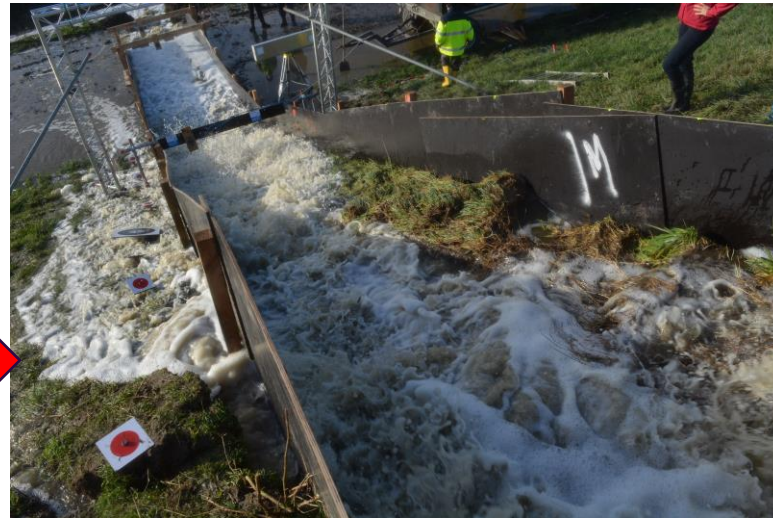
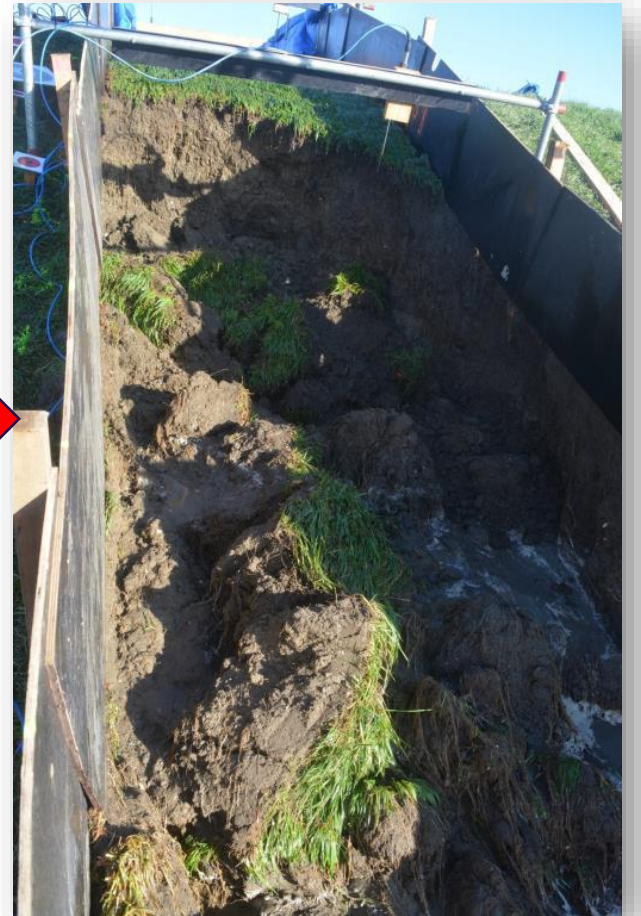
Overflow test on a fox/rabbit hole (failure after 1 h 13 min)

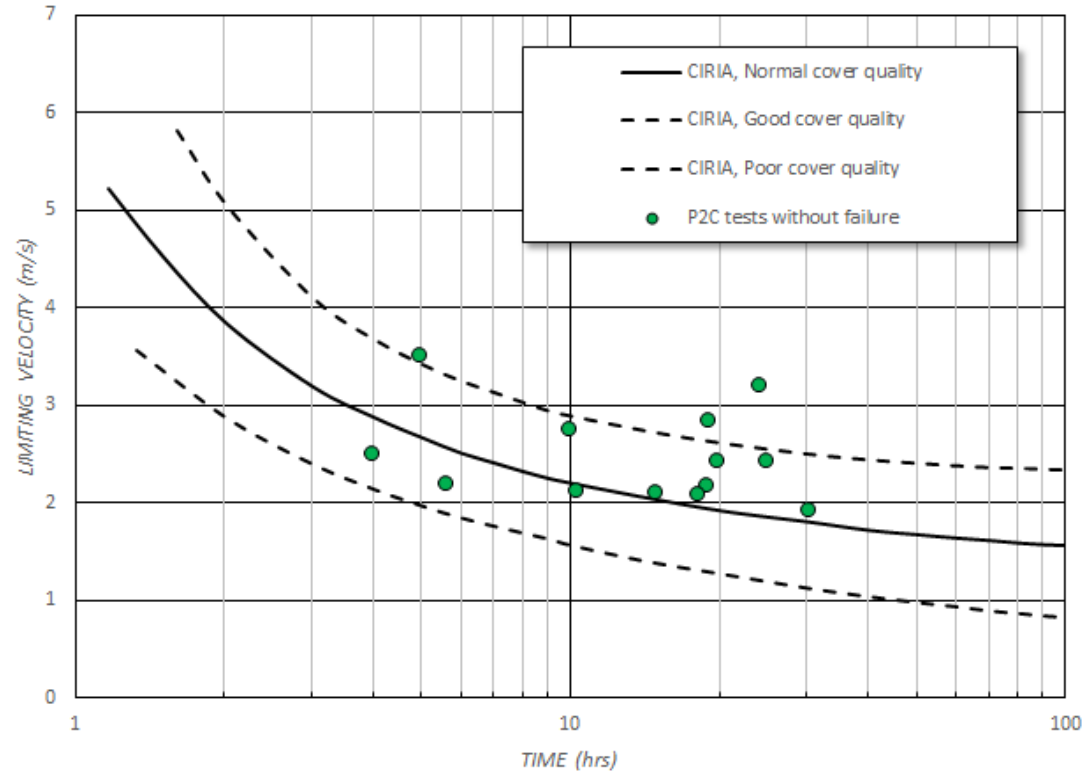
Overflow tests

Erosion resistance of grass (CIRIA, 1976)
and Polder2C's test results

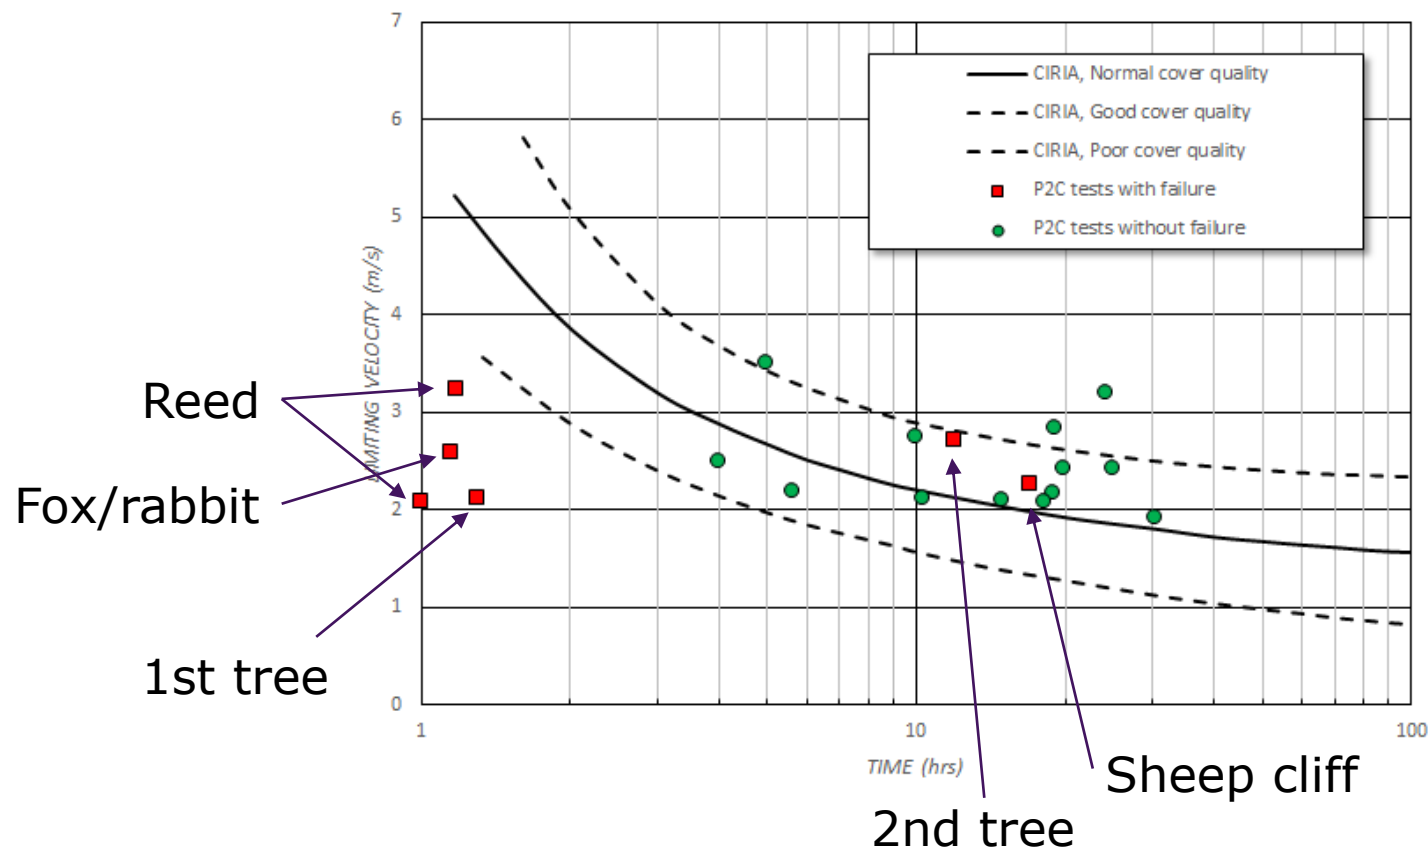
Overflow tests with animals

Erosion resistance of grass (CIRIA, 1976) and Polder2C's test results
