The safety standard defined for the Dutch coast is based on an exceedance probability of a 1/10,000 per year storm surge. Our goal is to improve the confidence interval of such a rare storm by estimating the surge height and morphological effect of the biggest storms of the 18th century. This poster describes the reconstruction of the morphological effect and surge height of the storm of 25 december 1717.

Reconstructing the 1717 Christmasflood

Fedor Baart, Marcel Bakker, Ap van Dongeren, Kees den Heijer, Sytze van Heteren, Marije Smit, Mark van Koningsveld & Arend Pool

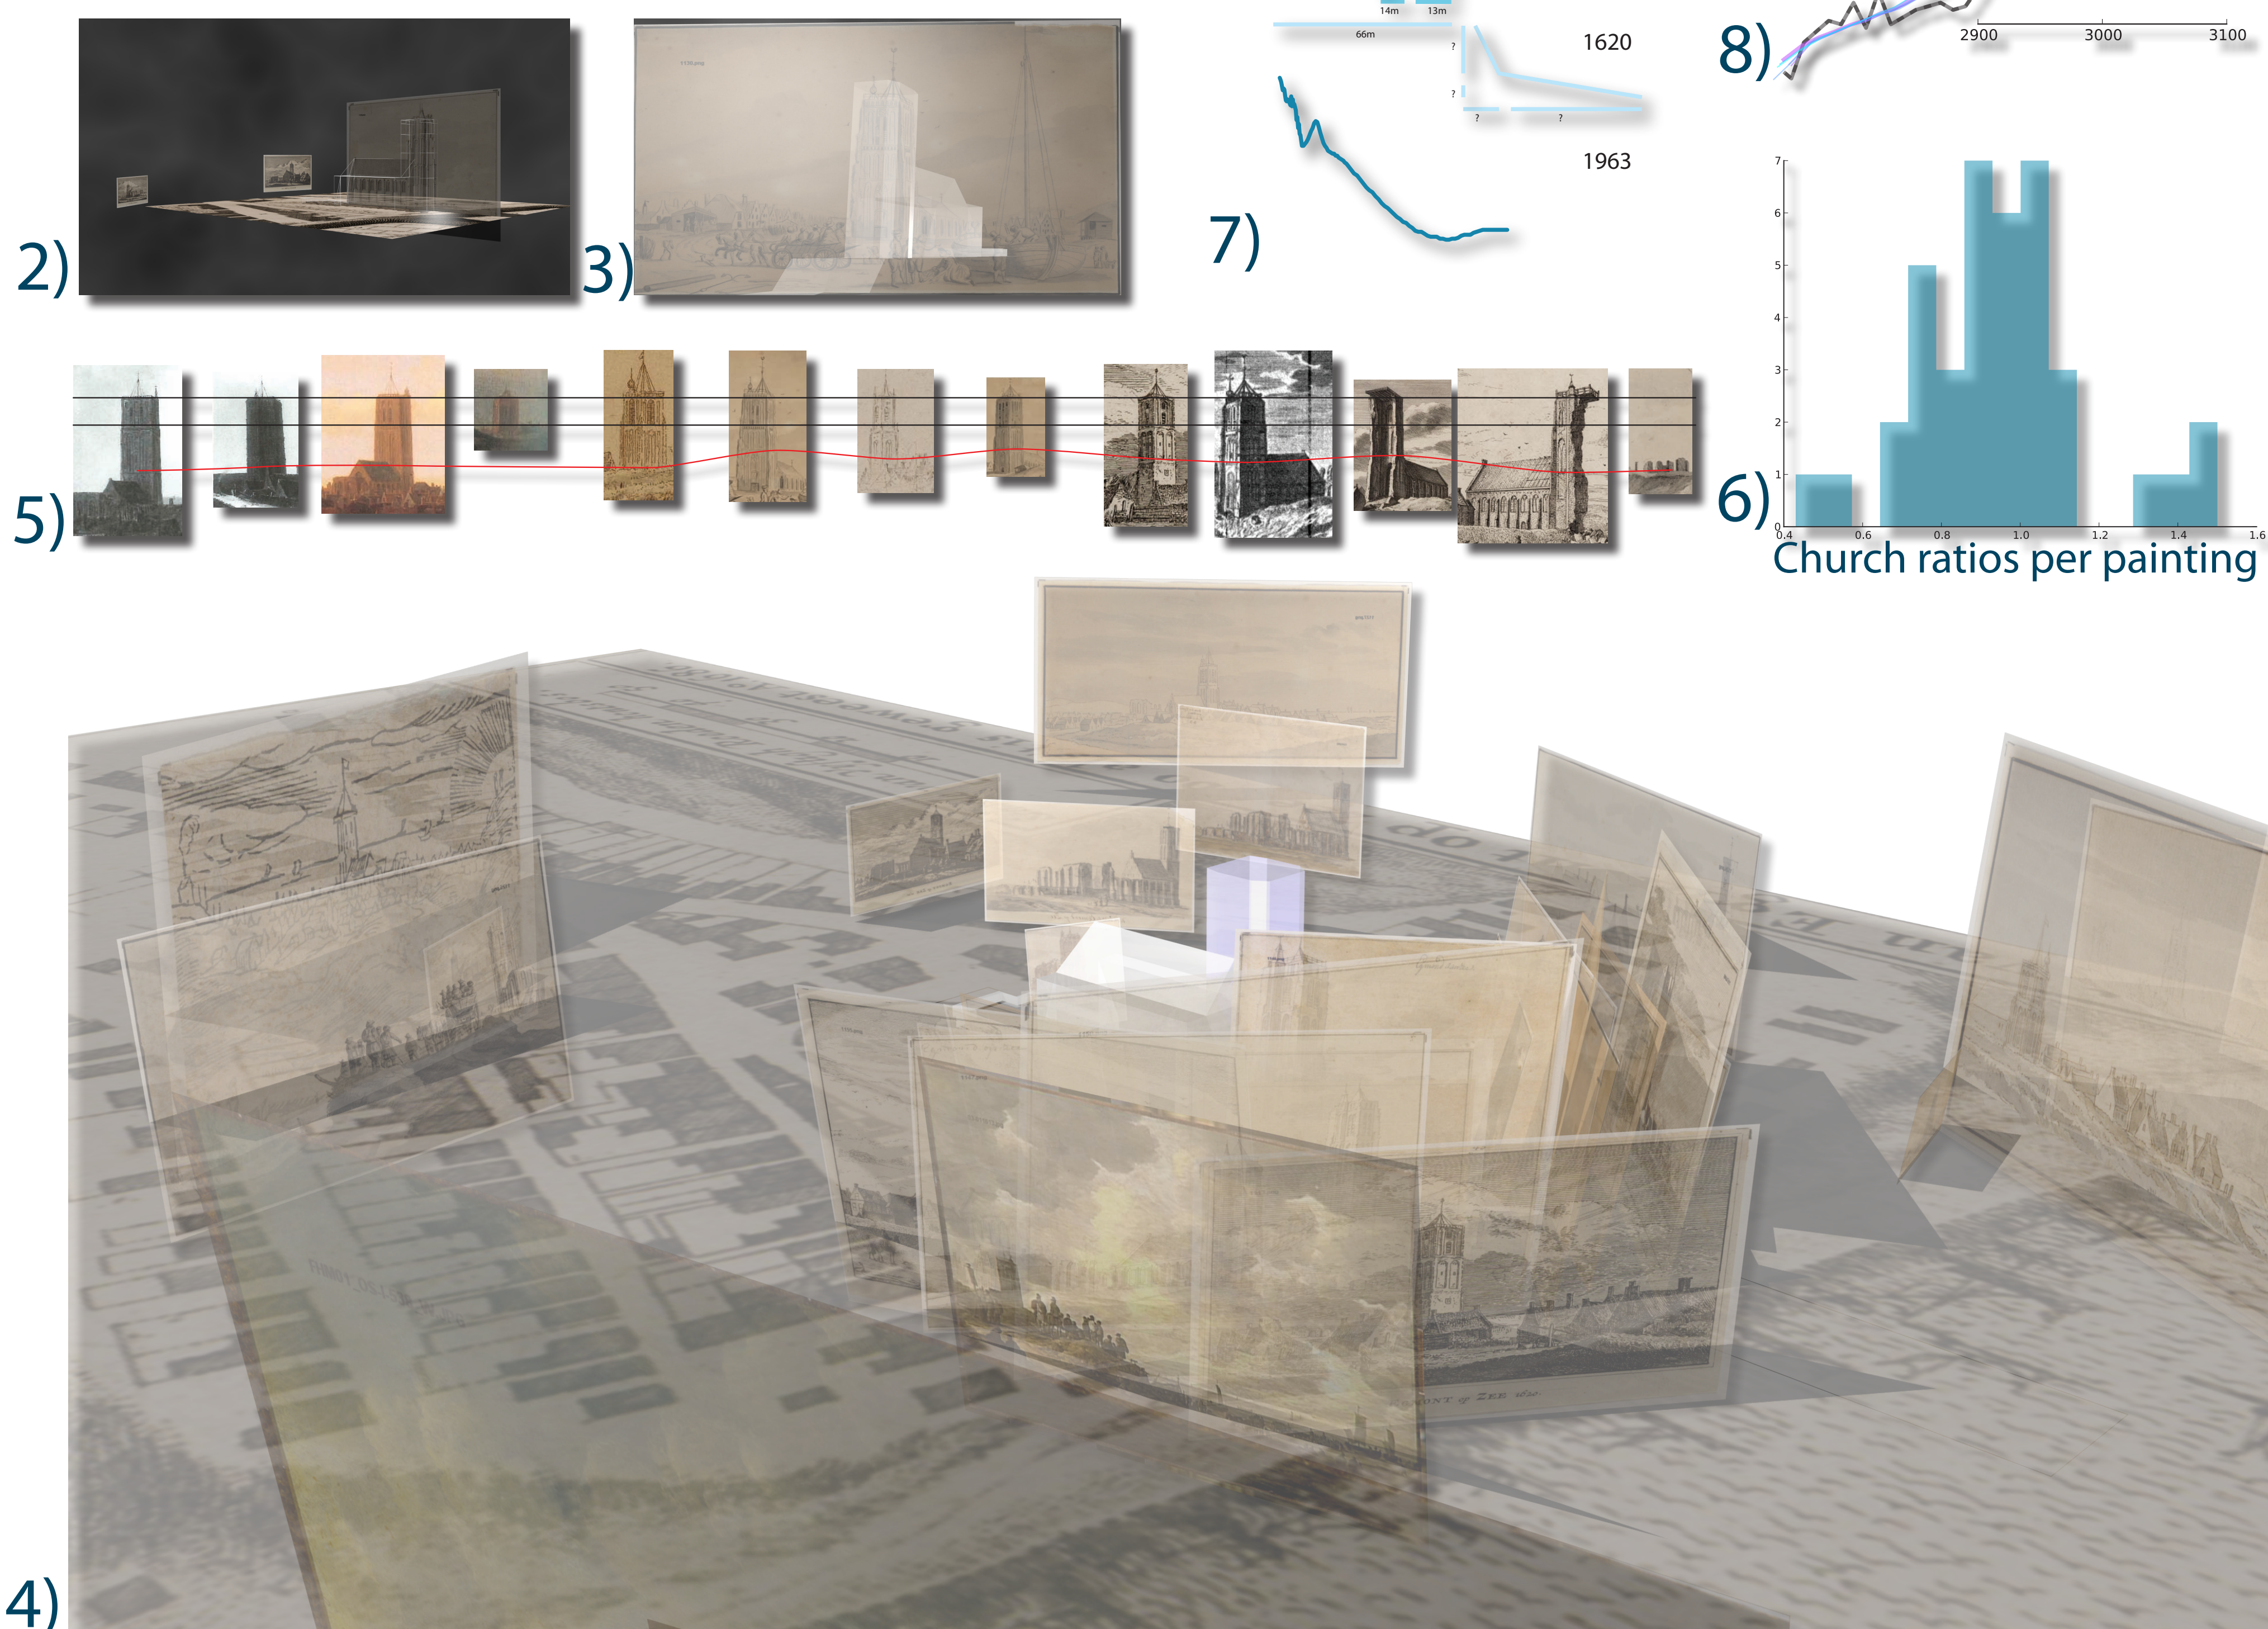
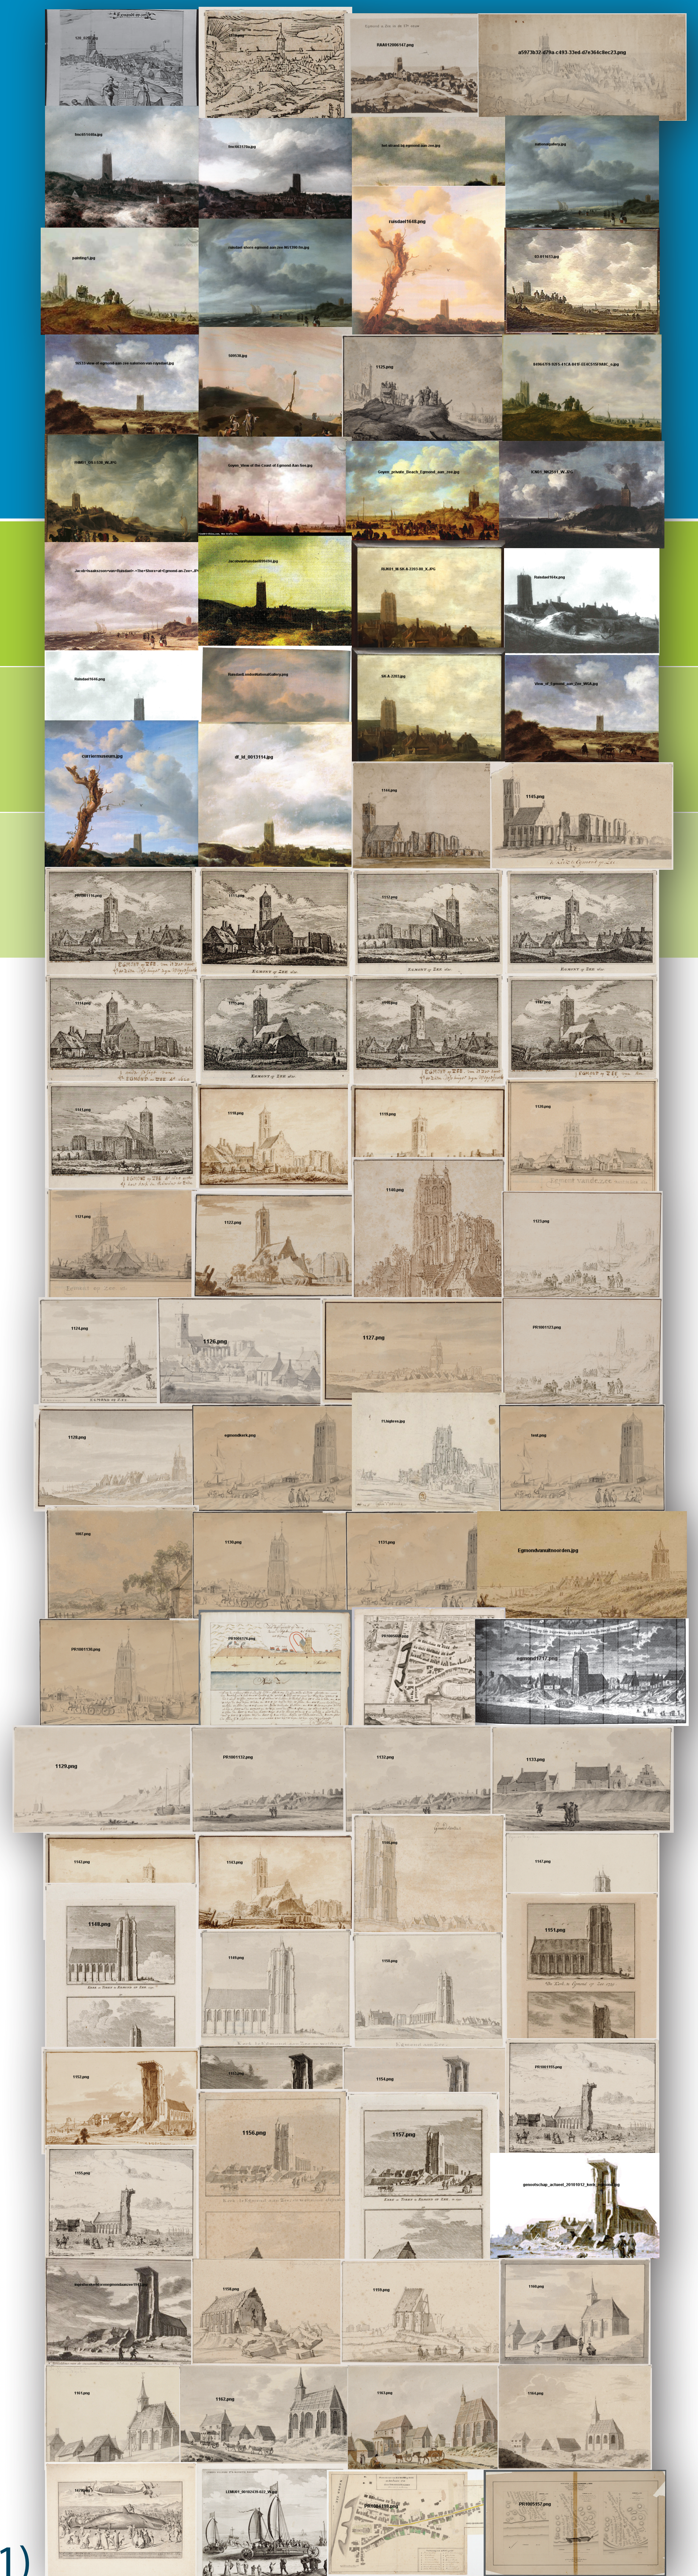
- Collect images between 1600 and 1750 (1)
- Position images in 3D space (2,3,4)
- Estimate painter reliability (5,6)
- Inverse model the surge height (7,8)
