The safety standard defined for the Dutch coast is based on an exceedance probability of a 1/10,000 per year storm surge. Our goal is to improve the confidence interval of such a rare storm by estimating the surge height and morphological effect of the biggest storms of the 18th century. This poster describes the reconstruction of the morphological effect and surge height of the storm of 25 december 1717.

Reconstructing the 1717 Christmasflood

Fedor Baart, Marcel Bakker, Ap van Dongeren, (C.) Kees den Heijer,
Sytze van Heteren, Marije Smit, Mark van Koningsveld & Arend Pool

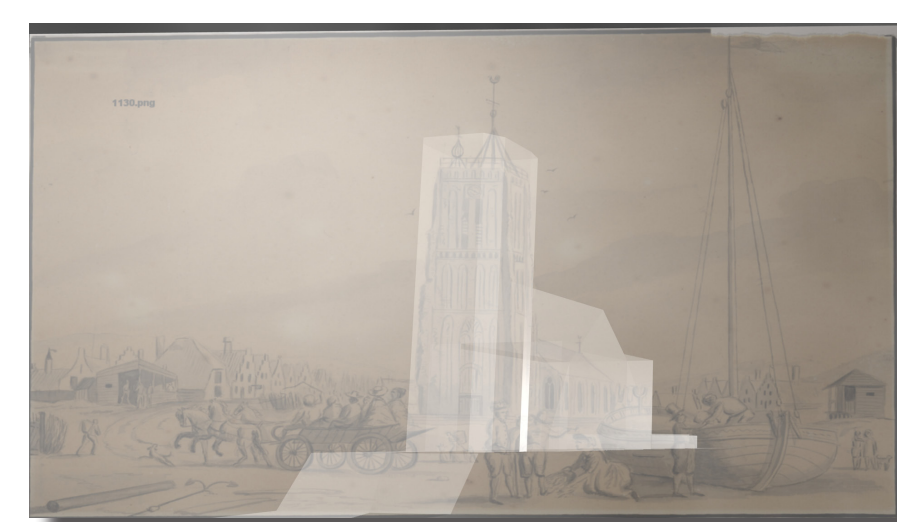
3D model of Egmond aan Zee

- Collect images between 1600 and 1750
- Position images in 3D space
- Estimate painter reliability

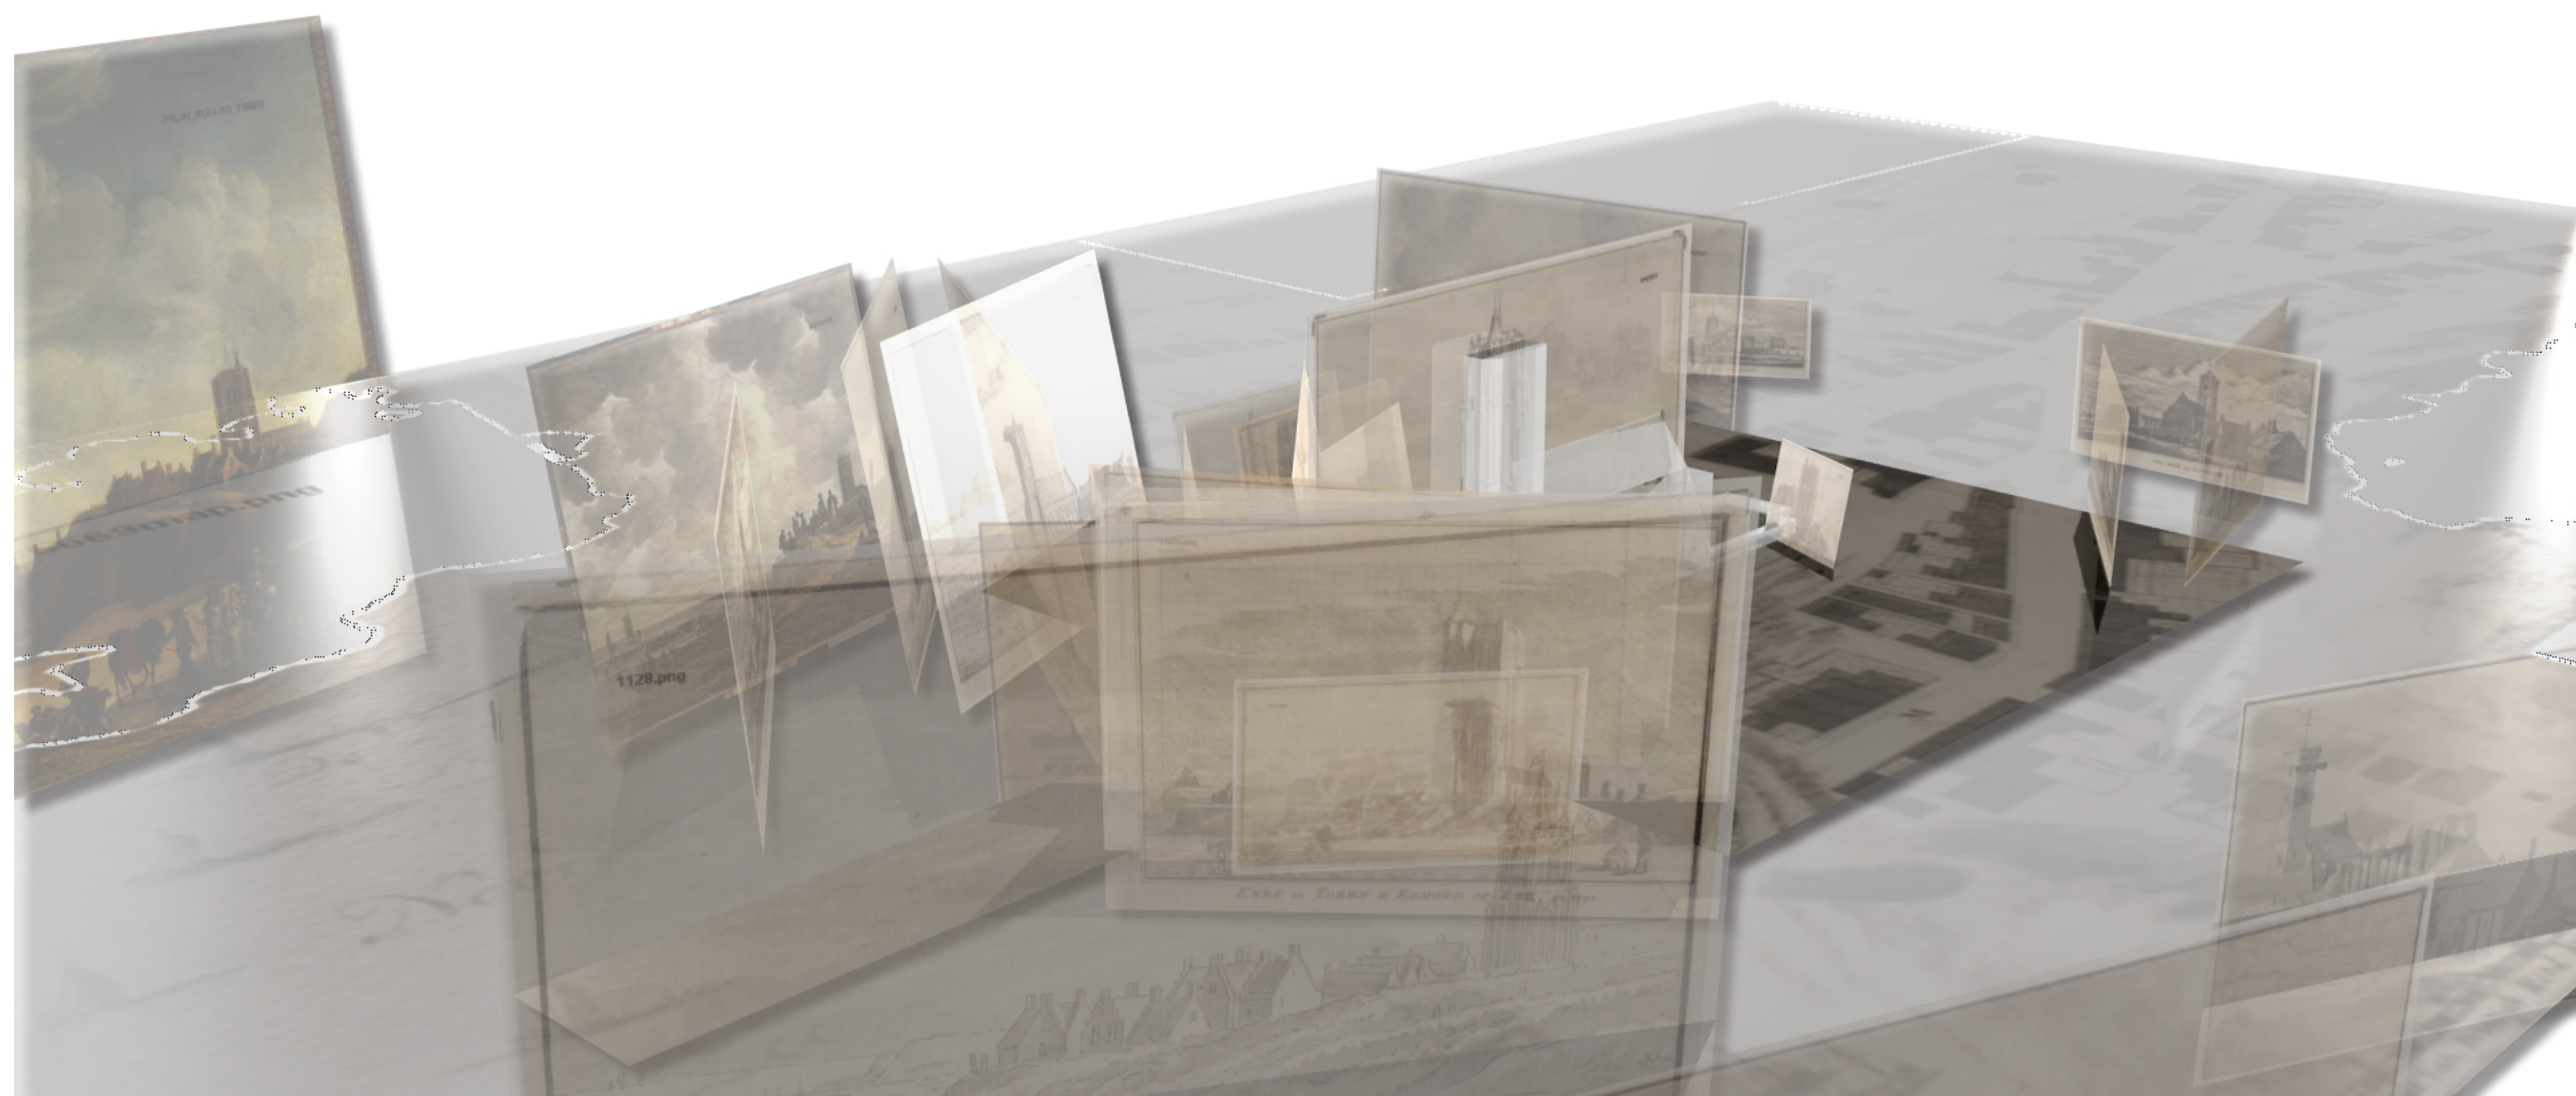
Estimating between and within painter reliability
