Monitoring of coastal morphodynamics using satellite imagery

Building with Nature Guideline

Type: Method

Project Phase: Planning and Design

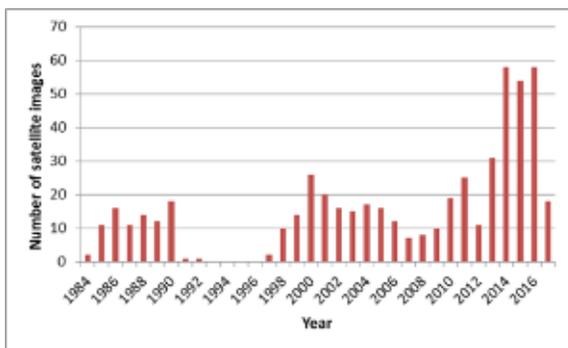
Number of satellite images per year for the Frisian Lake IJsselmeer coast.

In Google Earth Engine, analyses can be performed on large satellite datasets. However, in the case of the Frisian Lake IJsselmeer coast and especially the shallow foreshore, this turned out to be a hurdle because the morphological changes observed were difficult to define using computer code, as the colour and visibility of the foreshore sediments was dependent on water depth and turbidity. Therefore, a code was written that extracts all satellite images from the area within a rectangle with less than 10% cloud cover. The images were automatically given the name of the recording date, and contained information about the exact location of the images. The images could be immediately imported into a GIS system. Interestingly, it turned out that for the period between 1991 and 1997, almost no images were available. The reason for this data gap is unknown, and appears to be specific for this location.

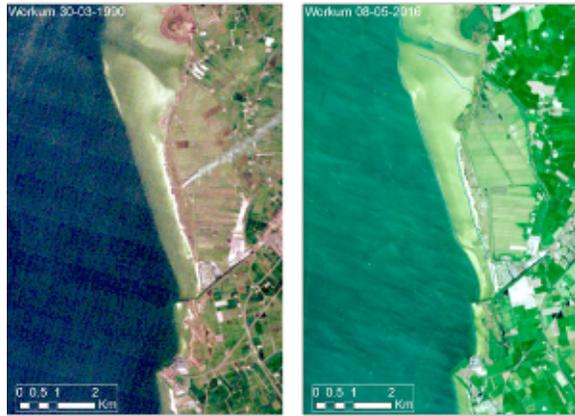
Satellite images of the area along the Workum coast in 30-03-1990 and in 08-05-2016.

For the entire coast, subdivided into five stretches, the differences were analysed and changes were quantified. For these guidelines, the stretch near Workum is used to show the potential of the tool. The results for the coastal stretch near Workum show several significant changes between 1990 and 2016:

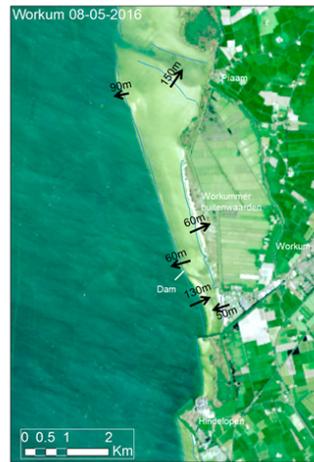
Observed changes of the coastal system between 1990 and 2016.

- The foreshore appears to prograde by 60 and 90 m in 25 years
- South of the bended dam, the foreshore has eroded 130 m. This dam was constructed 1995 and appears to be the cause for this coastal retreat.
- The shallow sandy foreshore has prograded by 150 m to the north
- The beach near Workum has prograded 60m, probably due to sand nourishments

These changes indicate sand transport to the north. In the south, the sand supply doesn't meet the demand, and erosion takes place. The coastal stretch in between the navigation channel towards the Workum harbour and the dam is clearly affected by the construction of the dam.
