Results

Hotspot in the Elsener brook

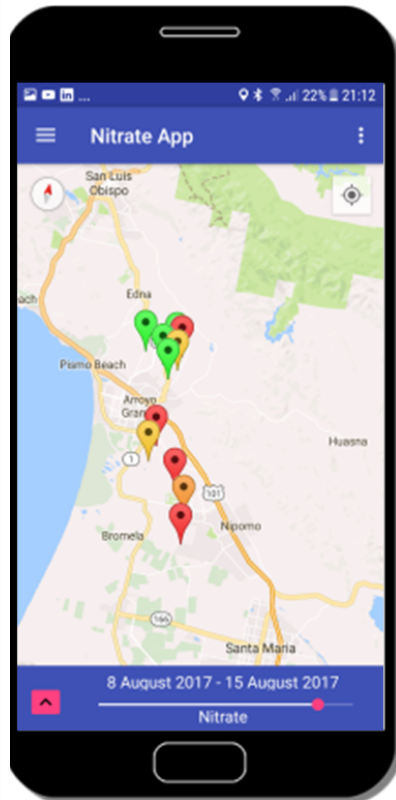
8 Drinking water quality screening

Around 250,000 people using 10,000 domestic drinking water wells in the Salinas and San Joaquin valleys in California are at risk of excessive exposure to nitrates³. The California State Water Resources Control Board alongside the Central Coast Water Board have been working on piloting the Nitrate app (now: Aquality App) to ensure its accuracy against laboratory results. This pilot project is testing the app as a screening tool for drinking water quality. So far, 100 wells in the San Luis Obispo County area have been sampled and tested for the pilot project. The first results look promising.

**Median Deltares Measurement, Sept-Oct vs. Lab Results
for NO₃+NO₂ as N (mg/L) RL=0.1**

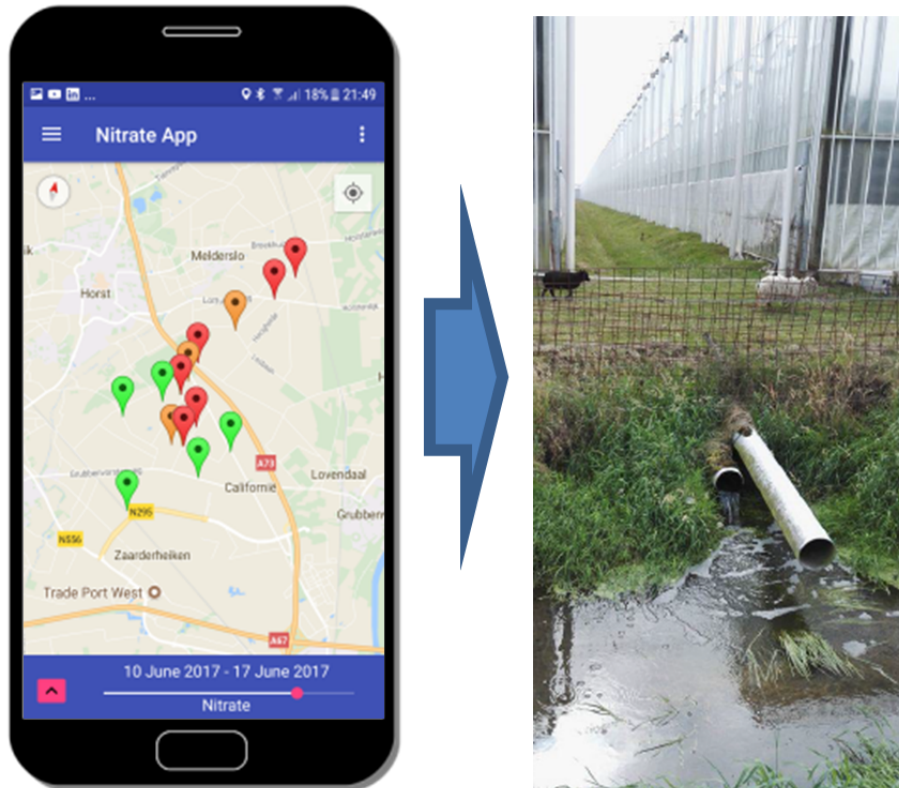
9 Locating point sources

Several Water Authorities in the Netherlands started applying The Nitrate app (now: Aquality App) for locating point sources of nitrate.

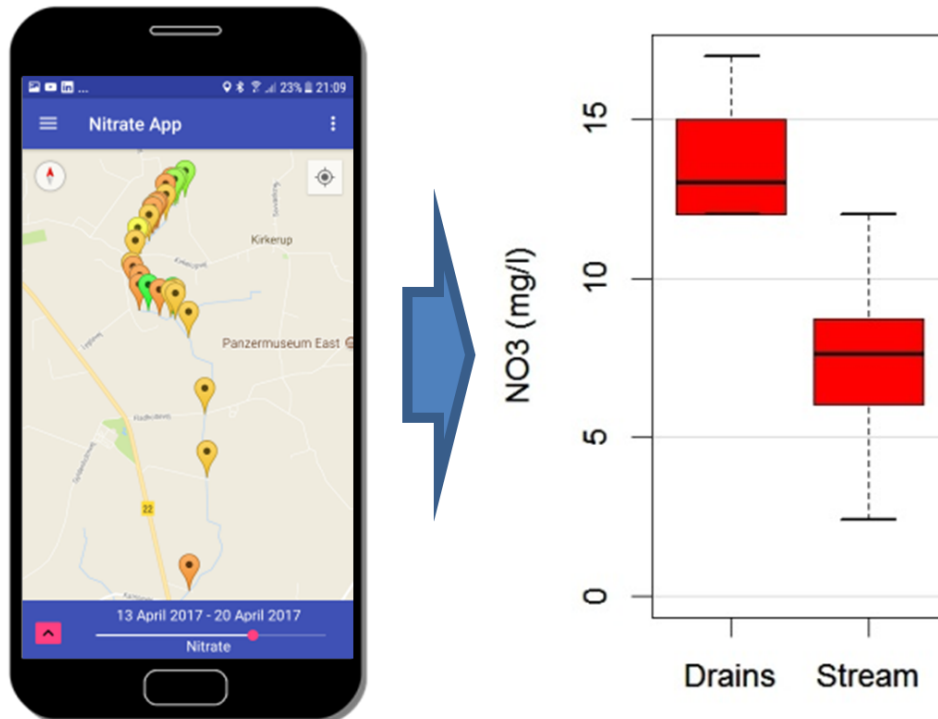
10 Flow route contributions

Is nitrate mainly transported to a stream via subsurface drains or via groundwater? A 3 hour screening was done on April 19th in the Salto river in Slagelse, Denmark. The nitrate concentrations in drainage effluent were significantly higher than in-stream concentration levels.
