Overtopping Tests on Lime Treated Clay in the Hedwigepolder

Overall report

Client	Waterschap Limburg
Contact	A. Gerrits
Reference	Order HWBP, POV DGG
Keywords	Lime treated clay, overtopping, erosion inner slope, dikes

Version	1.0
Date	20-12-2022
Project nr.	11206930-004
Document ID	11206930-004-GEO-0001
Pages	78
Classification	
Status	final

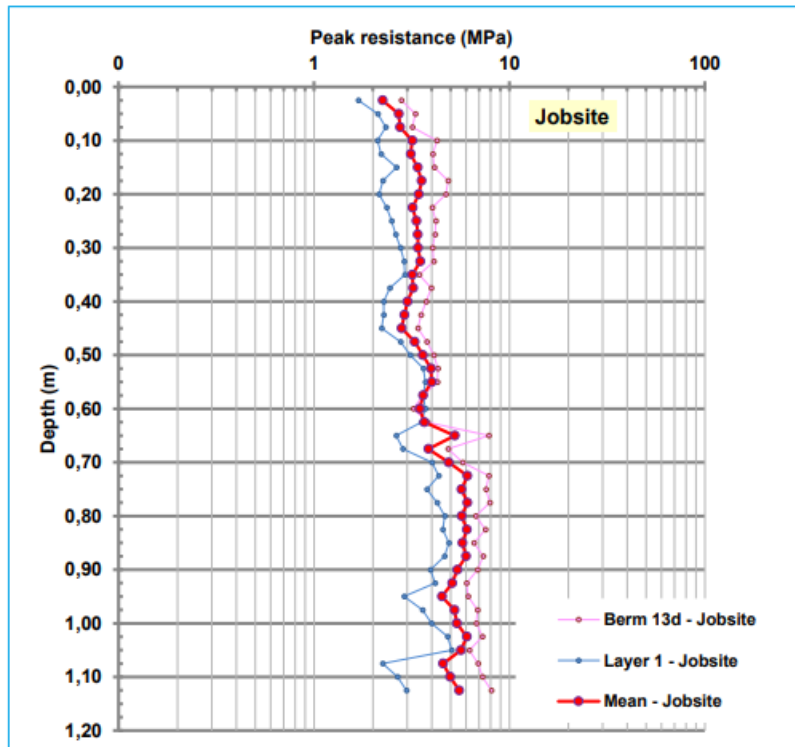
Figure 3-11 Results of PANDA test in November 2021 (Figure courtesy of Lhoist).

As an example the results are shown for Poor quality A clay, Section 1. These results are exemplary for the other sections as well.

From these figures it can be concluded that the lime treated material has gained in strength considerably, even though conditions have been far from optimal (too wet, too cold).

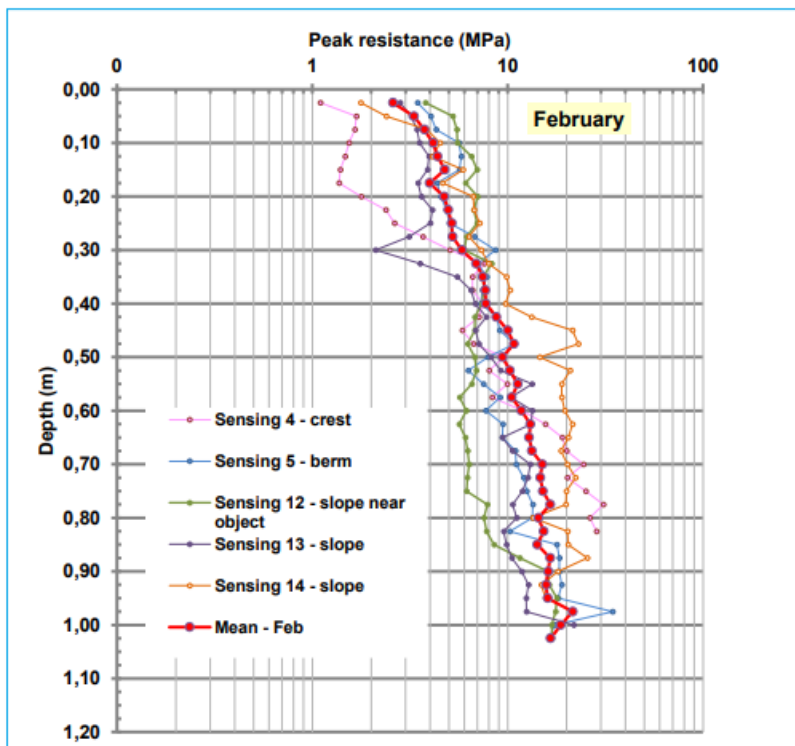
Figure 3-12 Result of PANDA test in February 2022 (Figure courtesy of Lhoist).

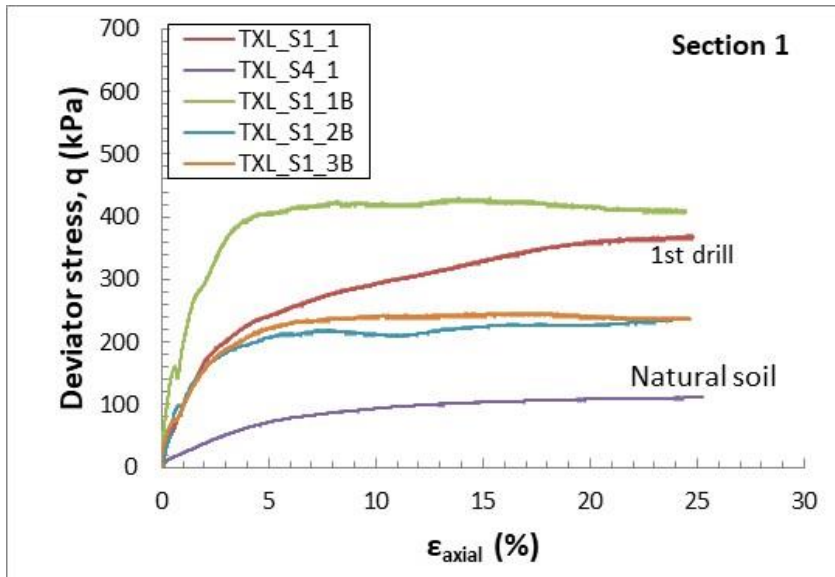
In the laboratory triaxial tests were performed on the samples from different sections. In figure 4-2 the results from samples of Section 1, 11 to 16 days after construction, are compared to one sample of the untreated natural clay. Compared to natural soil it was demonstrated that in a few days there was a substantial gain in strength for the lime treated samples.

Figure 4-2 Results from the first round of testing.

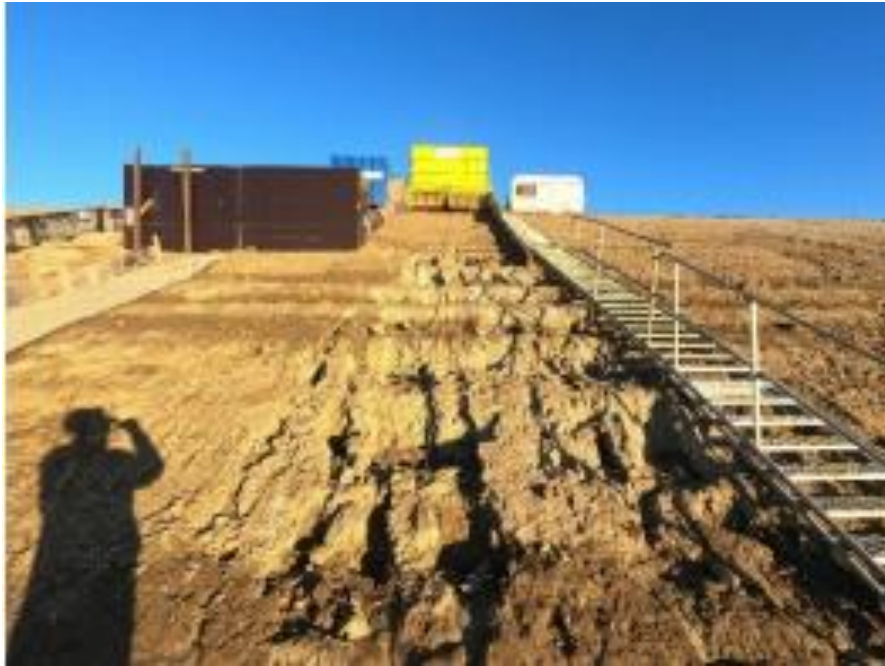
Before the start of the testing there already a substantial amount of erosion on the downward side of the object. This was caused by leaking water during testing of section 2A. Also on the berm and at the toe of the slope there was substantial erosion.

Figure 6-8 Before the start of testing in section 2B.

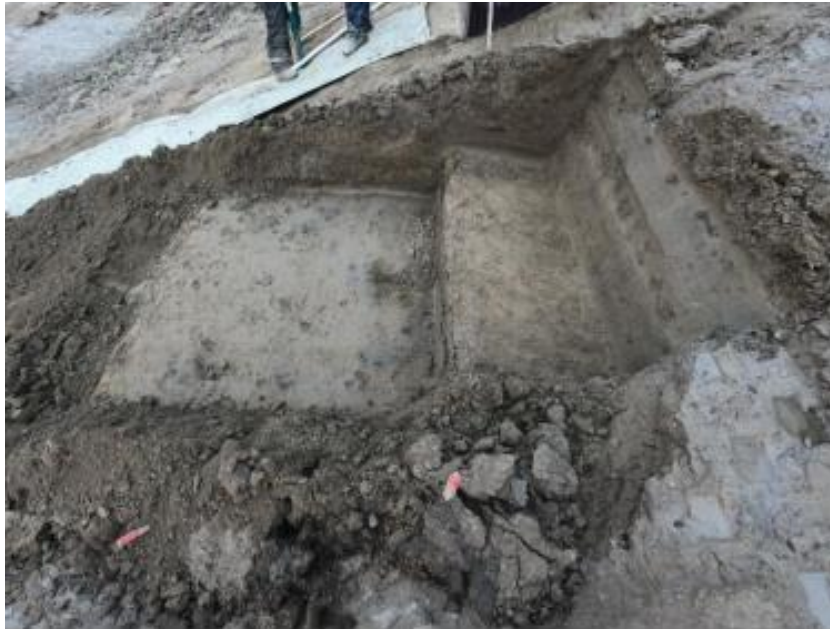
Figure 6-9 The situation at the start of the extra test: the original stair case is exposed to wave action (picture courtesy of Infram).

The test was started with half an hour of waves corresponding with an overtopping discharge of 10 l/s/m', which gave limited erosion of the stairs. After that the test was continued 1 hour with an overtopping discharge of 30 l/s/m'. After that the entire upper step was eroded and the step beyond that was seriously undermined (see picture).

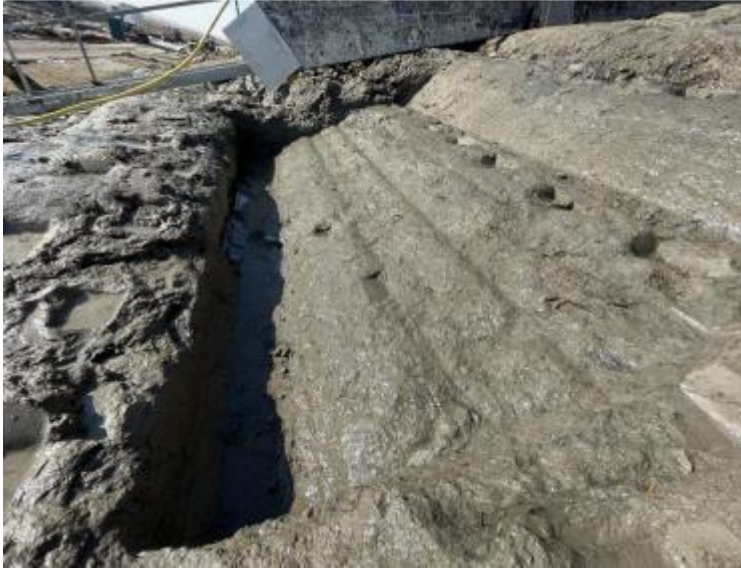
A 1,5 hour storm was simulated with overtopping rates of 1m 10 l/s/m', 1m 30 l/s/m' and 2m 50 l/s/m' . No ongoing erosion was observed. After that 25 full loads (3400 liter of water per meter) were released. Still no erosion occurred.

Figure 6-12 Situation after the final test (picture courtesy of Infram).

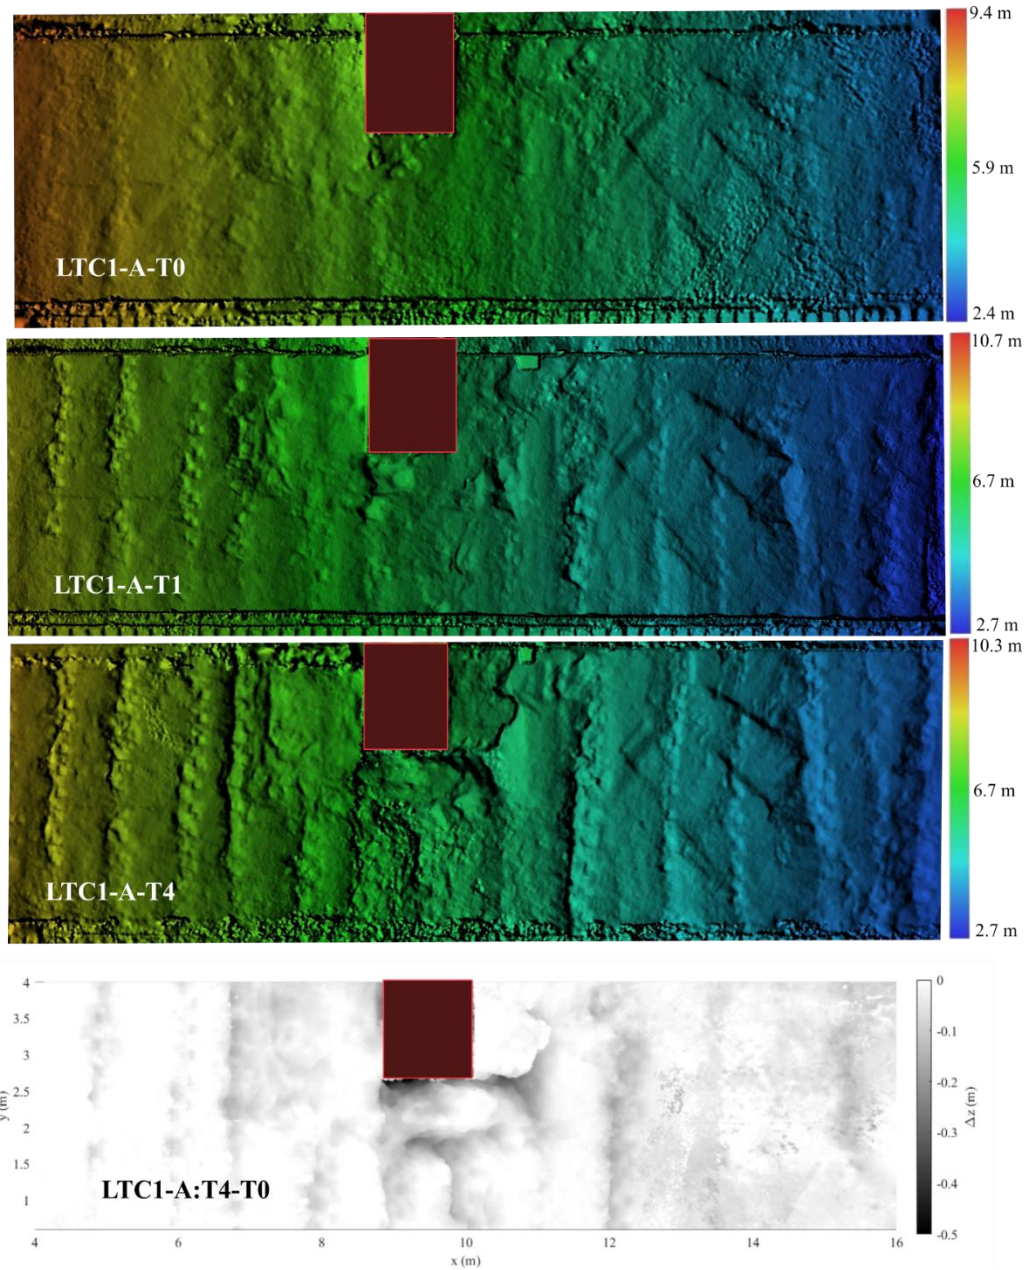
Figure 7-4 Results in test section 1A.

In Figure 7-4 the development of erosion into a staircase profile is clear. Also, around the object the most significant erosion is found, almost up to the layer thickness of 40 (minimum) to 70 cm (maximum).

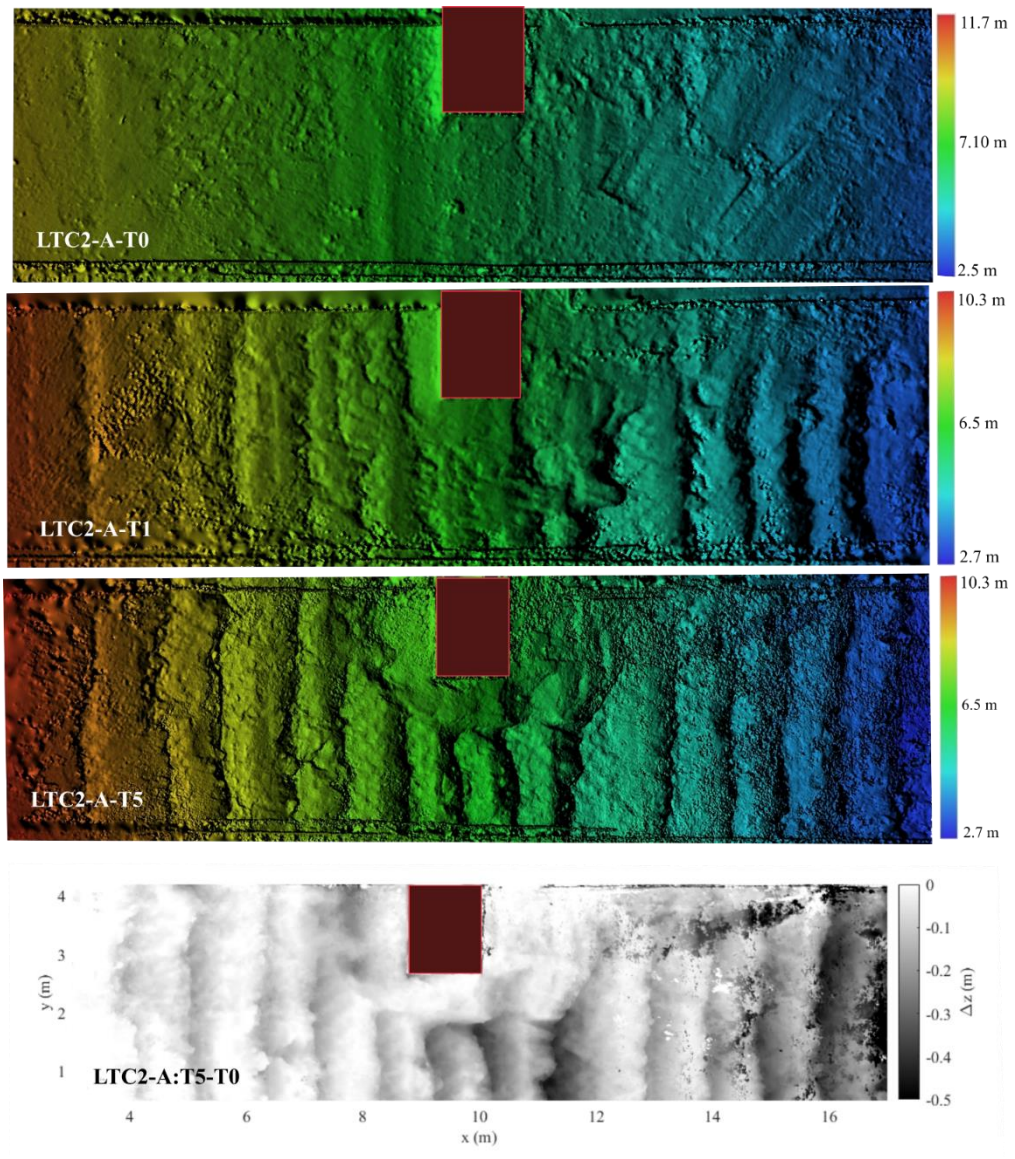
Figure 7-5 Results in test section 2A.

In Figure 7-5 it is evident that in contrast with Figure 7-4 almost no erosion has taken place around the object. There is, however, a gully and more erosion than elsewhere on the slope directly next to the carefully densified area around the object. The toe of the slope has also suffered more erosion than the slope.

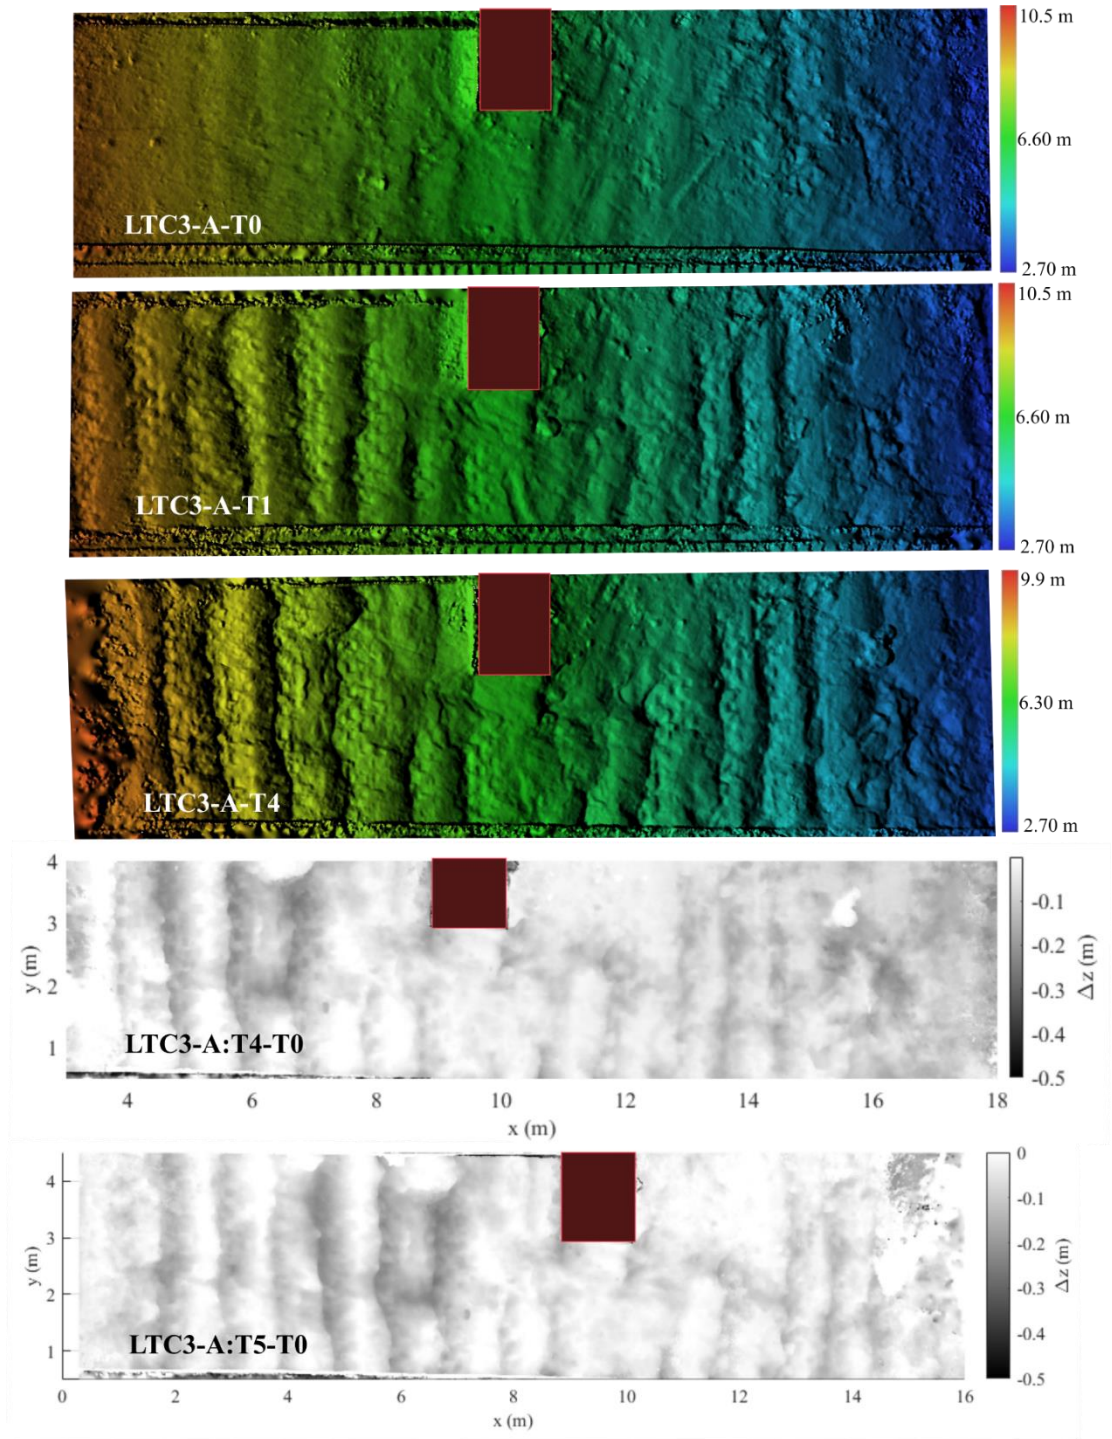
Figure 7-6 Results in test section 3A.

In Figure 7-6 (as is the case in the other test sections) a staircase profile forms, but in general the amount of erosion is less. This probably has something to do with the better quality of the clay used in this section. As will be discussed in paragraph 8.2 this has little to do with erosion of the lime treated material, but is a result of erosion in not treated material.

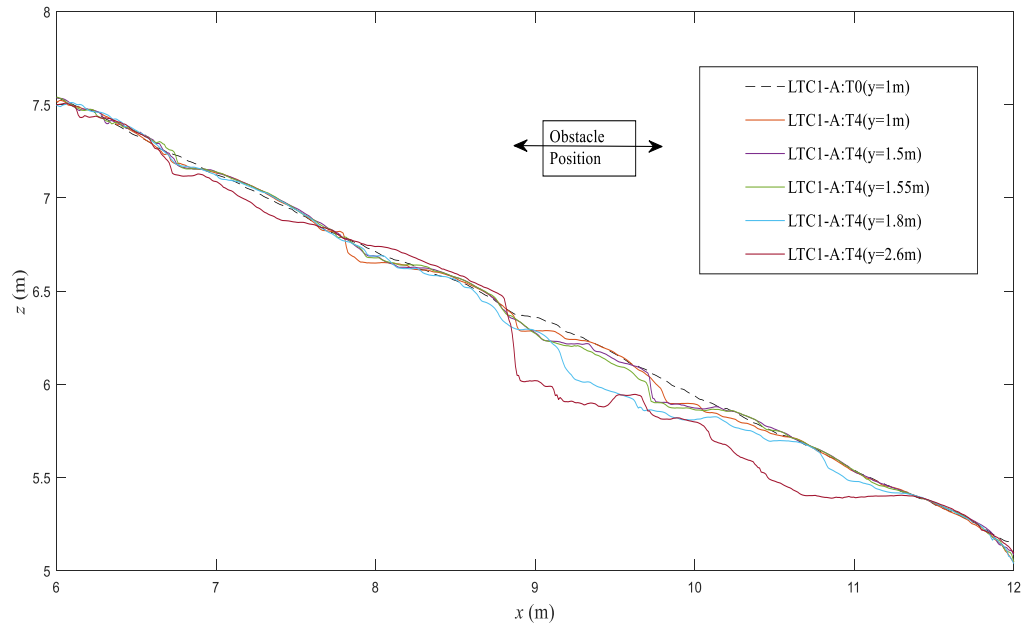
Figure 7-7: Final bed level profiles at different transversal distances (y) for LTC1.

In Figure 7-7 there is a considerable erosion in one trajectory ($y=2,6$ m), which is directly next to the obstacle. Also downstream from the obstacle erosion is visible. That results from the fact that the erosion gully next to the obstacle also attracts the most water.

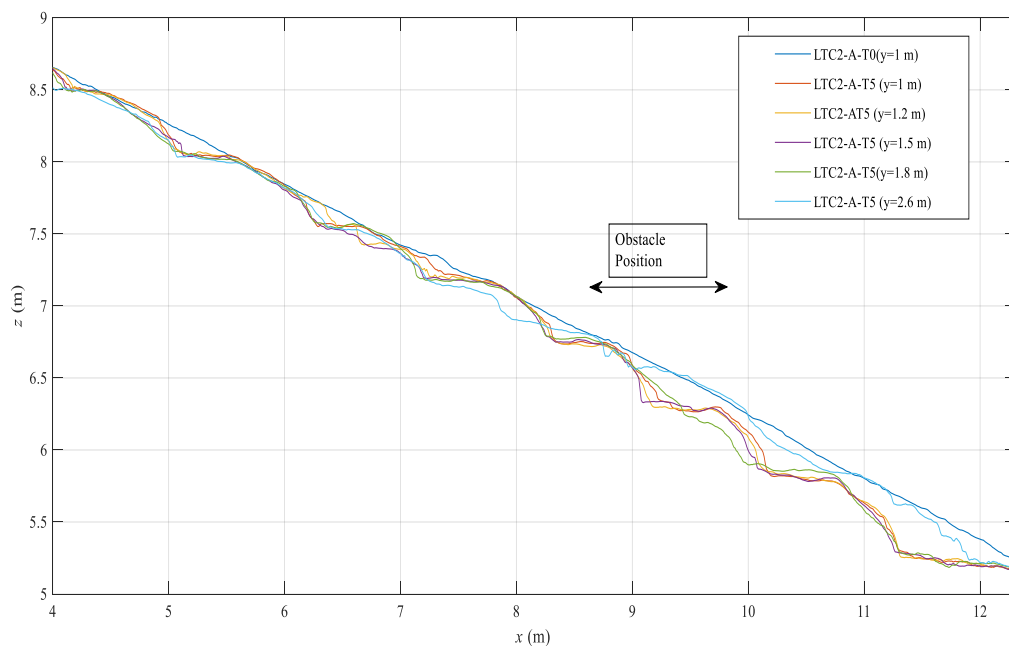
Figure 7-8 Final bed level profiles at different locations (y) along LTC2 slope.

In Figure 7-8 the final bed profiles are shown at different locations within test section 2A. In the area marked as “Obstacle Position” there is a substantial amount of erosion, but as $y = 2,6$ m is the position with the obstacle it is clear that there is little erosion near the obstacle and more erosion further away from the obstacle. This is also clear from the Figure below.

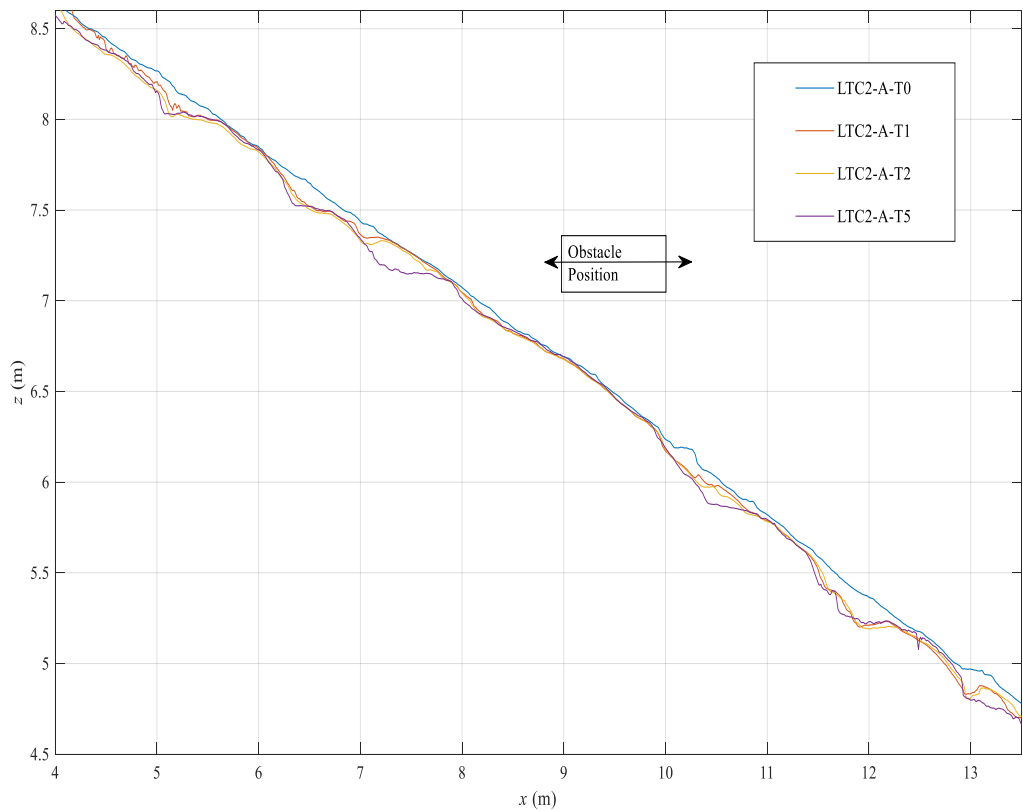
Figure 7-9: Temporal bed level evolution at $y=2.3$ m for LTC2-A.

Figure 7-9 shows the erosion in one cross section during time. This illustrates the development of the staircase profile but also shows that the total amount of erosion does not increase severely with increasing hydraulic load. Around the obstacle in Section 2A there is no erosion.

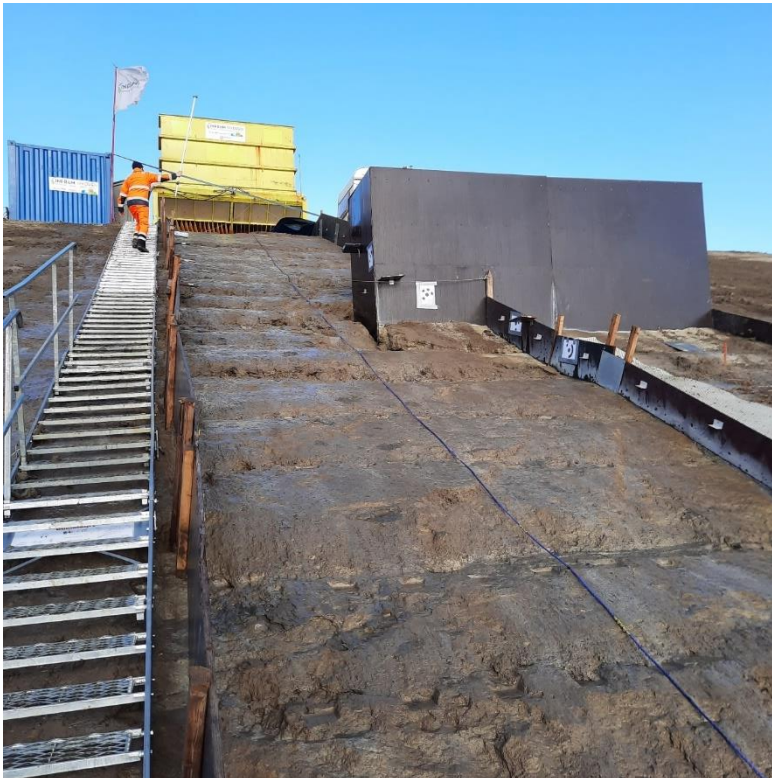
Figure 8-2 Situation in Section 1A after the test with 190 l/s/m'.

After the tests (see Figure 8-2) a new staircase profile has been formed, again with 17 steps. The top of each step is formed by the top of the compaction layer. The footprint of the compacting machine can distinctly be seen in each step (see Figure 8-3). The soil above this level has been eroded, but the soil beneath this level is not eroded even at the highest hydraulic loads.

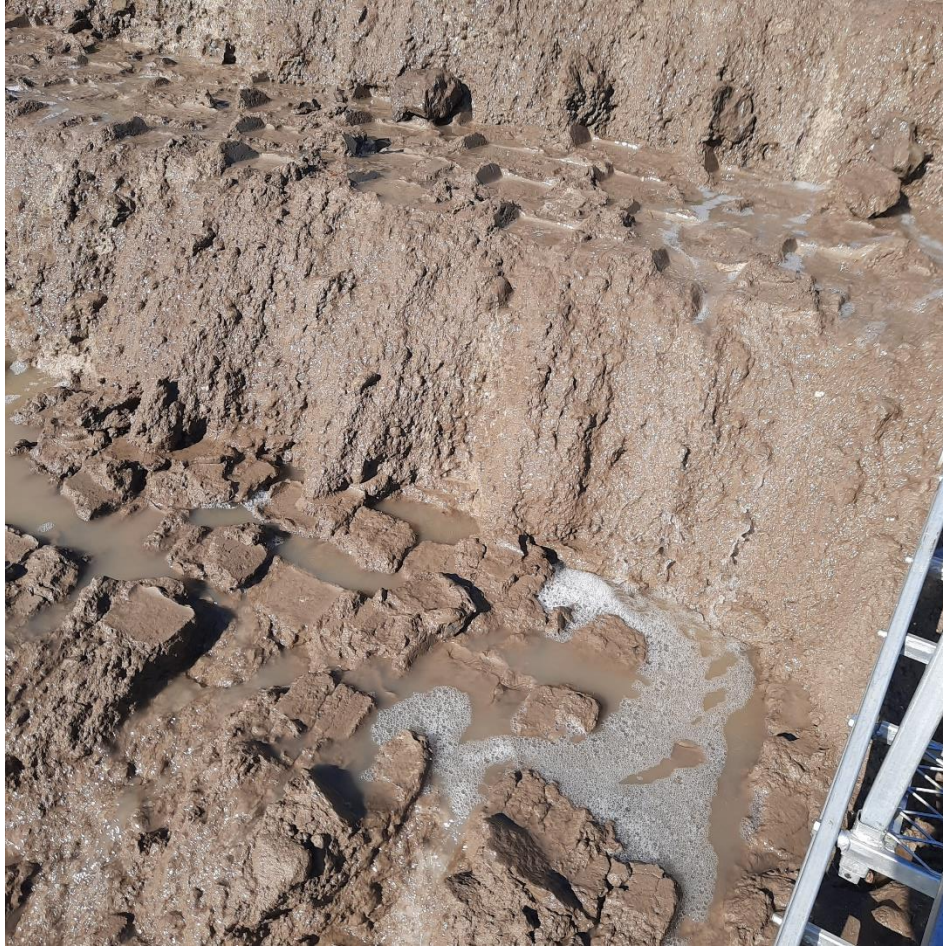
Figure 8-3 Footprint of the compacting machine.

The observed behaviour means that the constructed cover layer was not homogenous. In Figure 8.4 the situation as observed on site is shown.

It is the most plausible explanation that a) the very well densified material (directly below the compaction machine) does not erode, but b) material that is densified to a lesser degree and that is close to the surface does not cure well and remains erodible for a longer period of time. This division in erodible and none to less erodible material follows more or less the picture in figure 8.4. When constructing a cover layer it should be taken care of that there is always a very well compacted layer present or a sufficient layer thickness (see figure 8.5).

In conclusion: a learning point from this experience and the observed behaviour would be that a further research into the development of strength as a function of compaction, depth and time could further enhance our knowledge of the curing process and the resulting erosion resistance.

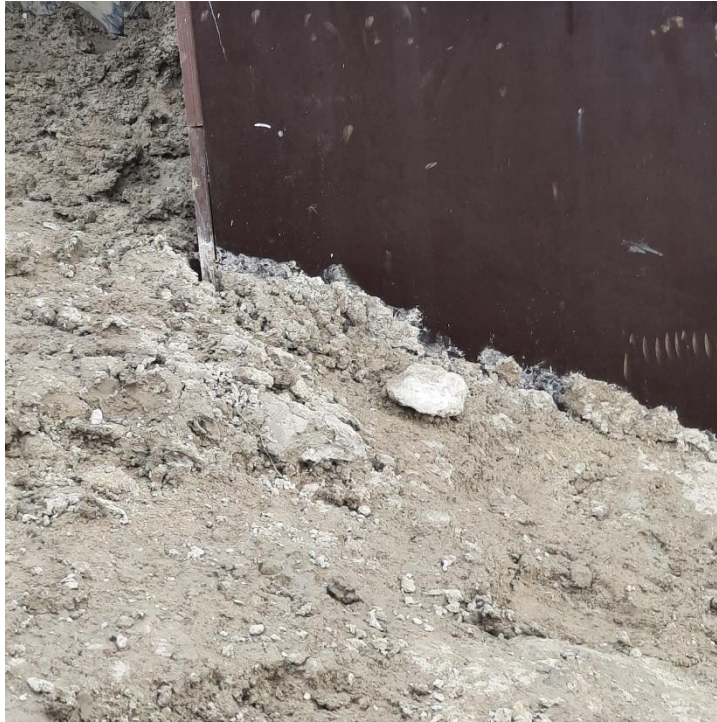
In Figures 8.6, 8.7, 8.8 and 8.9 an impression of erosion around the objects is given.

Figure 8-6 Before testing.

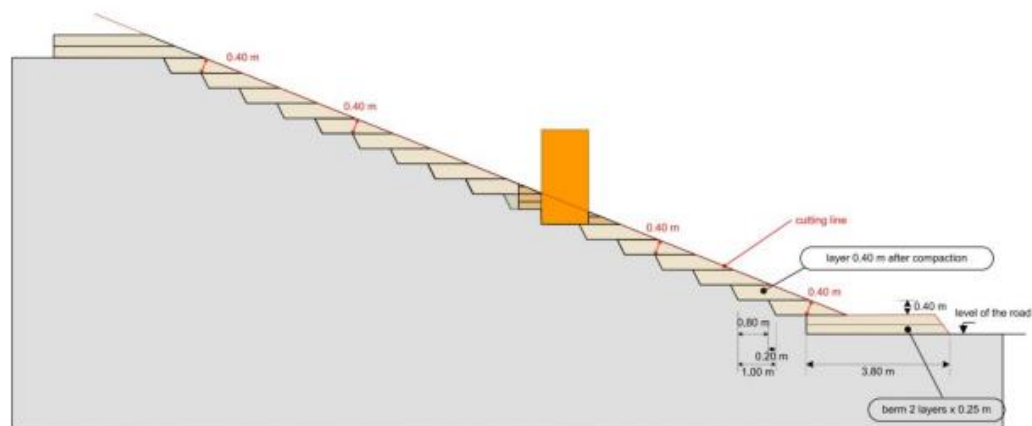
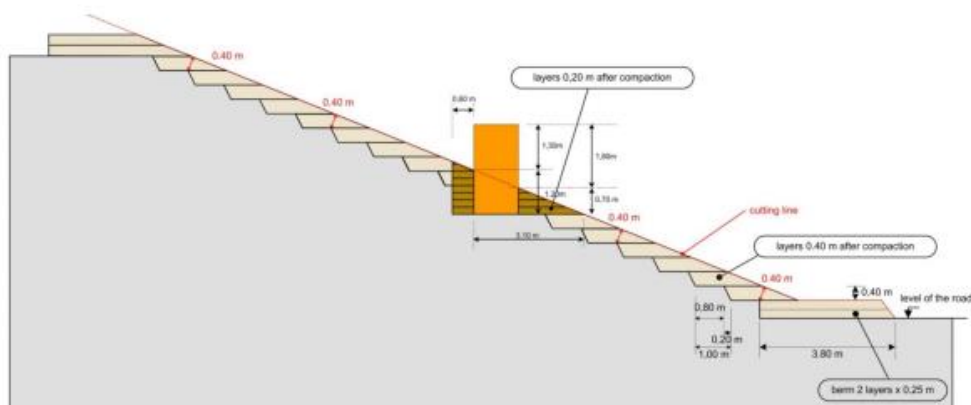
From the Lhoist report on the construction of the dike shell with lime treated clay there is not much reference. The results of densification have been checked especially around the object in Section 1 and in one point in section 2. There appears to be no decisive difference. The compaction was even slightly better in Section 1. The measurements of density used here are apparently not a safe way to predict erosion resistance. There are three remarks to be made on explaining the observed behaviour:

- The water content of the treated soil in section 1 was high. This can be a factor when compacting.
- The object in section 1 was the first object to be placed and there was no previous experience in densifying around the object. While compacting it was experienced that the slope with lime treated material was very slippery when wet. This made operating difficult, both for personnel and for equipment. Supervision was not as strict as it could have been, for instance in regard to the number of passes with the compaction rammer. It was difficult operating under the given circumstances. The experience gained in Section 1 was used to have better results and stricter supervision in sections 2 and 3. The eroded spot in section1A was a weak spot, likely caused by improper compaction due to difficult working conditions.

Figure 8-10 Difference in depth of placing the objects (figures courtesy of Lhoist) The upper part of the picture represents test section1 and the lower part test sections 2 and 3.

- It was concluded that the object in section 1 was less deep into the slope. The object in section 2 and 3 was dug in 20 cm deeper, which gave more room for densification. It is also possible however, that the object in section 1 could move a bit more under waves and current forces than the objects in sections 2 and 3 as a consequence of the shallower foundation. As the erosion (and the heaviest attack from flowing water) is concentrated around the corner of the upper part of the object movement of the object itself can be an extra reason for erosion.
