Management of dynamic river banks

21 September 2021 International Meuse Symposium

Nature friendly riverbanks

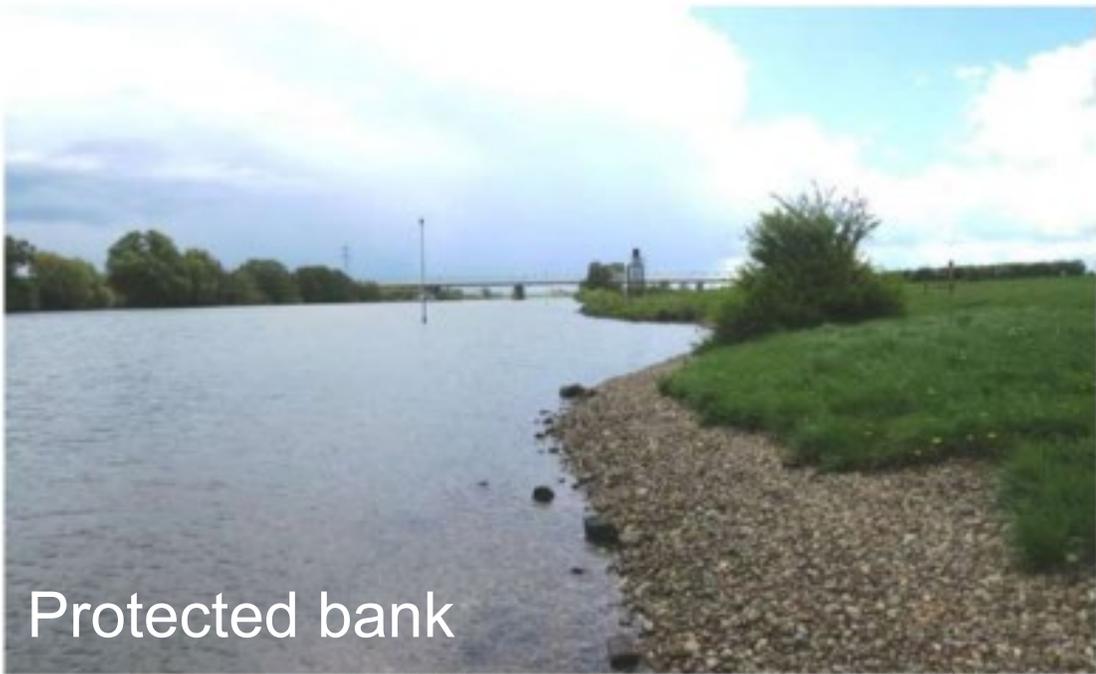
Protected bank

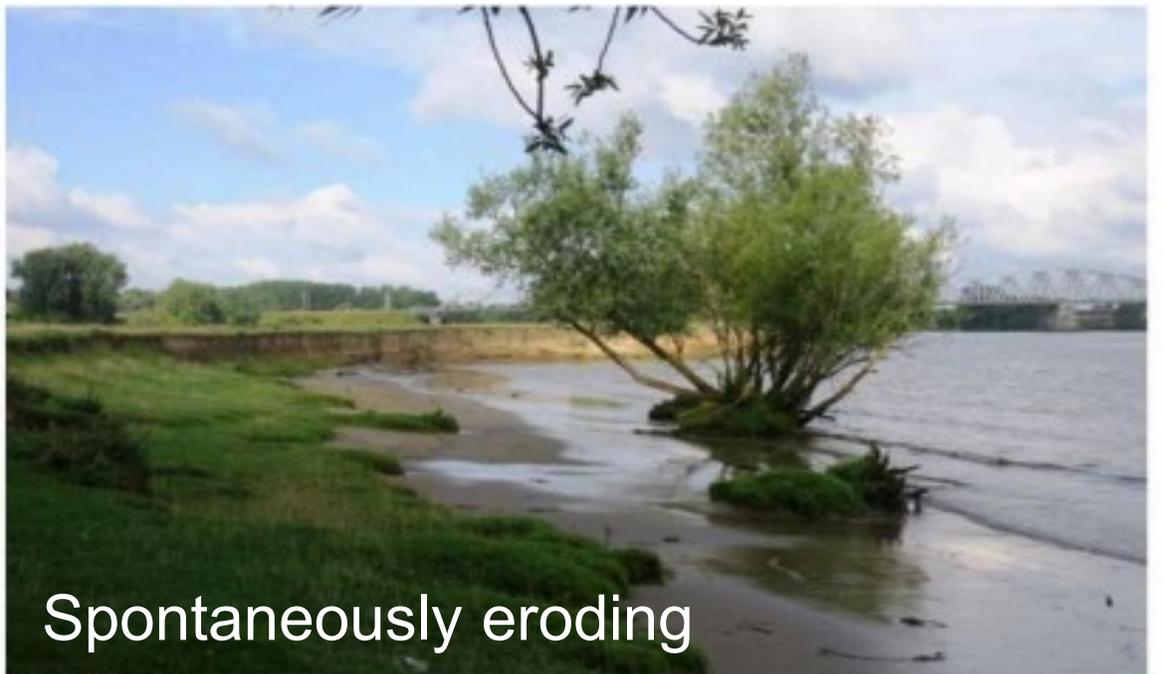
Spontaneously eroding

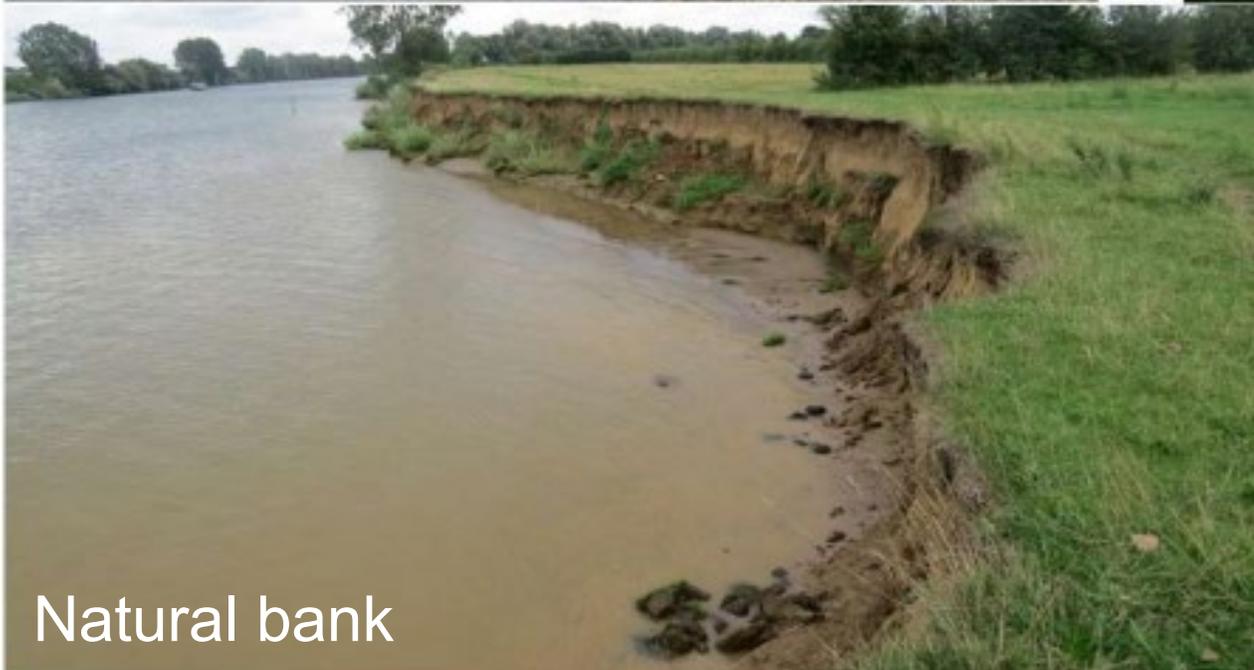
Natural bank

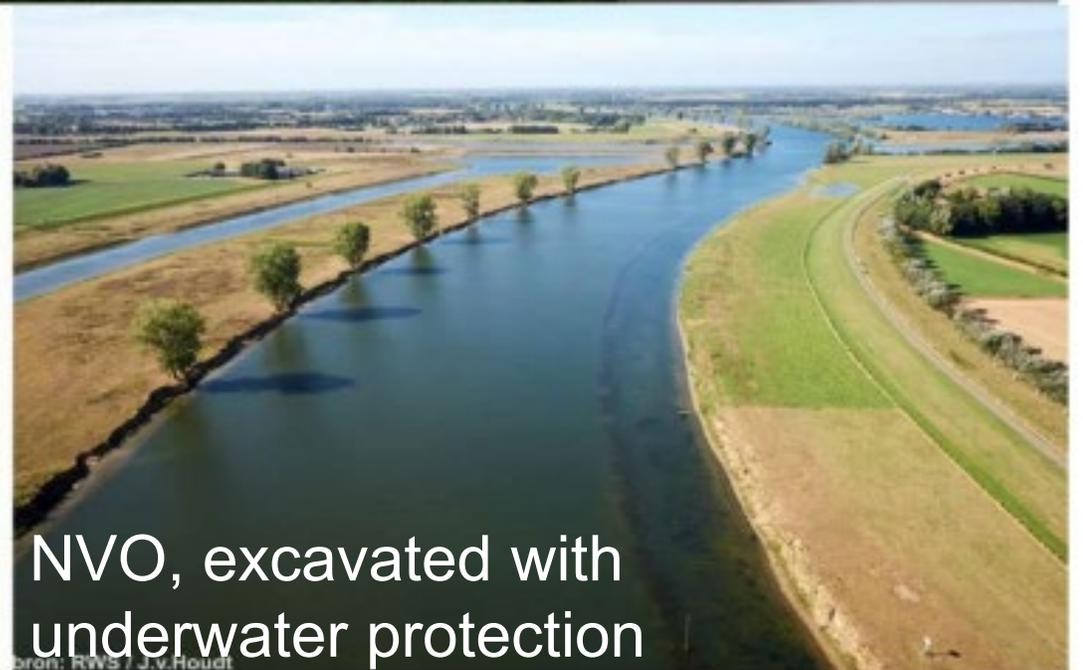
NVO, excavated with underwater protection

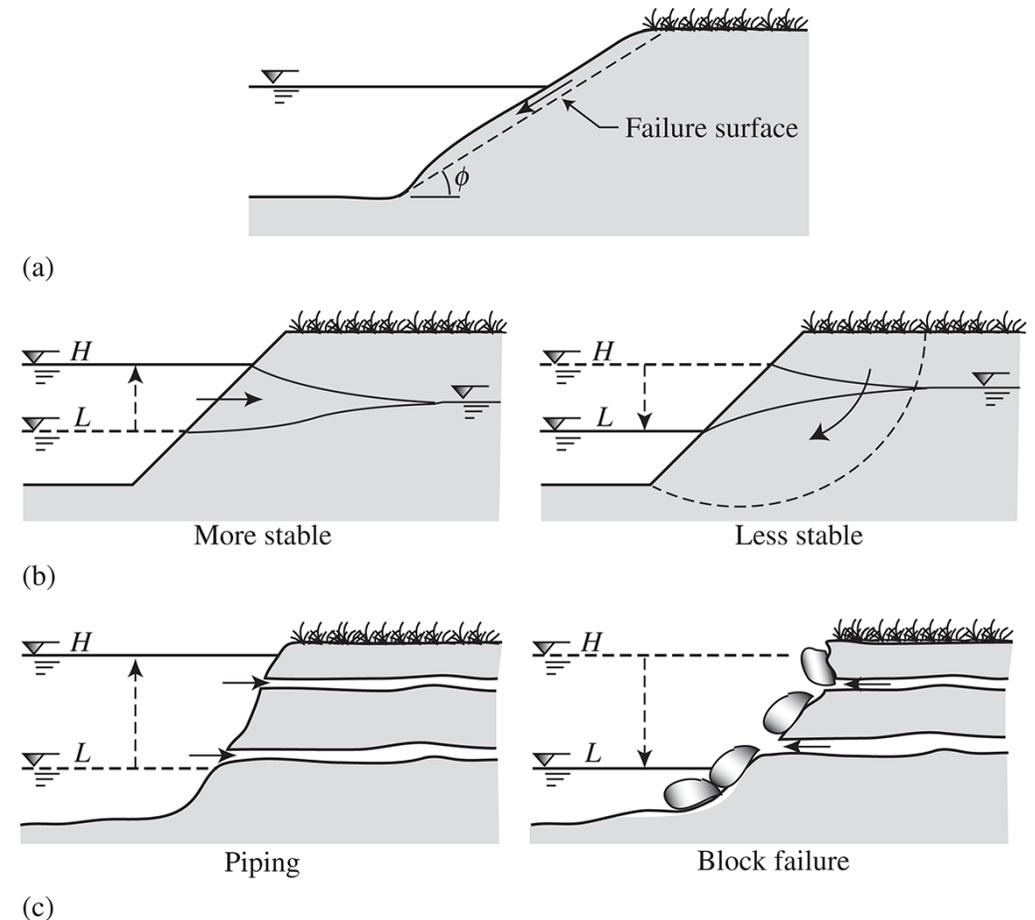
- **Bank scour**
 - Fluvial erosion
 - Wind waves
 - Ship waves (primary, secondary)
 - Turbulence
 - Groundwaterflow
- **Mass failure**
- **Risk factors:**
 - High flow velocities
 - Fast drop in water level
 - Shipping
 - Wind
 - River bank material and or vertical/horizontal heterogeneity
 - Absence of vegetation

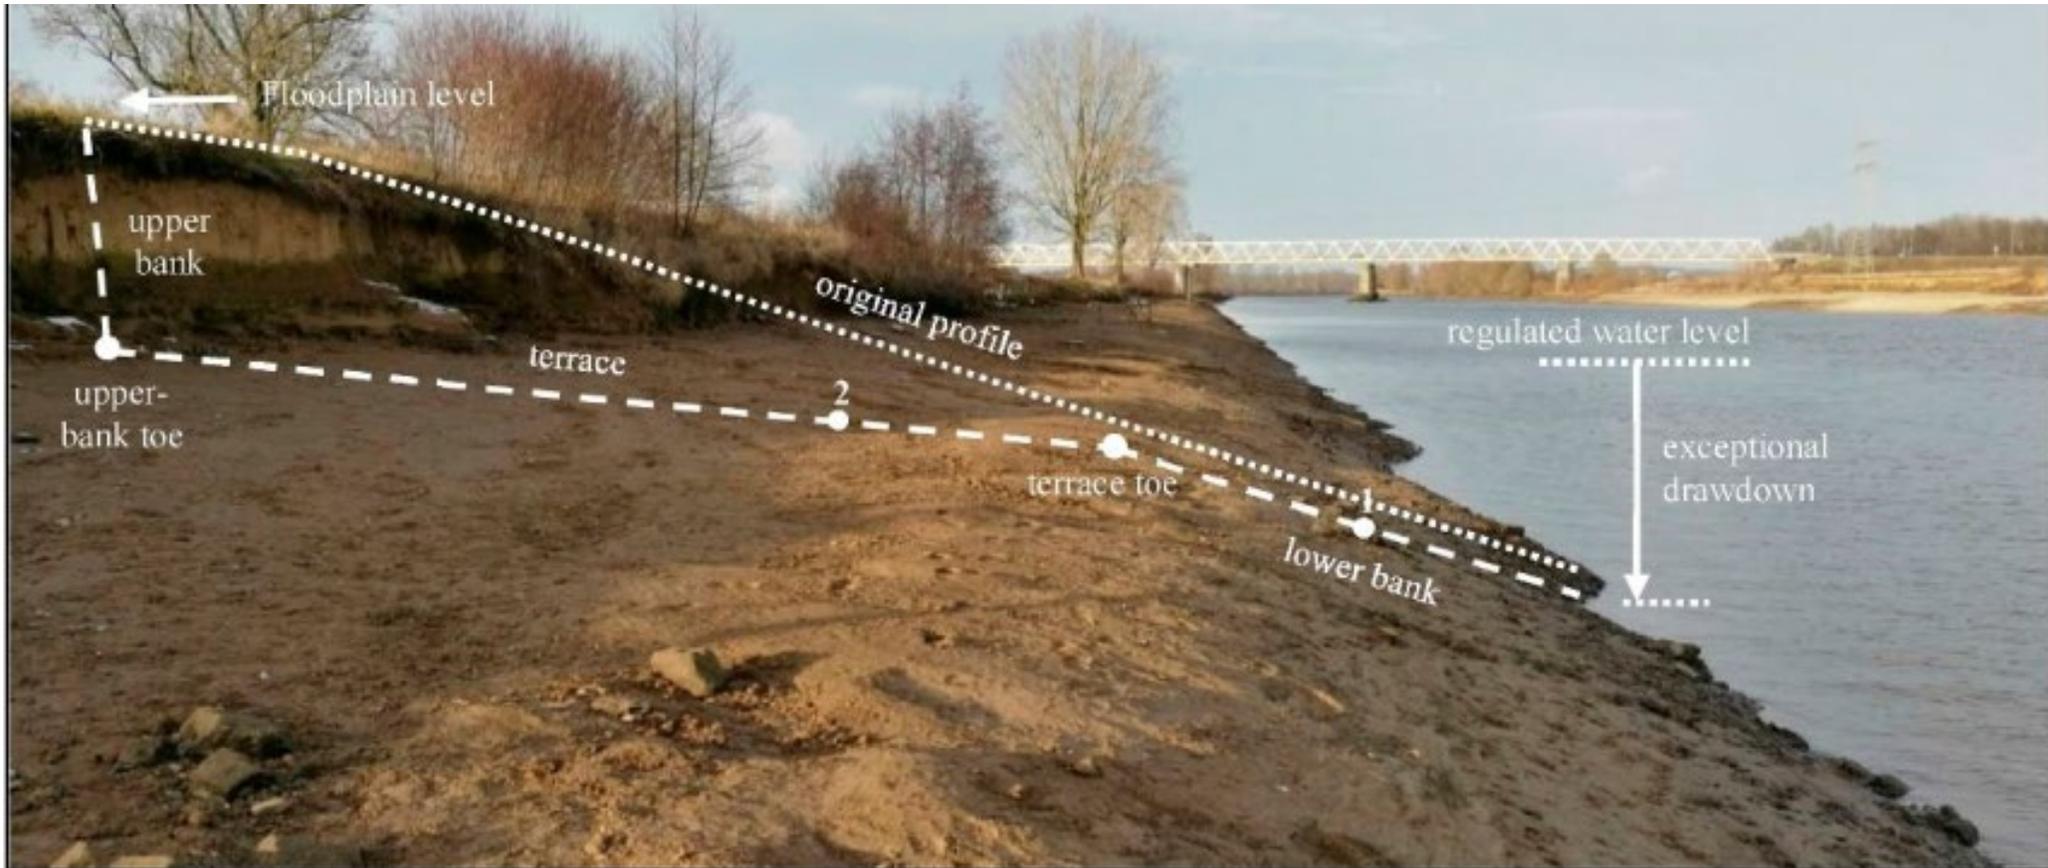
Typical bank profile shaped by ship waves in a regulated reach of the Meuse river

Figure A-1. Features of a bank profile shaped by ship waves along a regulated reach of the Meuse River (km 154.1), visible after a ship accident against Grave weir (source: Duró et al., 2020b).

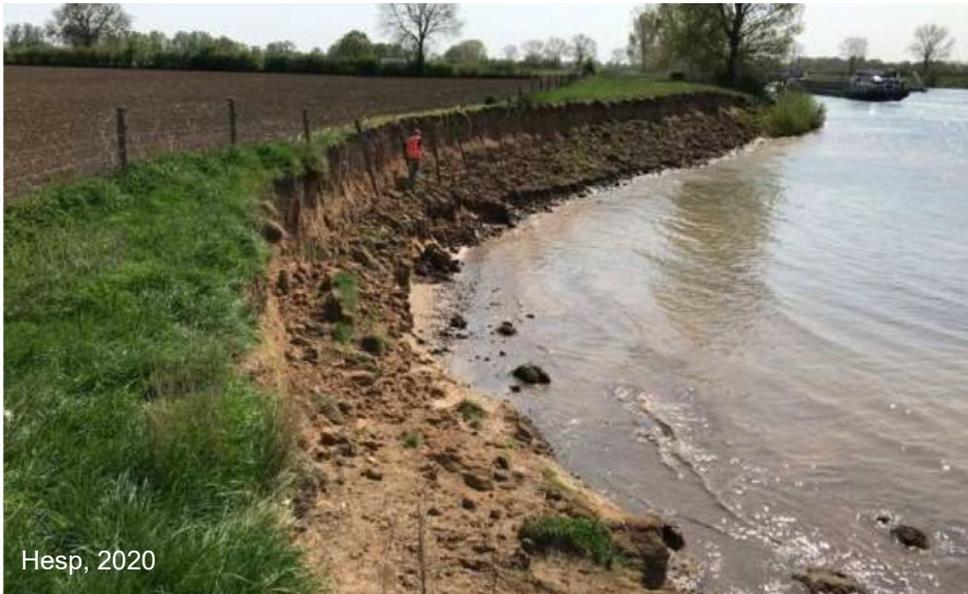
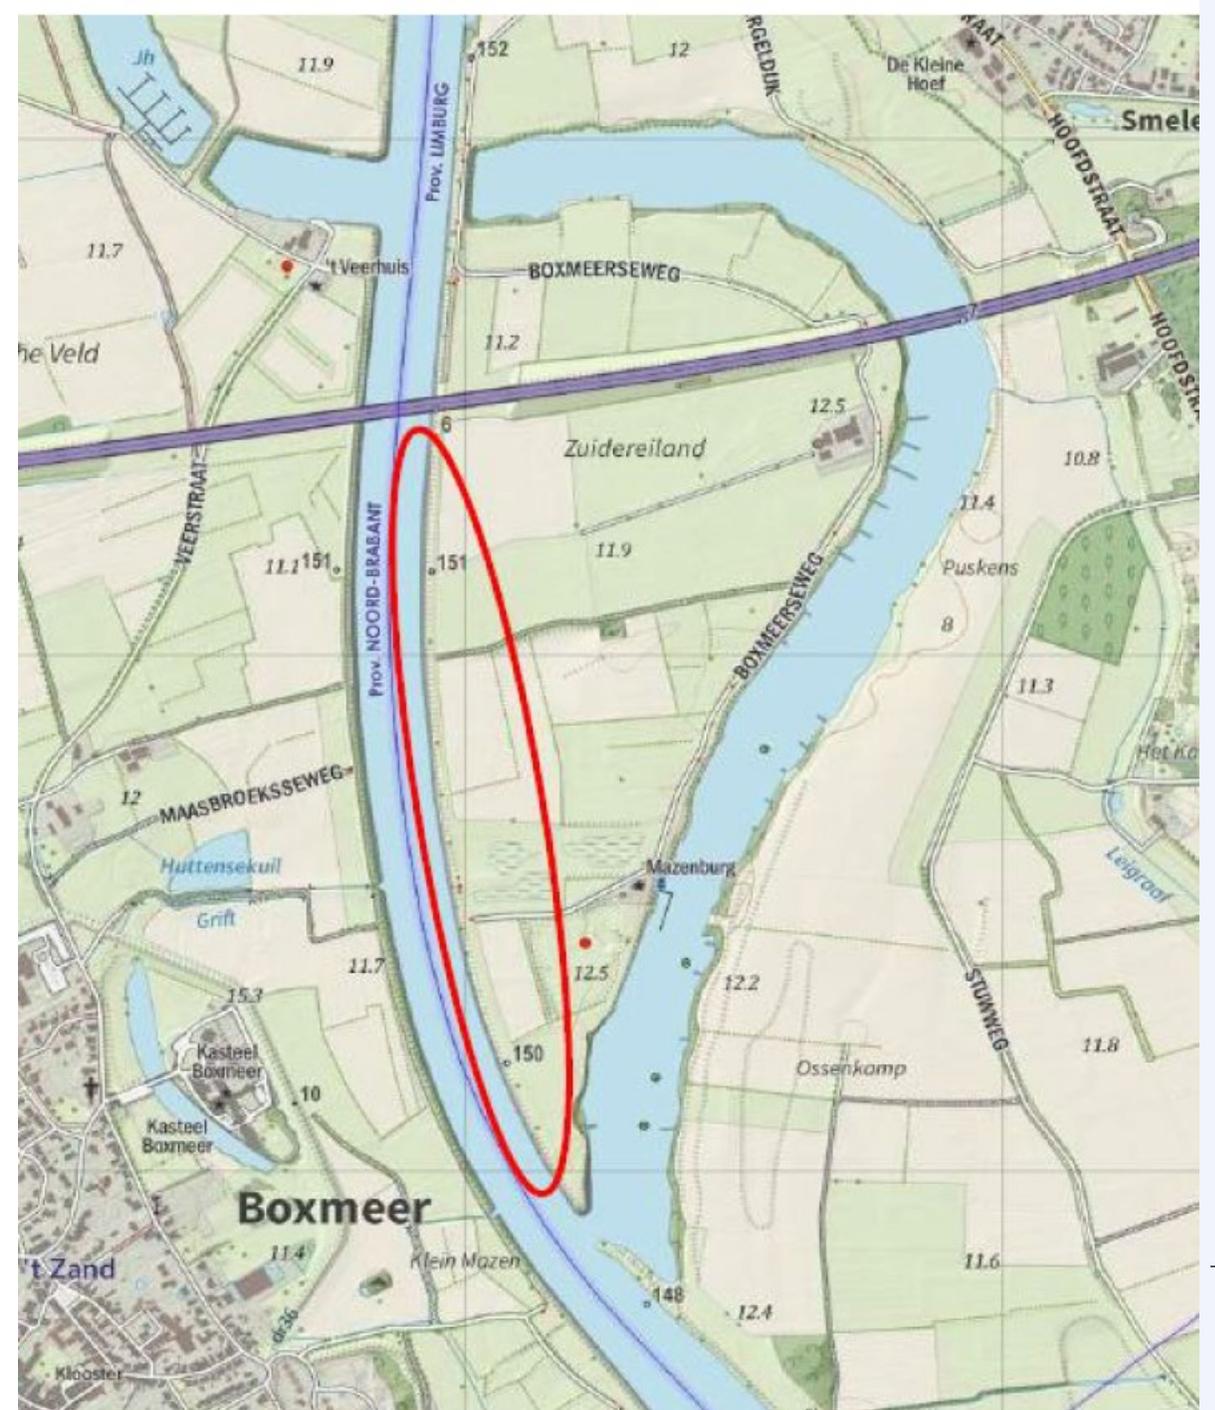
Zuidereiland (rkm151)

- High bank (4 m above water level)
- Large rates of erosion expected

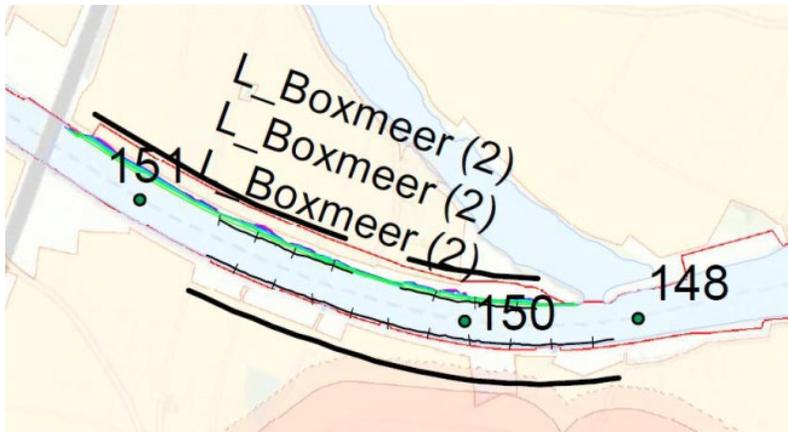
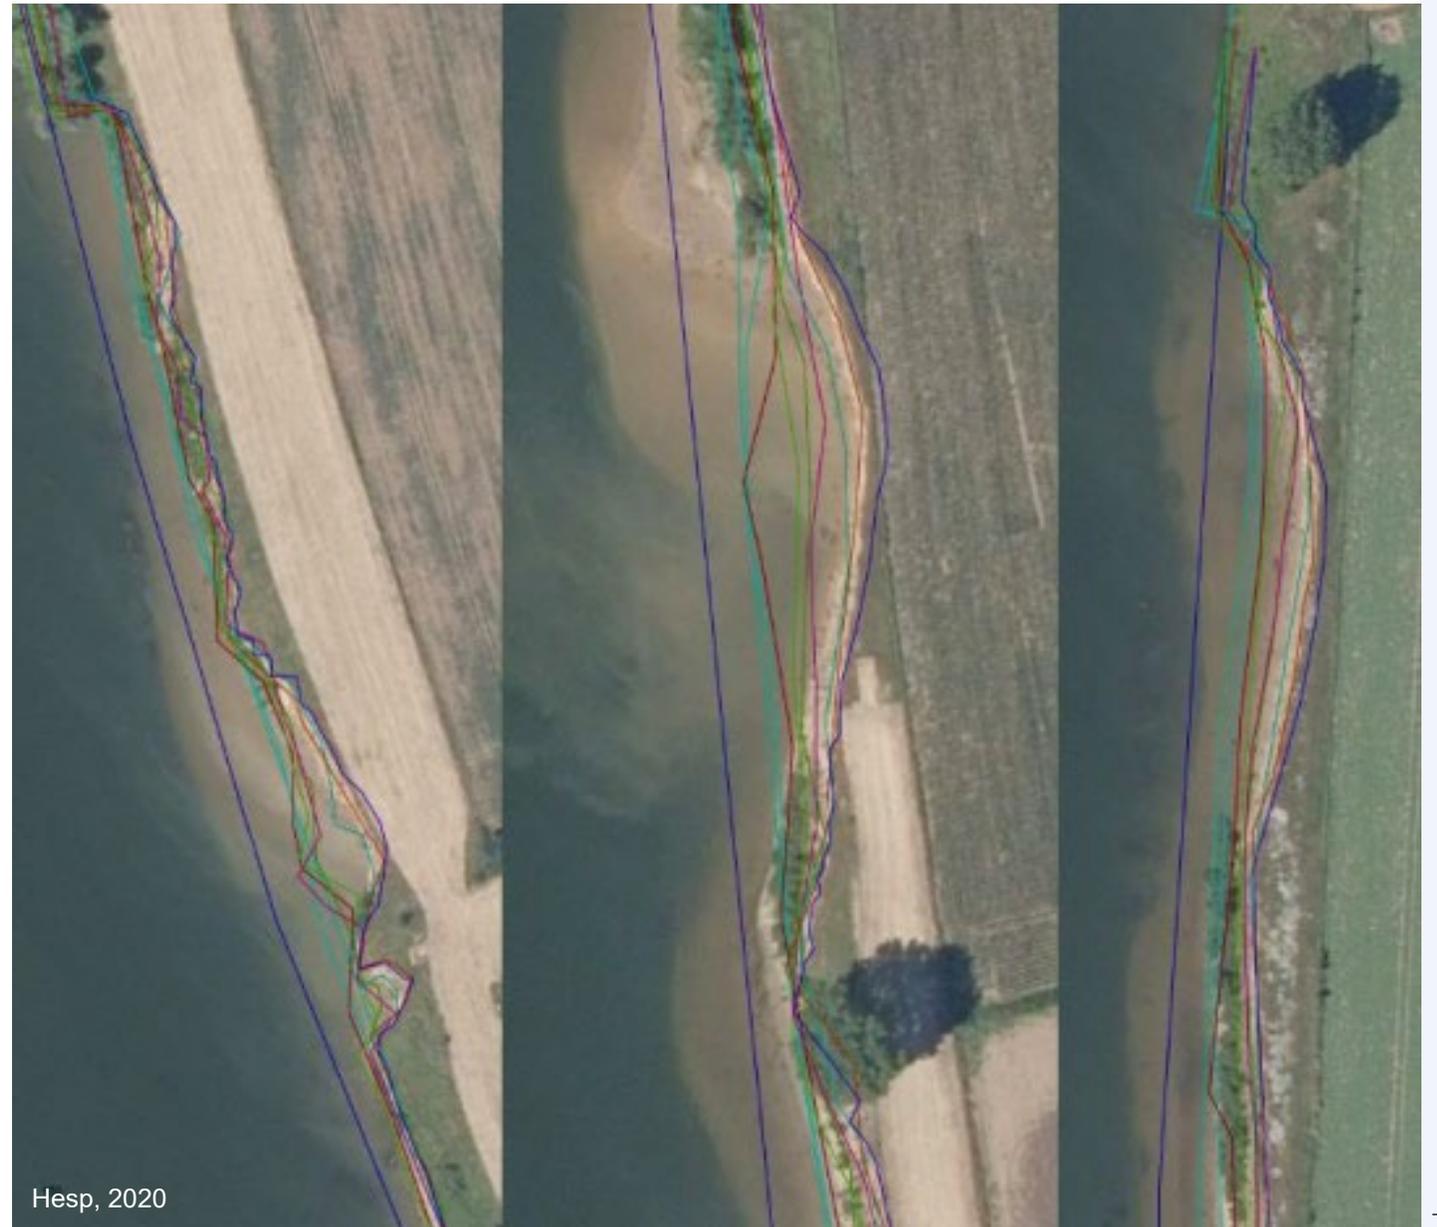
Erosion 2010-2020

- Class B
- Land can be bought -> class A
- Only clay -> no ecological value

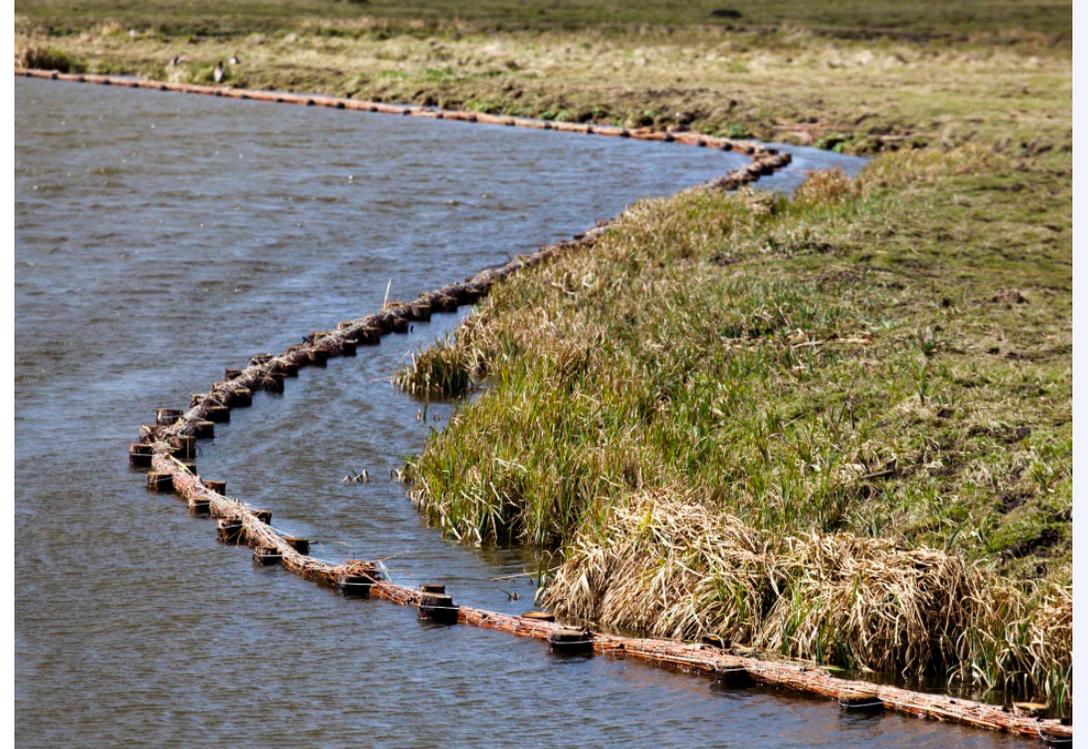
- Stabilize both the baseline and the steep edge
- Hard protection of the terrace
- Promote dense bank vegetation (reed or willows)

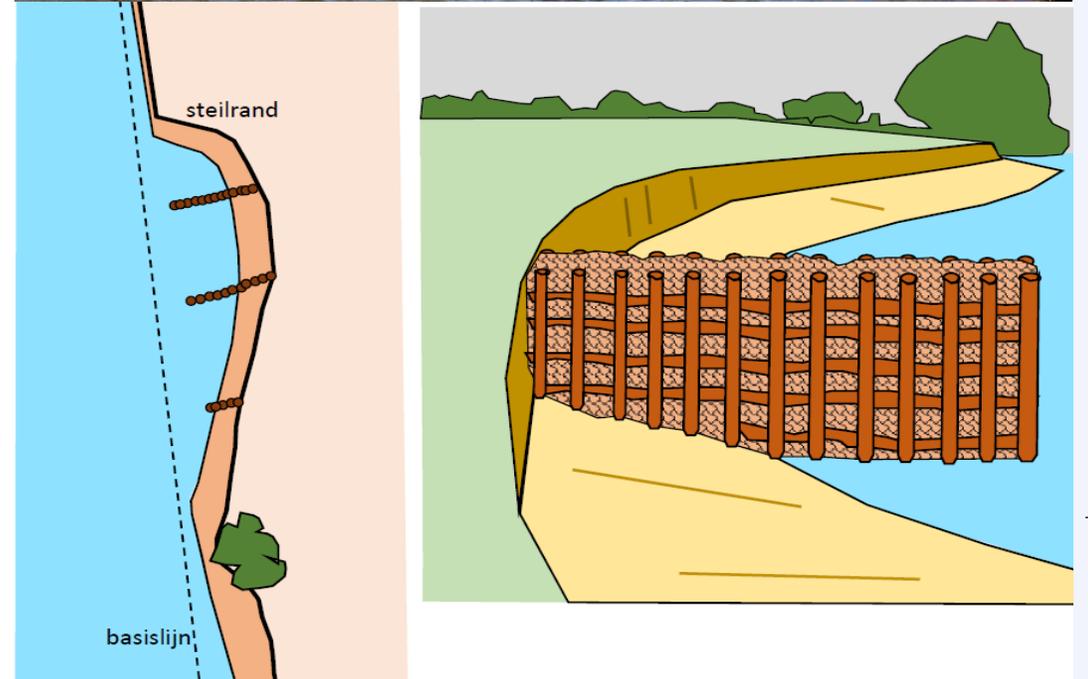
- Groyne-like constructions
 - Double rows of posts, stones, dead wood, vegetation

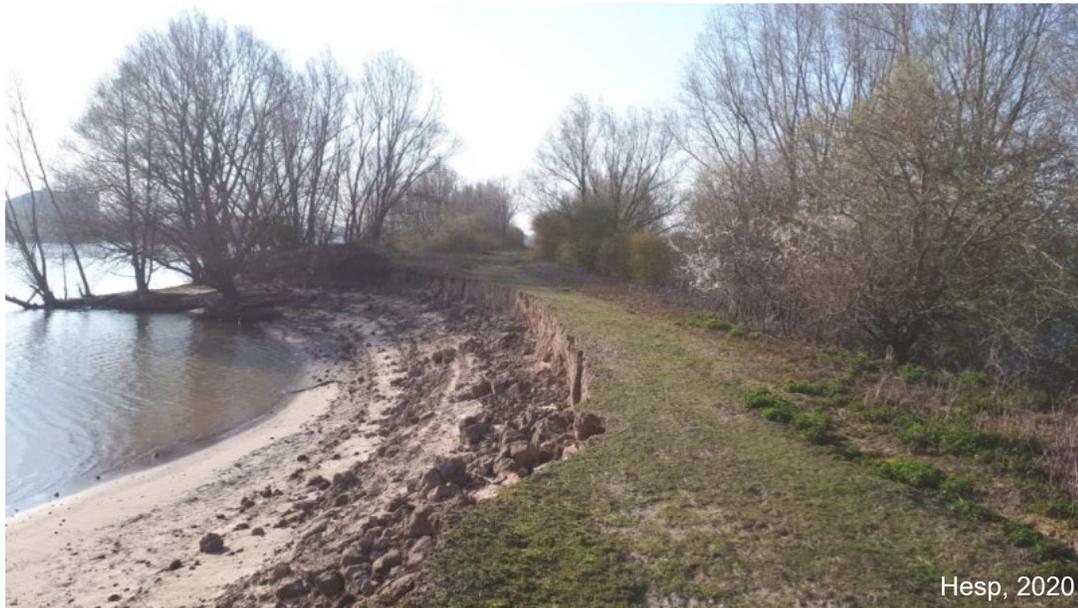
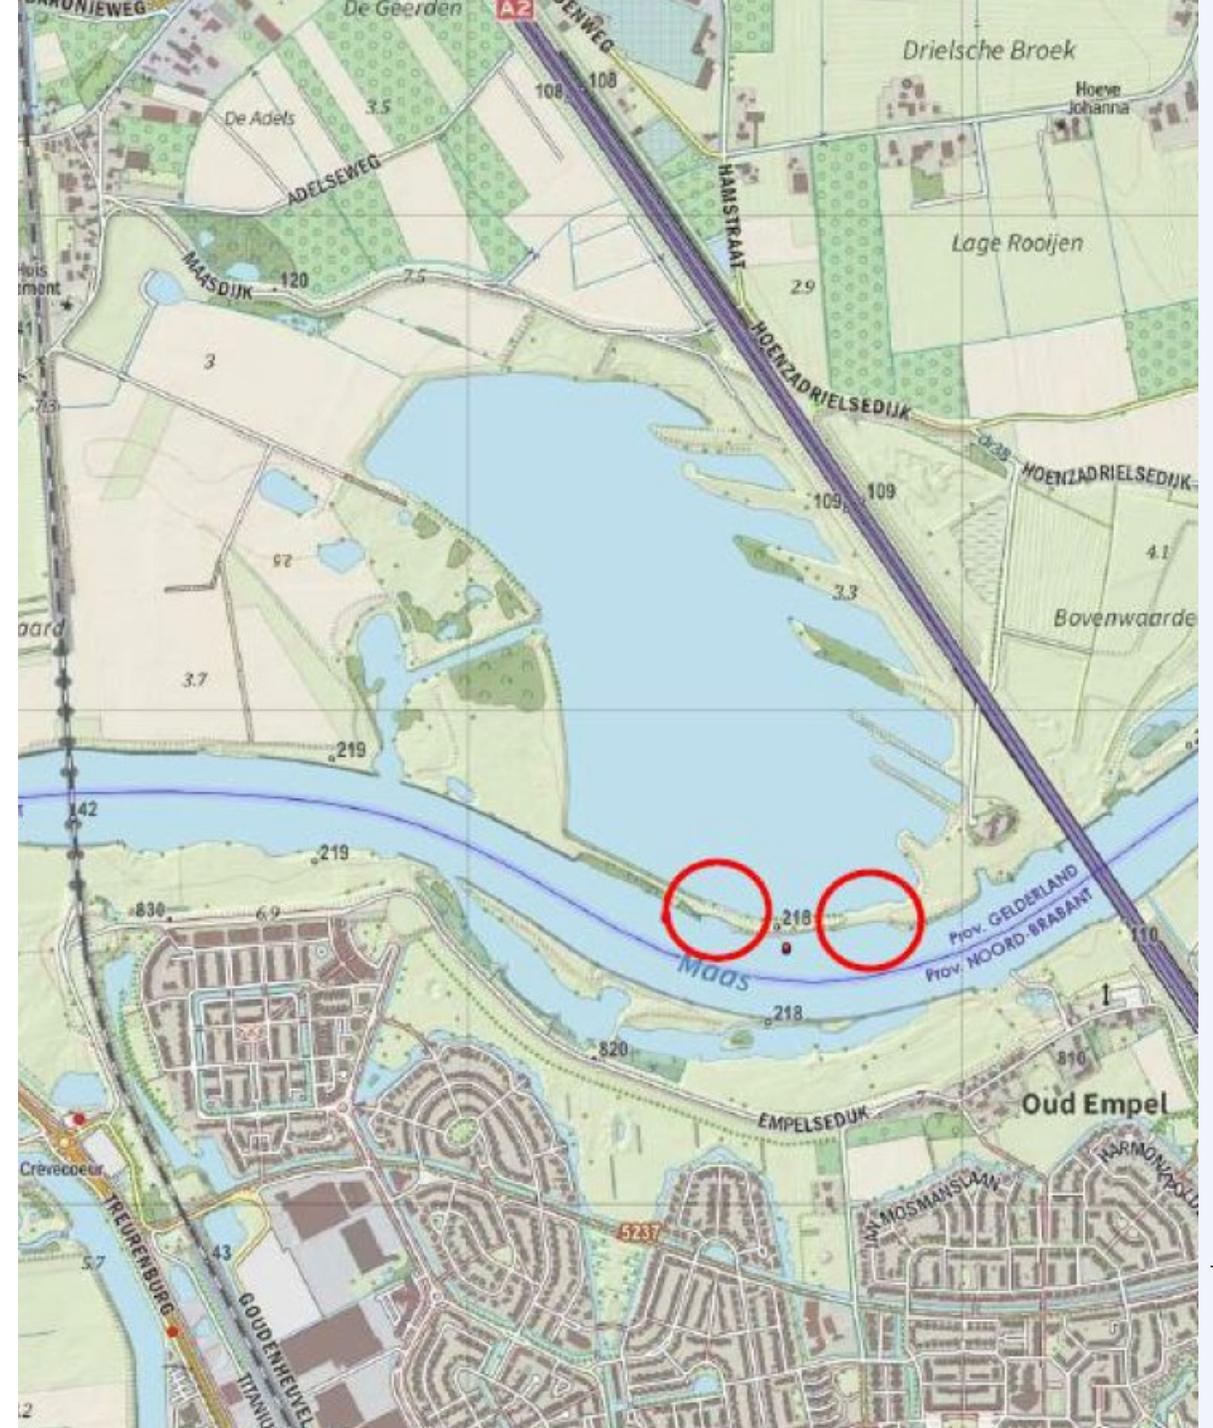
Hedelse Bovenwaard (rkm 218)

- High bank (3 m above water level)
- Bank not equal in height, locally lower
- Large rates of erosion expected

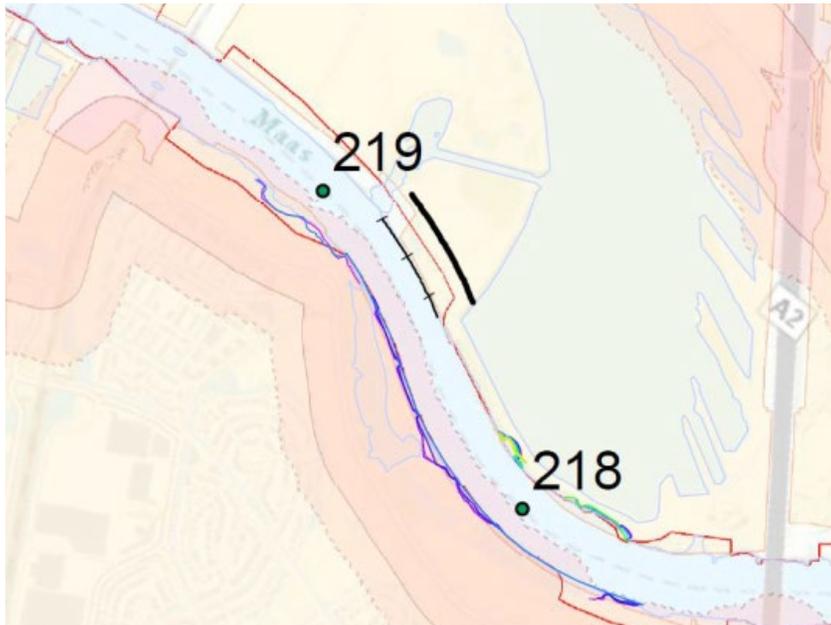
Erosion 2007-2020

- Bank not equal in height, locally lower
-> overtopping
- Shipwaves
