# LIME TREATMENT IN HYDRAULIC STRUCTURES

DURABILITY AND OTHER ELEMENTS

Version 1 – 13<sup>th</sup> December 2023

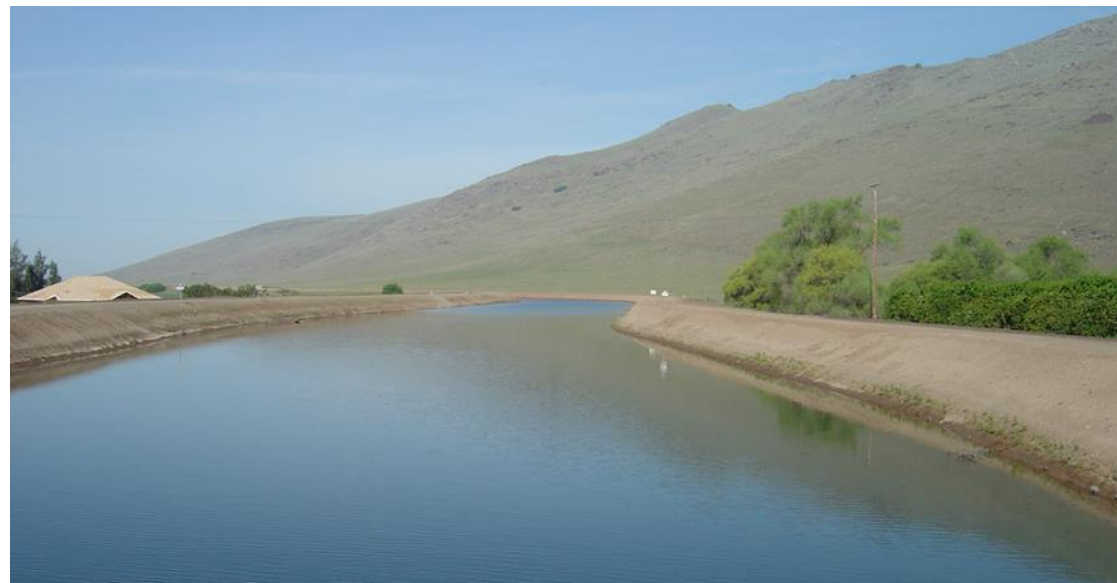
## Disorders since construction

- › Swelling clays ( $I_p \sim 40$ )
- › Slope slides
- › Failures of concrete cover

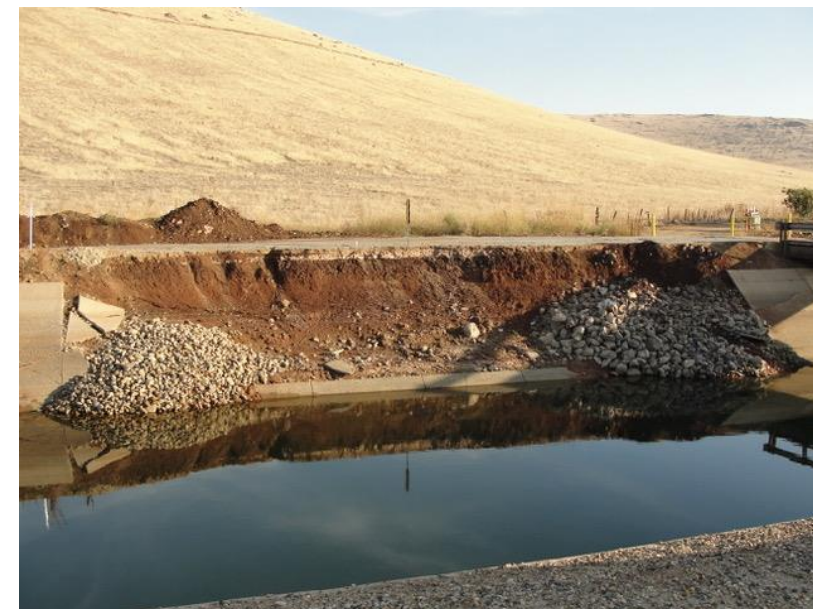
## Repair activities

- › 1972 – 1977: repair of 6,4 km banks
- › *Soil treated with 4% lime*

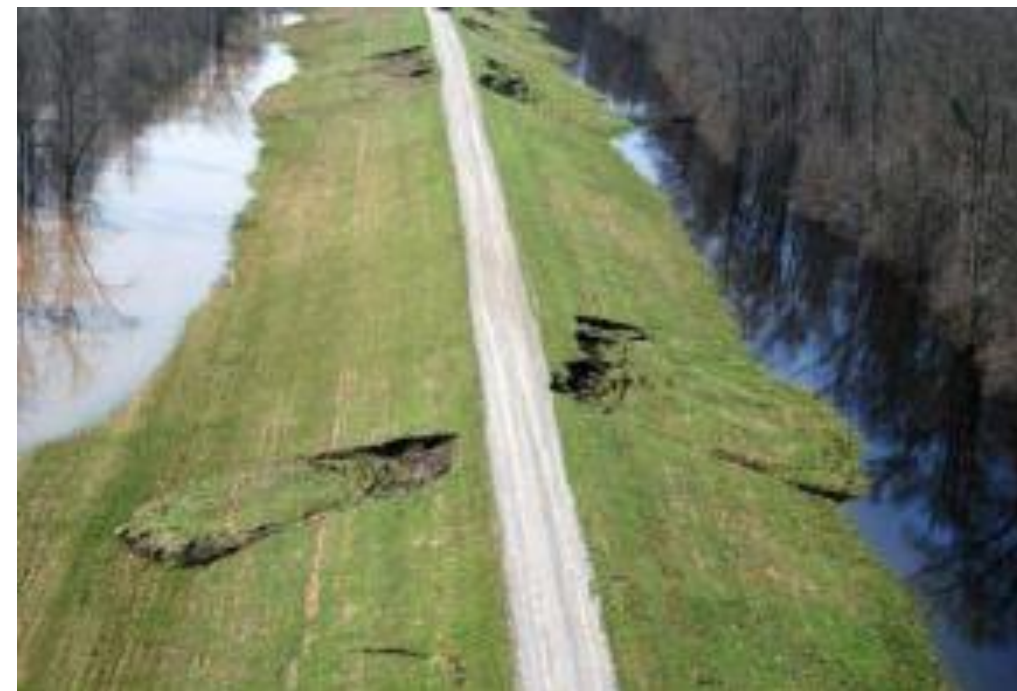
## Disorders since construction

- › Cracks in the body during dry periods (1 to 2 m deep)
- › Water infiltration during wet periods through cracks
- › Slope too steep for low residual resistance of very plastic swelling clays
- › Surface slidings (tens of m) or even failure

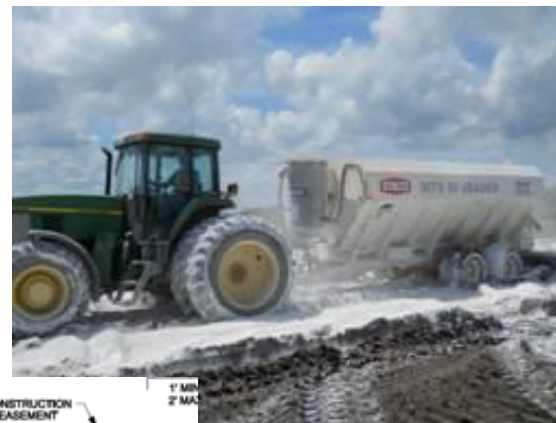
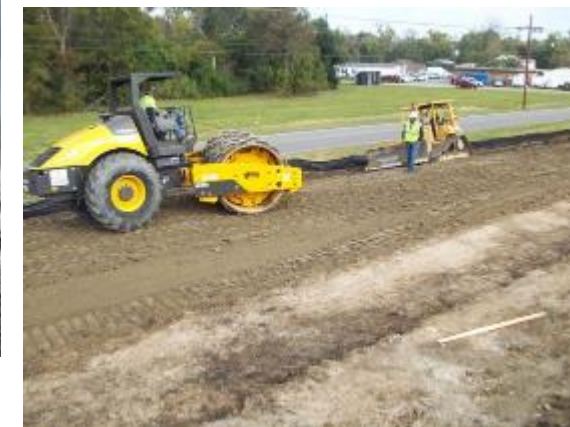
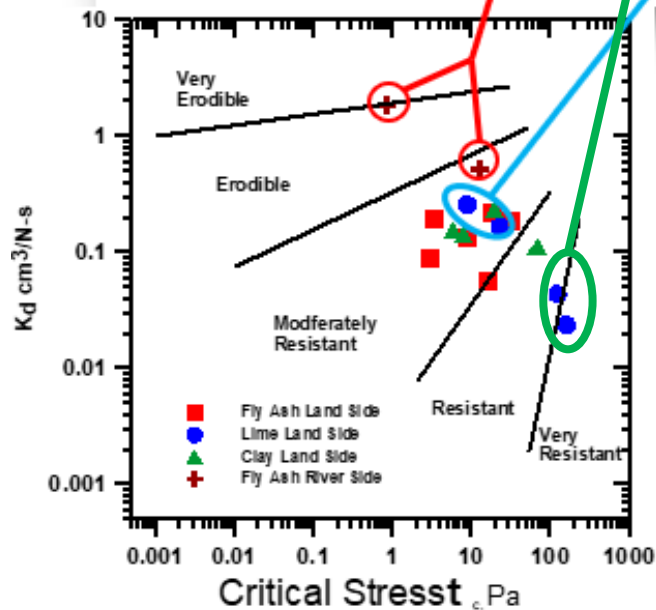
## Reinforcement of 45 km in (early 2010s)

- › Plaquemine Parish dike
- › *Treatment with 8% lime*
- › In-situ JET tests

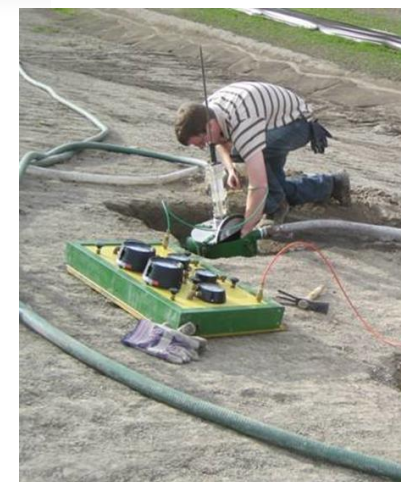
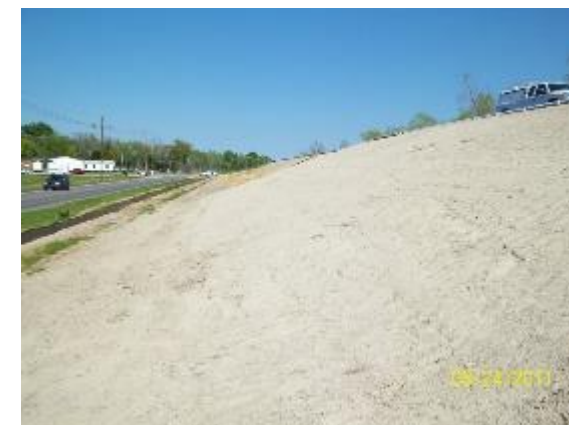
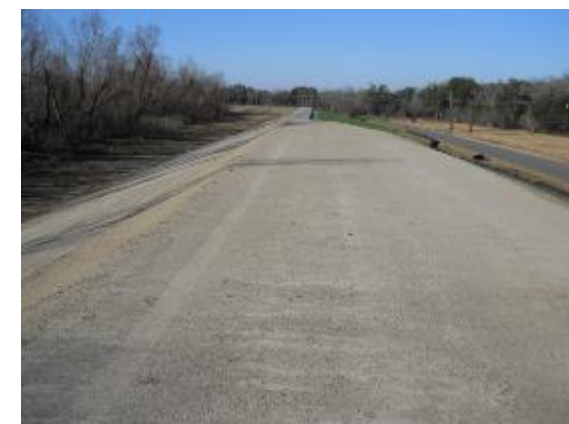
**Raised geometry:  
compaction efficiency  
issues**

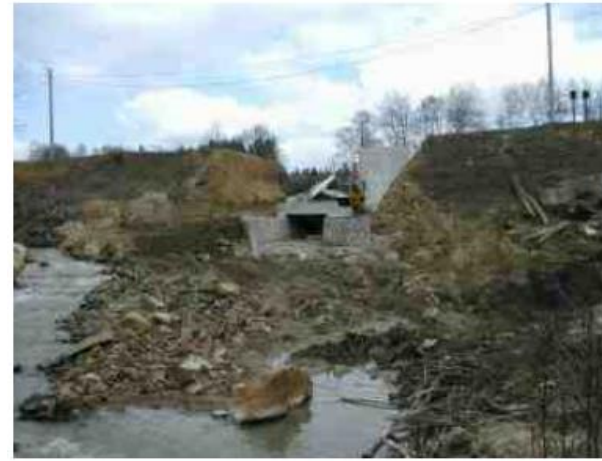
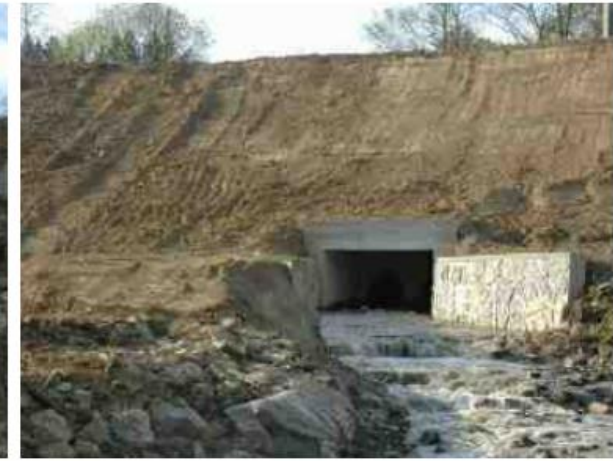
## Dike of Chobot lake (2002)

- › Breach after 2002 floods
- › Reconstruction with *lime treatment*

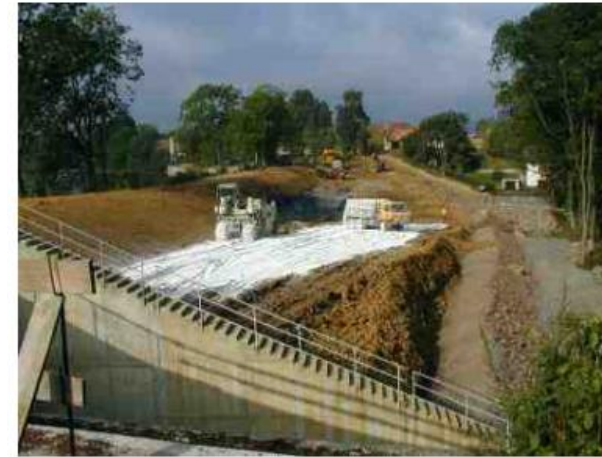
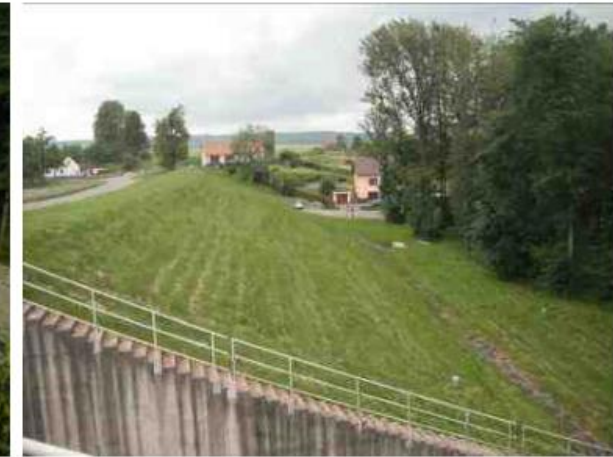
## Dike of Hvezda lake (2004)

- › Damages after 2002 floods
- › Difficulties of reconstruction due to very wet soils
- › Reconstruction with *lime treatment*

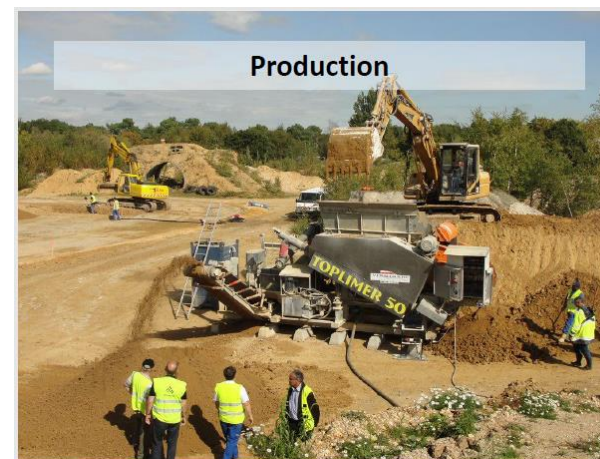
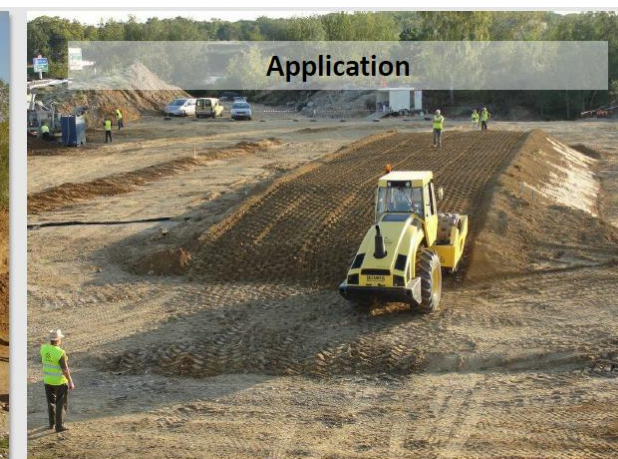
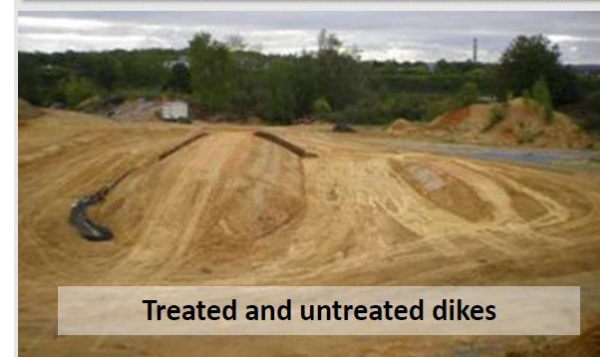
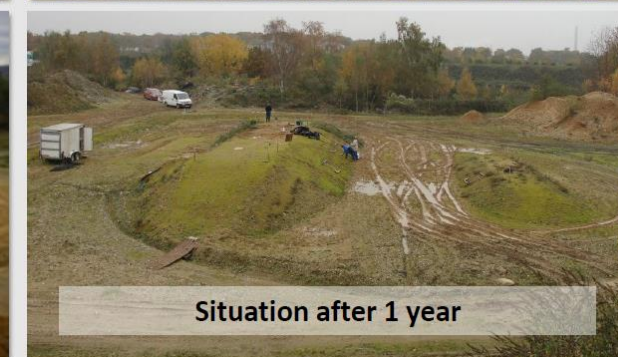
- › Silty Soil ( $I_p = 11$ )
- › **2,5% lime treatment**
- › Height: 2m
- › Slope: 3/2
- › Mobile treatment facility

- › Permeability
- › Coring - mechanical performance
- › Internal and external erosion
- › Vegetation

- › Physico-chemical analysis
- › Sampling of blocks - mechanical performance
- › Microstructural analysis

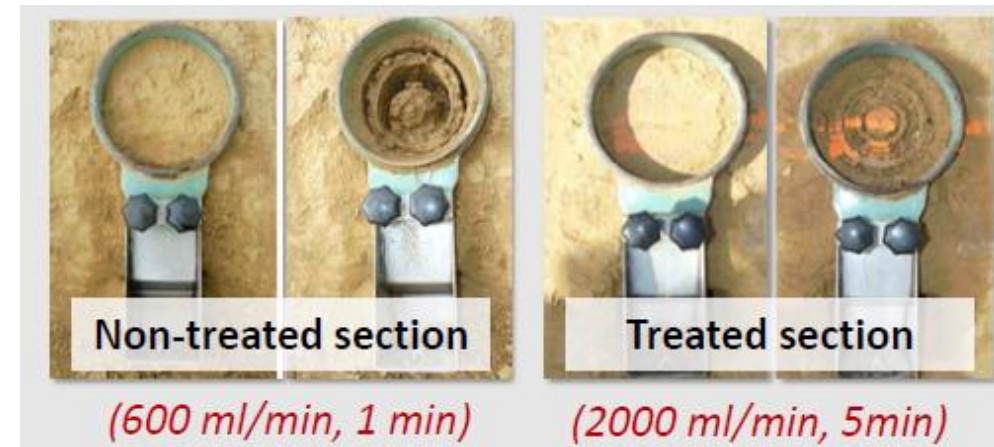
Loss of lime effect on a small surface thickness ( $\sim 10$  cm)

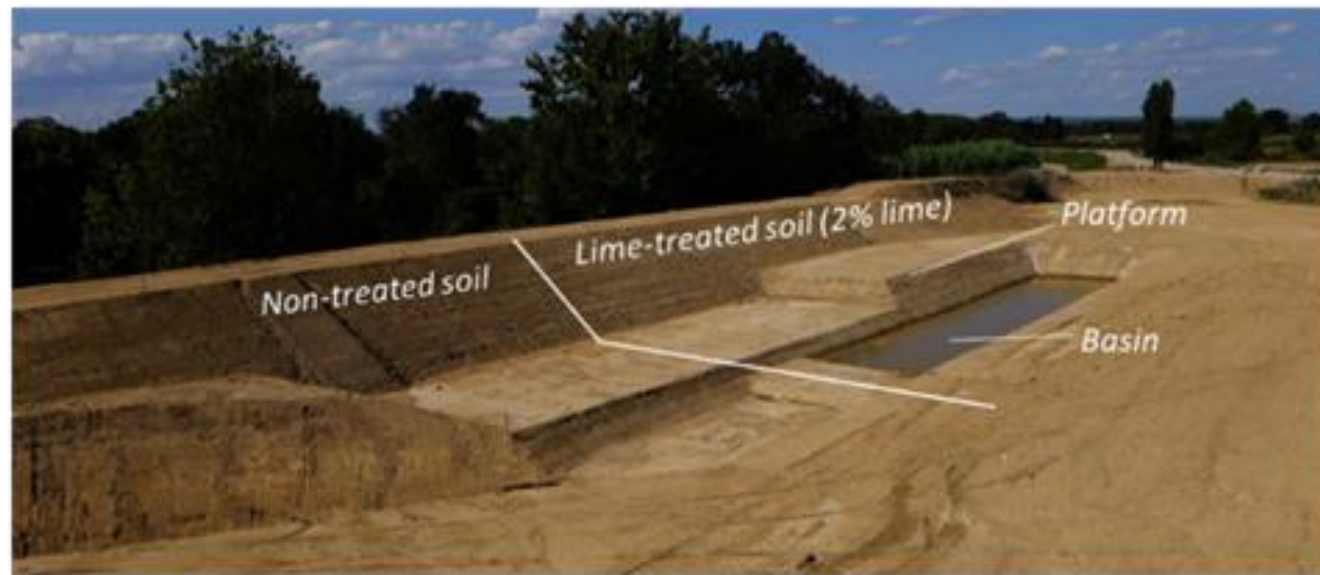
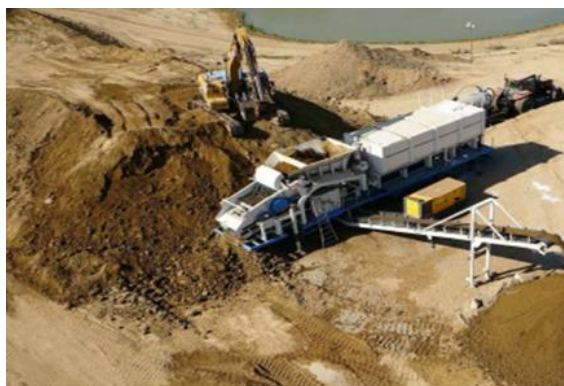
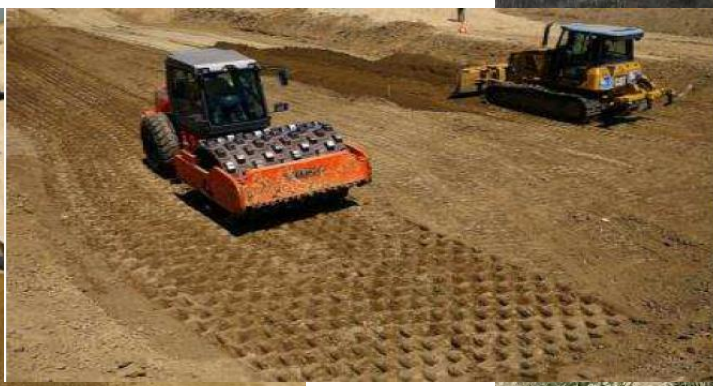
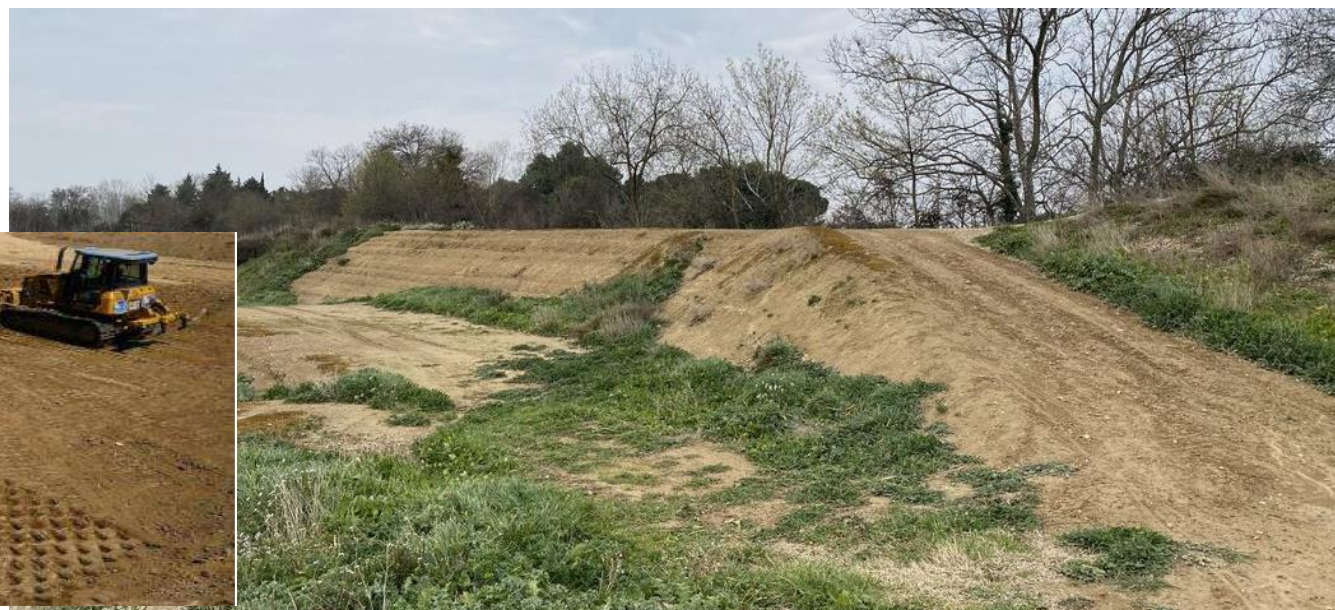
- › Silty soil ( $I_p = 5$ )
- › **2% lime treatment**
- › Height: 3,5m
- › Slope: 3/2
- › Mobile treatment facility

- › Lab feasibility tests
- › After construction
  - › External erosion JET (1 – 6 years)
  - › Overflowing tests (9 – 22 months)
  - › Mechanical performance (7 years)
  - › Physico-chemical analysis (6 years)

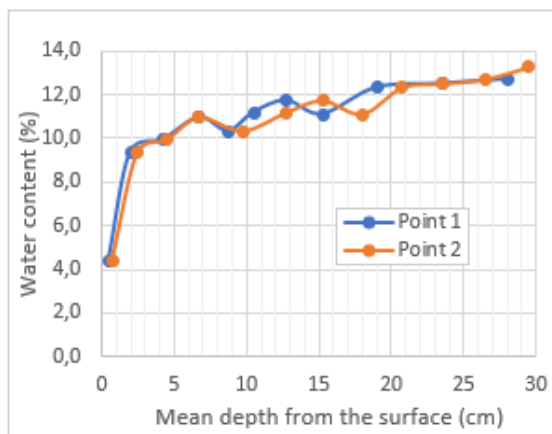
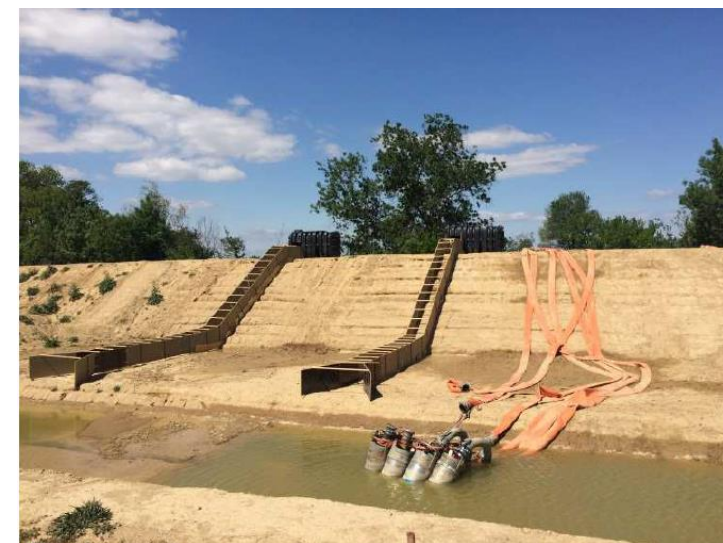
- › **Low permeability:**  $10^{-8}$  to  $10^{-10}$  m/s after 6 years from the construction
- › Increased resistance to **internal and external erosion**  
 Overflowing test & JET: x2 to x100 more resistant after 6 years ( $50 < \tau_c < 2000$  Pa)  
 HET test in-situ sampling: no erosion ( $\tau_c > 500$  Pa - device measurement threshold)
- › Increase and maintenance of **mechanical resistance** (some heterogeneities)  
 0,2 MPa natural soil | 1,2 MPa soil reconstituted in lab (1 year) |  $0,8 < R_c < 2,4$  MPa (6 years)  
 Cohesion x12 – x20 compared to natural soil
- › **Superficial cracks** rapid drying/suction phenomena (high temperature during construction)
- › Thickness of **environmental degradation:** 10-20 cm

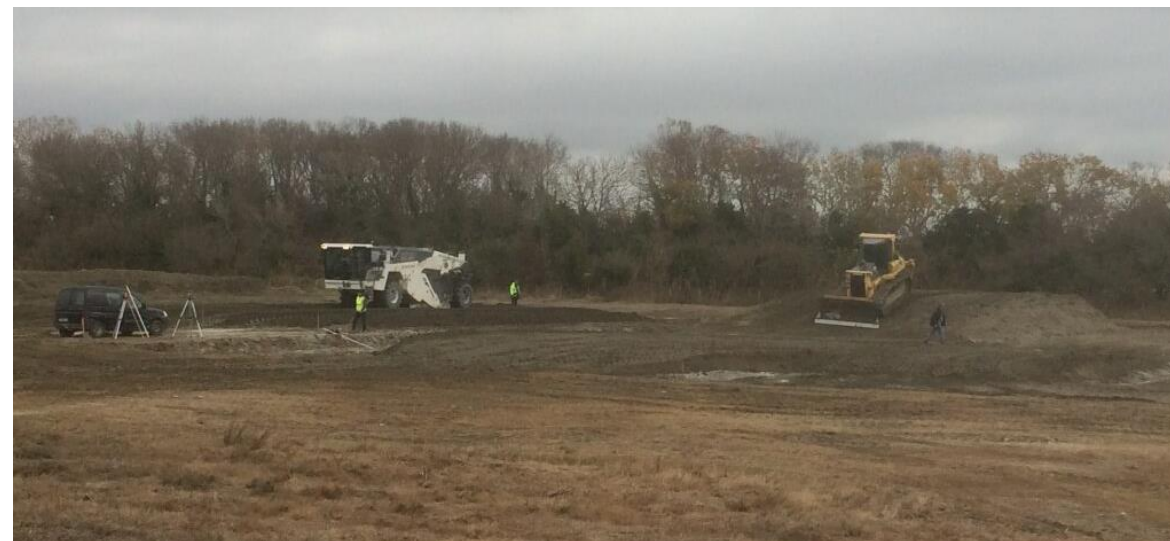
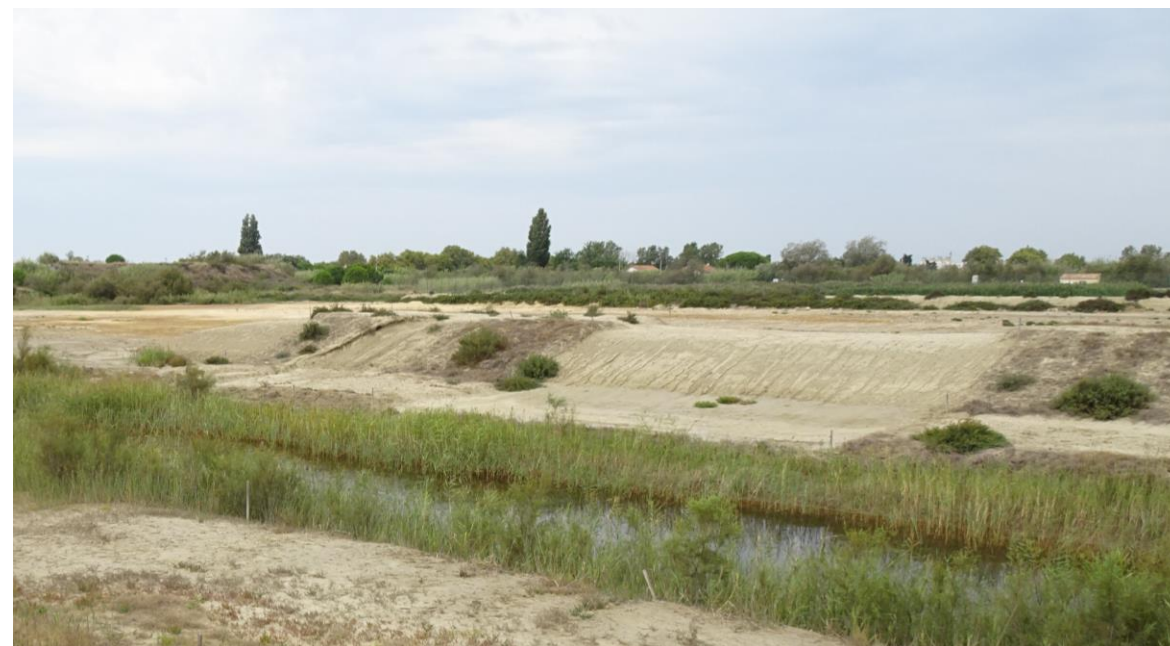
- › Mix of sandy - silty soil + clay (average  $I_p = 9$ )
- › **2% lime treatment**
- › Height: 2m
- › Slope: 2,5/1
- › Treatment on the platform
- › Saline environment

- › Lab feasibility tests
- › After construction
  - › Overflowing tests (6 months)
  - › Internal/external erosion HET/JET on cores (1 year)
  - › JET tests (5 years)
  - › Mechanical tests on cores (5 years)
  - › Physico-chemical analysis (5 years)

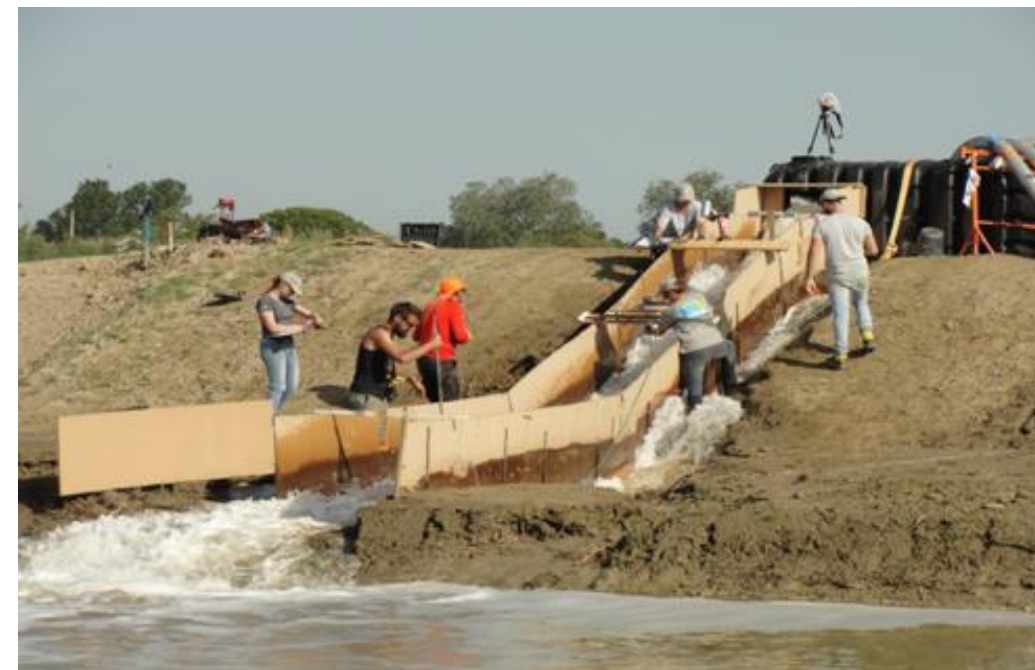
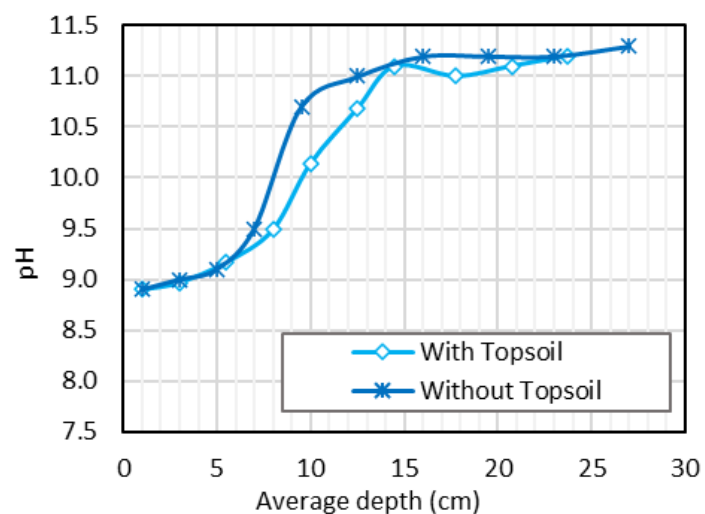
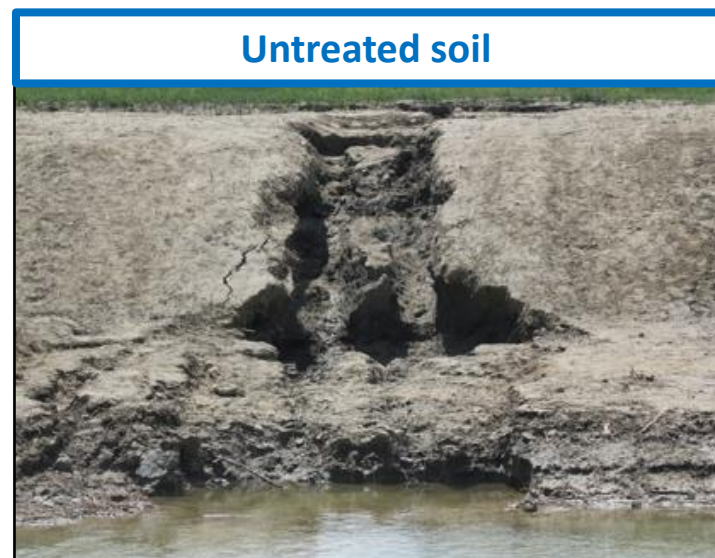
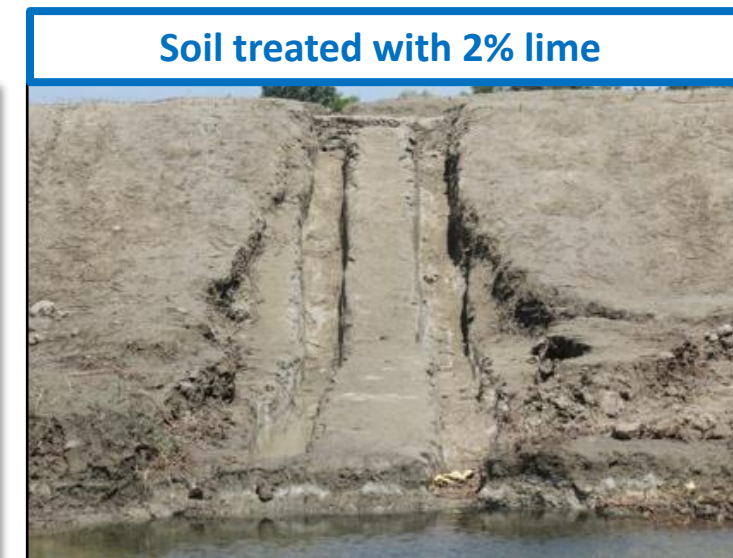
- › **Low permeability:**  $10^{-9}$  to  $10^{-10}$  m/s after 5 years from the construction
- › Very good resistance to **external erosion** (overflowing tests)
  - Little to no erosion vs breakdown of untreated soil (2h of stress under  $q = 400$  l/s/m,  $h = 35$  cm)
- › High resistance to **internal erosion**
  - HET tests after 5 years ( $\tau_c = 450$  Pa)
  - JET tests on samples taken in situ after 1 year ( $\tau_c = 350$  Pa)
  - JET tests on surface after 5 years ( $100 < \tau_c < 150$  Pa) to be compared with values on material taken in situ (in progress)
- › Mechanical characterization ongoing (5 years)

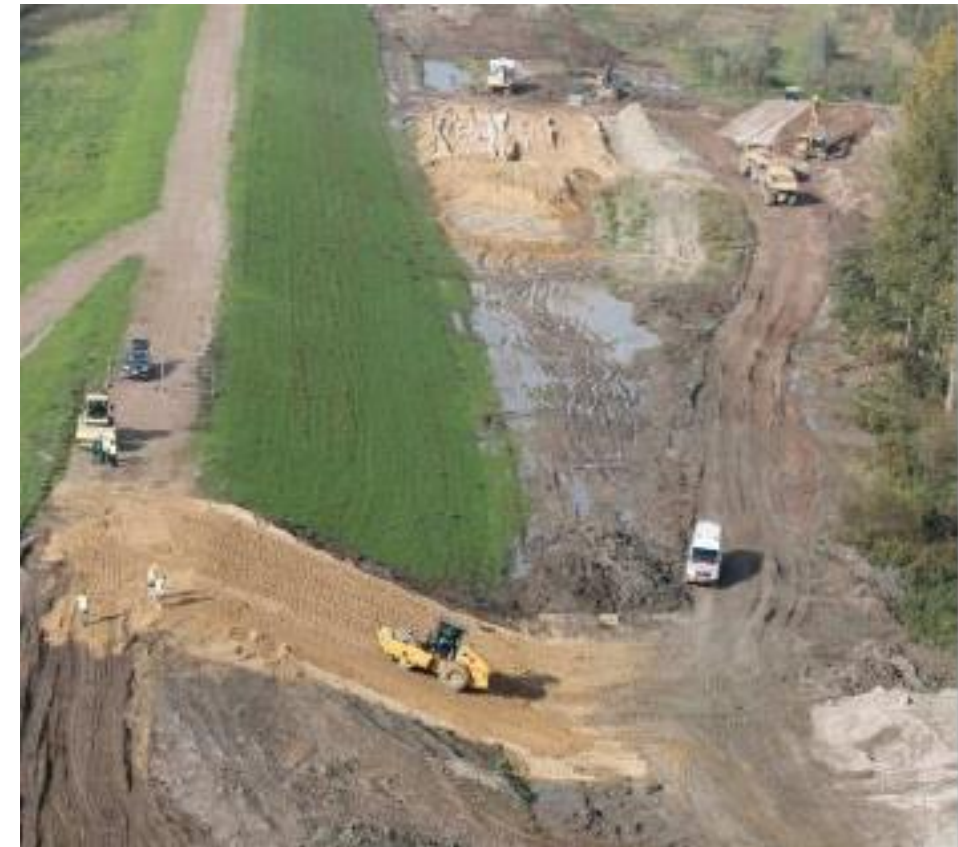
# VLASSEN BROEK DEMONSTRATOR (BELGIUM)

- › Silty Soil ( $I_p = 8-10$ ) → **2% lime treatment**
- › Sandy Soil ( $I_p = 3$ ) → **3% formulated lime treatment**
- › Protective shell
- › Height: 6,5m
- › Slope: 3/1
- › Treatment on the platform
- › Compaction in the direction of the slope

- › Lab feasibility tests
- › After construction
  - › Permeability
  - › Vegetation growth
  - › Mechanical performance
  - › External erosion (JET)
  - › Overflowing tests planned for 2024/2025

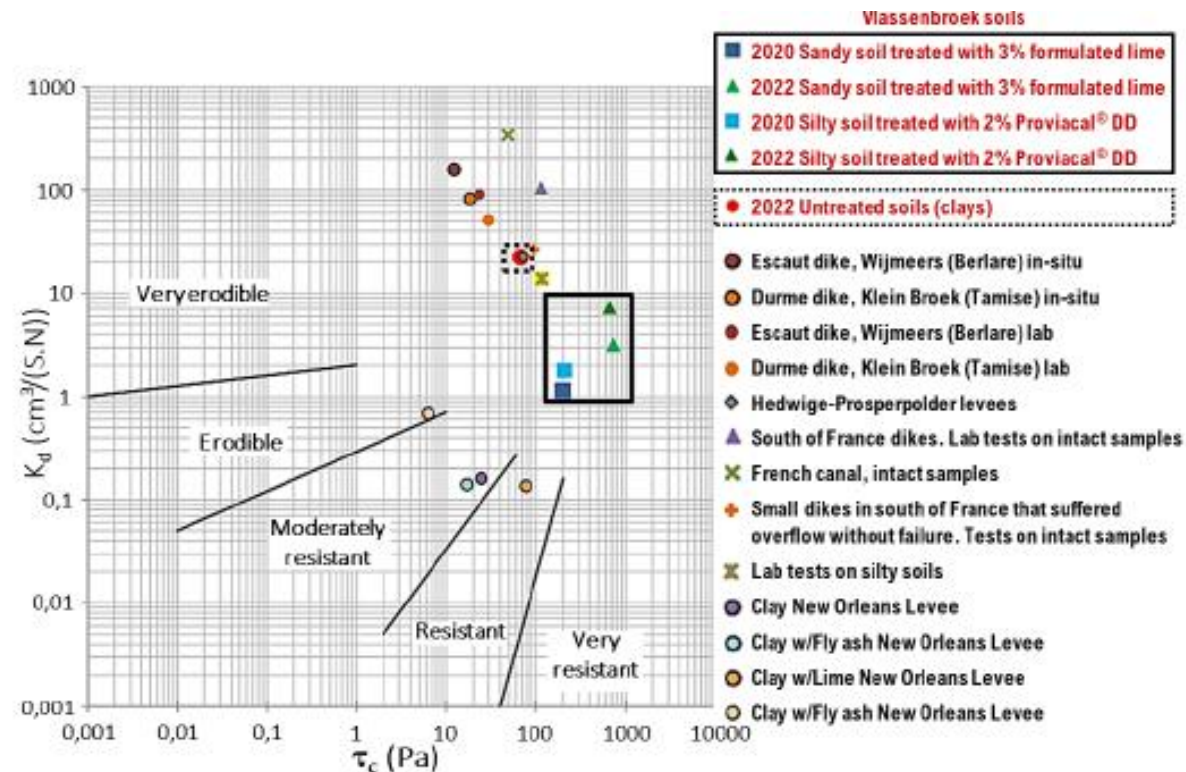
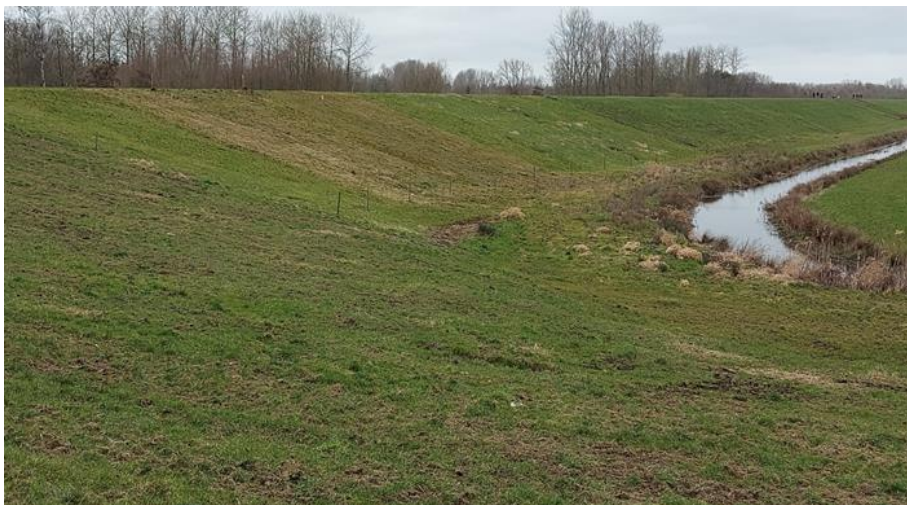
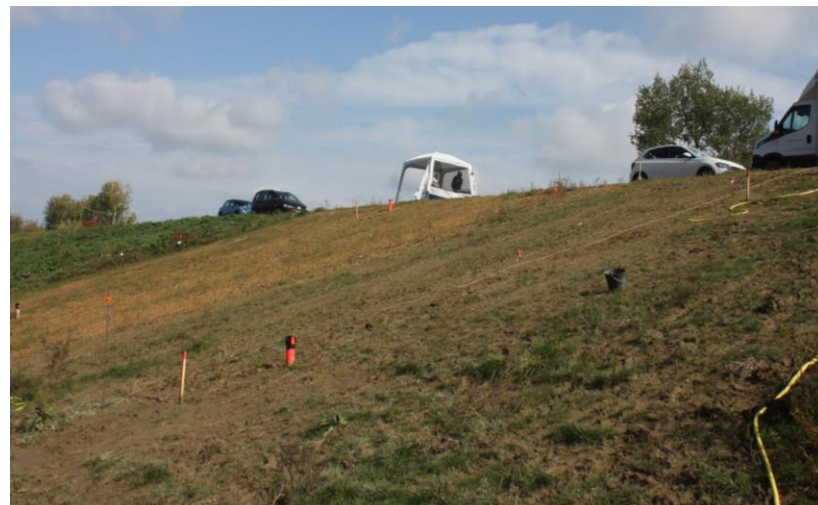
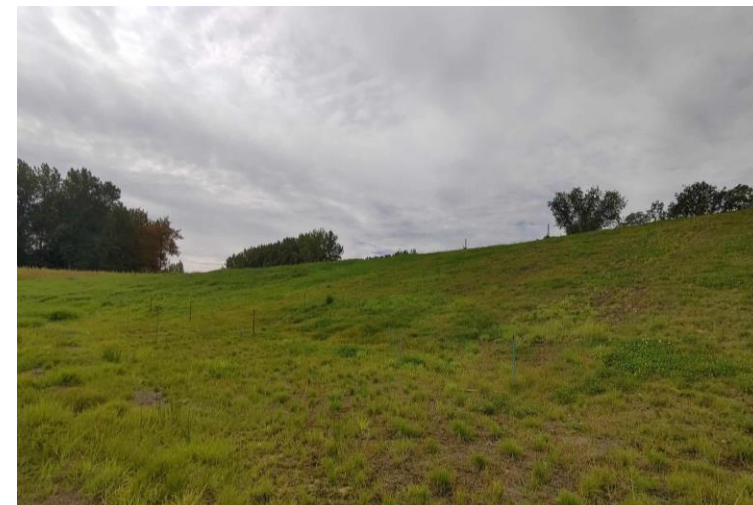
# VLASSEN BROEK DEMONSTRATOR (BELGIUM)

- › Increase **external erosion** through JET (1 year to 3 years)  
 $160 < \tau_c < 250$  Pa to  $280 < \tau_c < 1000$  Pa
- › Gradual improvement in **vegetation growth**
- › Monitoring of **permeability** by infiltration tests using tubes or double rings on in-situ samples  
 Average permeability  $\sim 10^{-7}$  m/s
- › Evolution of **mechanical resistance** monitored with a light penetrometer  
 Too high resistance (in the first 20-40 cm) after 1 year  
 Onsite coring planned for 2024-2025
- › Overflowing tests planned for 2024-2025

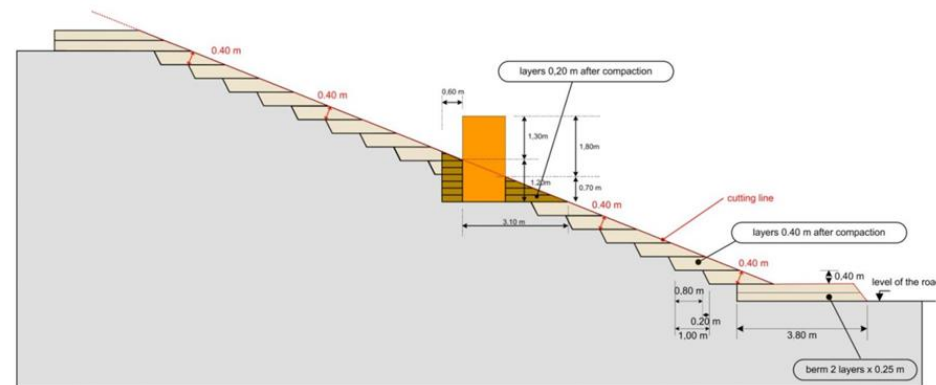
# HEDWIGEPOLDER DEMONSTRATOR (THE NETHERLANDS)

- › Clayey Soils ( $I_p = 20$  to 45)
- › **4% - 5% lime treatment**
- › Protective shell
- › Height: 8m
- › Slope: 2,5/1
- › Treatment on the platform
- › Staircase compaction
- › Presence of obstacles on the slope

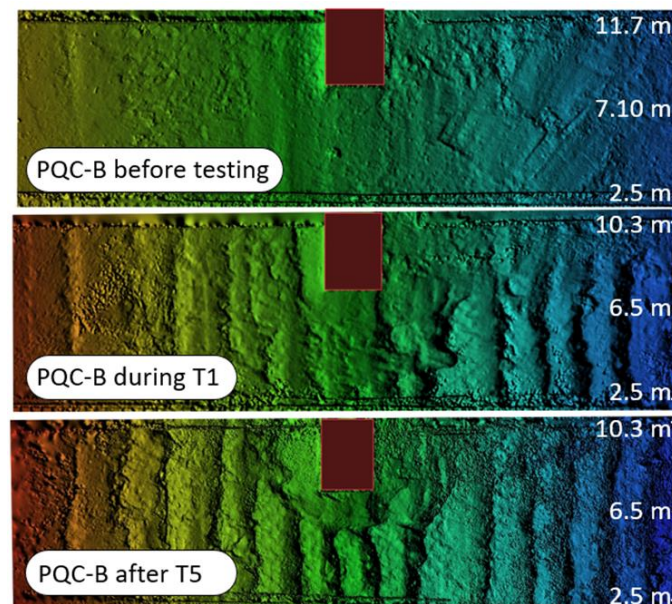
- › Lab feasibility tests
- › After construction: overtopping tests after 3 months

- › Good resistance to **external erosion**
- › Improved **availability** of usable materials
- › Increased **resistance to erosion around obstacles**
